TEST REPORT

REPORT No.:
CTK-2026-02102

4. Test sample / Model : NETWORK CAMERA / XNV-A9095RZ

6. Test Standard (Method) used : IEC 62262:2002+AMD1:2021

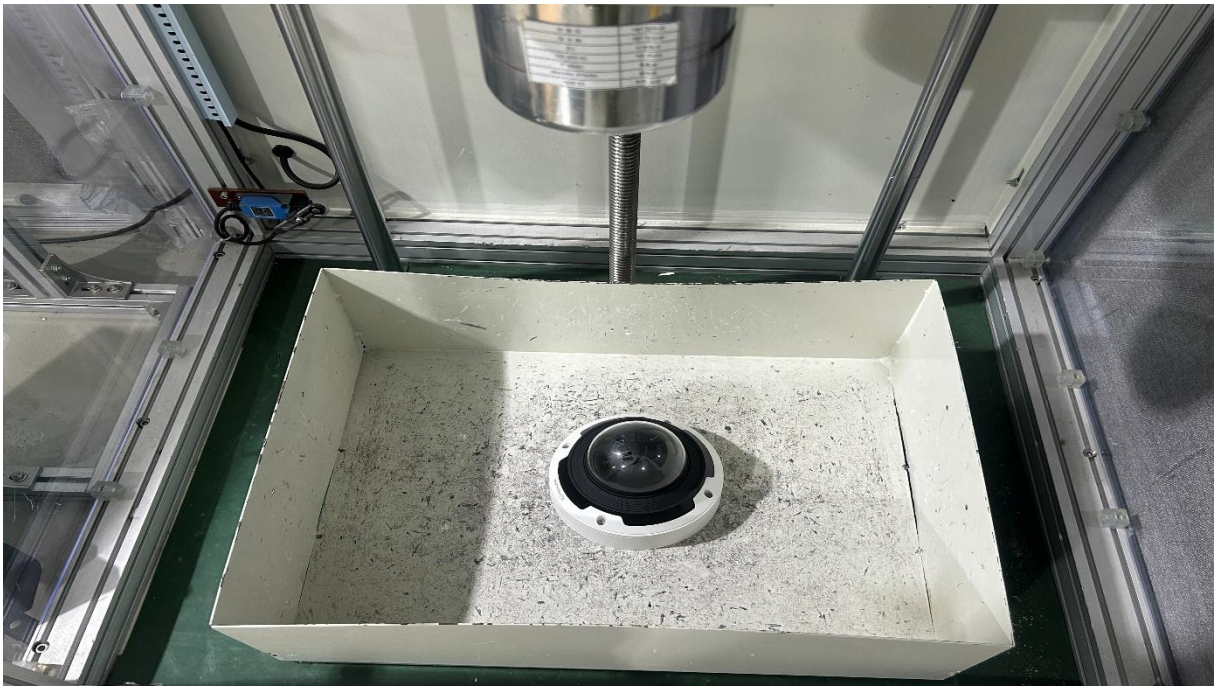
3.3.1 Evidence of test setting

Evaluation Criteria	Test Results	Remark
Visual Inspection	Some scratches were generated on the outside of the Sample.	-
