# TEST REPORT

REPORT No.:  
CTK-2025-00975  
Page (1) / (14) pages

NETWORK CAMERA / PNO-A9092R

IEC 60529:1989 +A1:1999+A2:2013

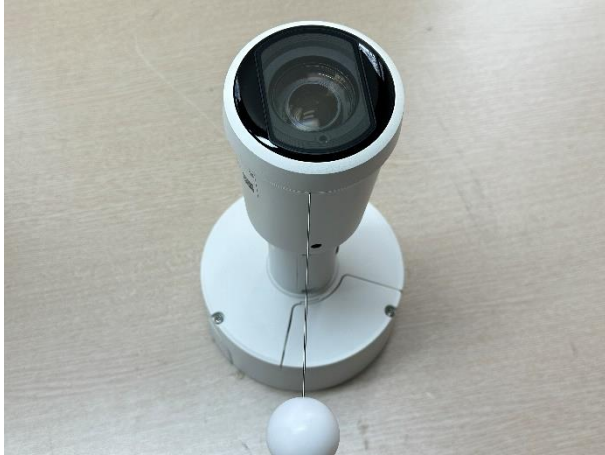
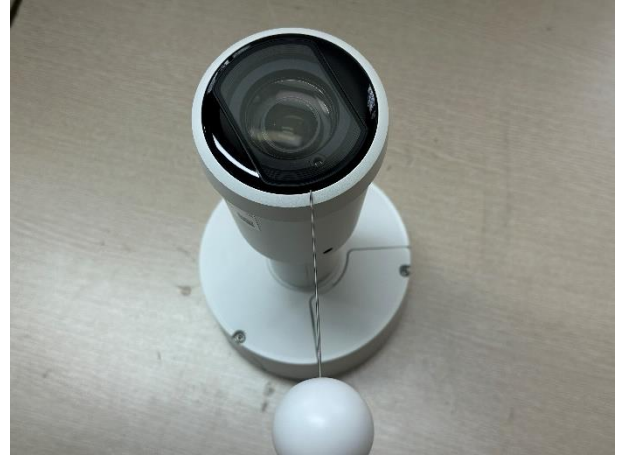
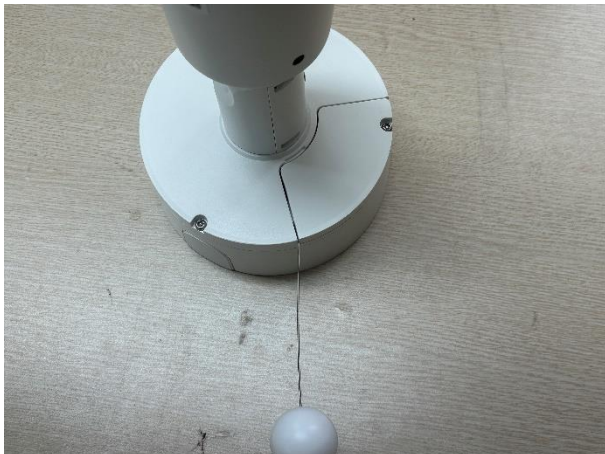
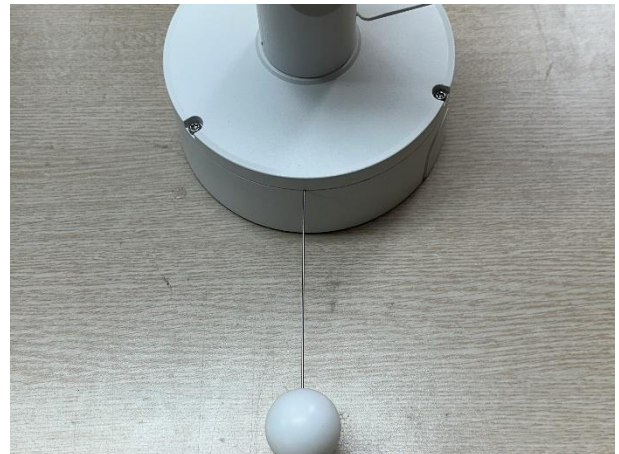
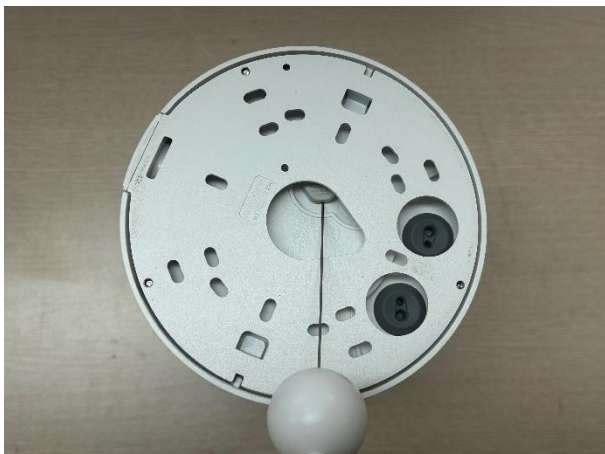
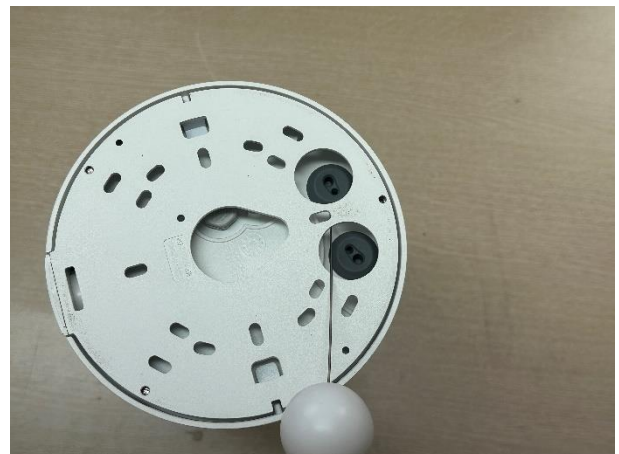
#### 3.3.1 Evidence of test setting (1)

| First characteristic numeral | Degree of protection | Application |
|---|---|---|
| 6 | Protected against access to hazardous parts with a wire.<br>The access probe of 1.0 mmØ, shall not penetrate.<br>Test force: 1 N ± 10 % | <input checked="" type="checkbox"/> |

Probe test

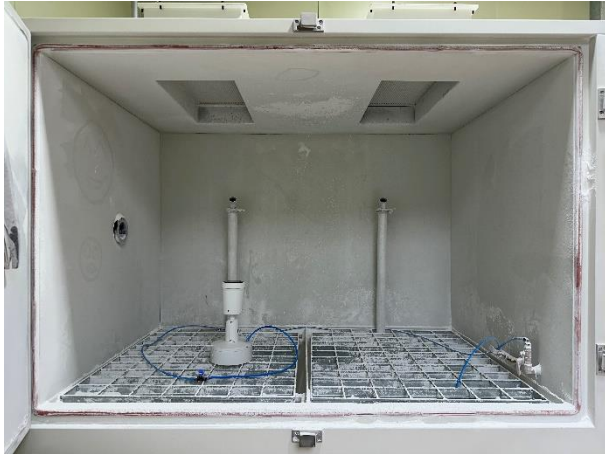
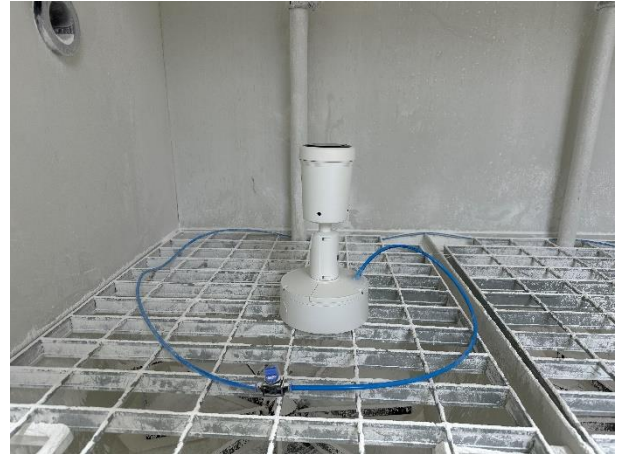
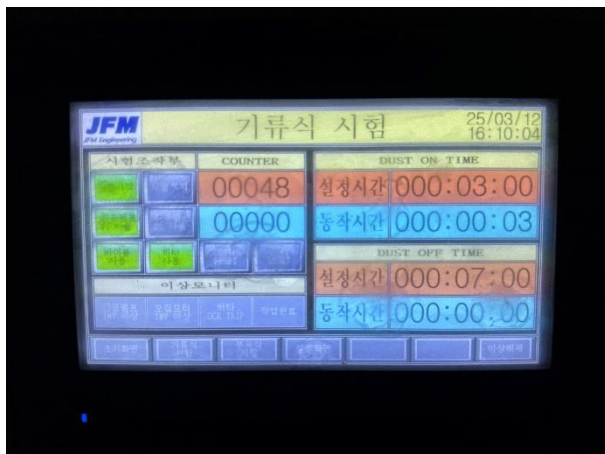
### 3.3.2 Evidence of test setting (2)

| First characteristic numeral | Degree of protection | Application |
|---|---|---|
| 6 | <p>In Dust Testing Equipment, the test sample must have no ingress of dust after testing atmospheric pressure present condition for 8 h.</p> <p>(The talcum powder must pass through a calibrated sieve with a 50 µm wire mesh, spaced at 75 µm intervals in a square pattern. Additionally, the bulk density of the talcum powder should be 2 kg/m<sup>3</sup>)</p> <p>Products in volume .....: <b>7 626.24 cm<sup>3</sup> → 7.63 L</b></p> <p>Target intake volume (Products in volume 80) : <b>610.1 L</b></p> <p>Suction volume (Max product in volume 60) ..: <b>457.57 LPH → 7.63 LPM</b></p> <p>Actual Suction volume .....: <b>7.63 L</b></p> <p>Suction pressure (Up to 2 kPa) .....: <b>1.78 kPa</b></p> <p>Test time (Up to 8 time) .....: <b>8 hr</b></p> | <input checked="" type="checkbox"/> |

Dust test

Dust test Monitor

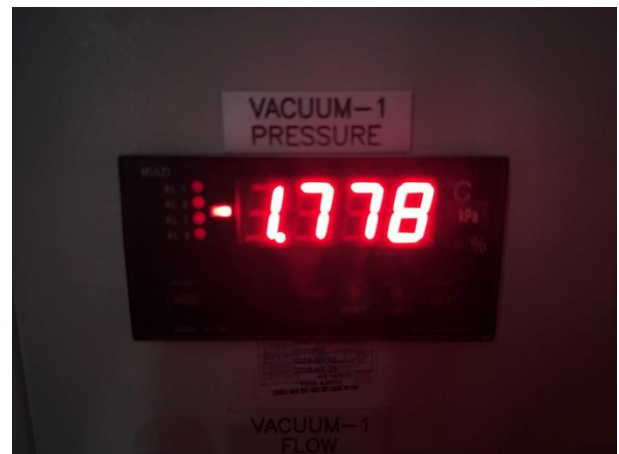
Digital Vacuum Pressure

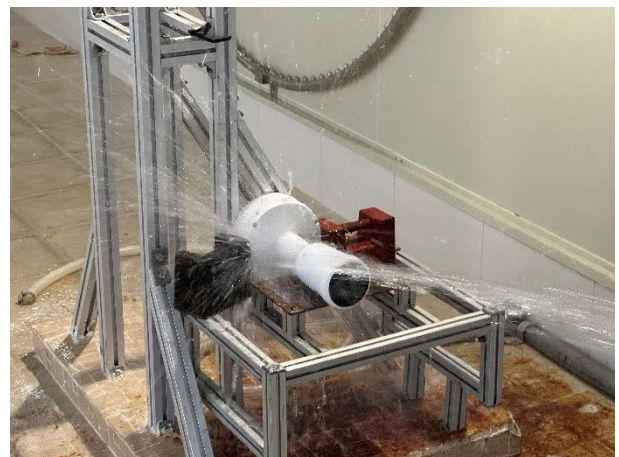
| Second characteristic numeral | Degrees of protection | Application |
|---|---|---|
| 6 | <p>The product must not be harmed in any direction even strong jet water.</p> <p>Water jet hose nozzle Fig.6, Nozzle 12.5 mm diameter</p> <p>Water flow rate: 100 l/min ± 5 % : <b>100 LPM</b></p> <p>Distance: 2.5 m to 3 m: <b>3 m</b></p> <p>Duration of test: 1 min/m<sup>2</sup> at least 3 min: <b>3 min</b></p> | <input checked="" type="checkbox"/> |

Water test

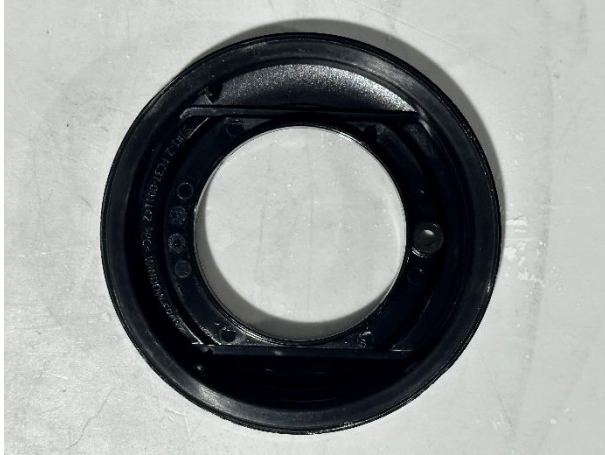
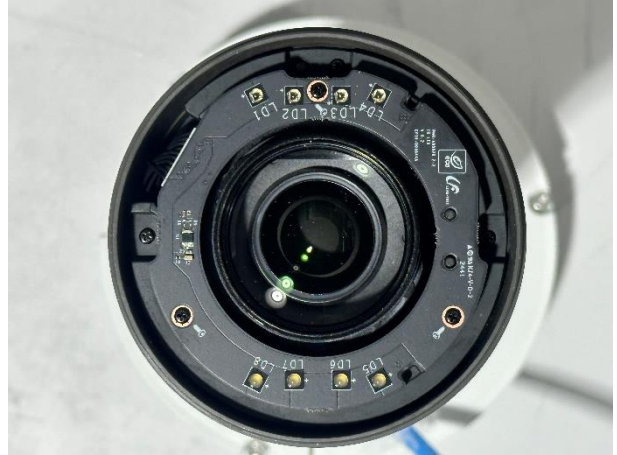
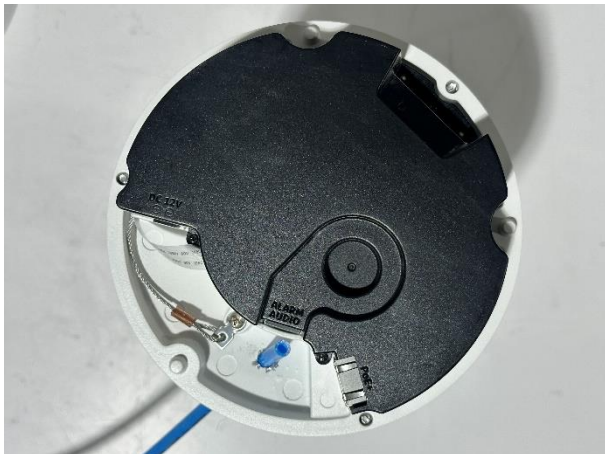
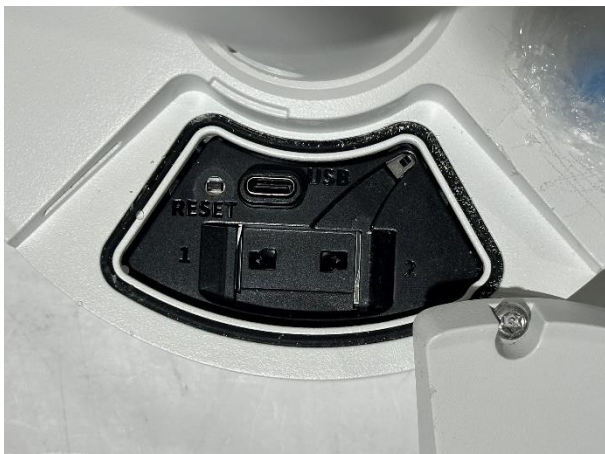
#### 3.5.1 Product internal images after test [The first characteristic numeral test]

| IP code | Evaluation Criteria | Test Results | Remark |
|---|---|---|---|
| IP 6X | No ingress of Probe | Normal | - |
| | No ingress of dust | Normal | - |

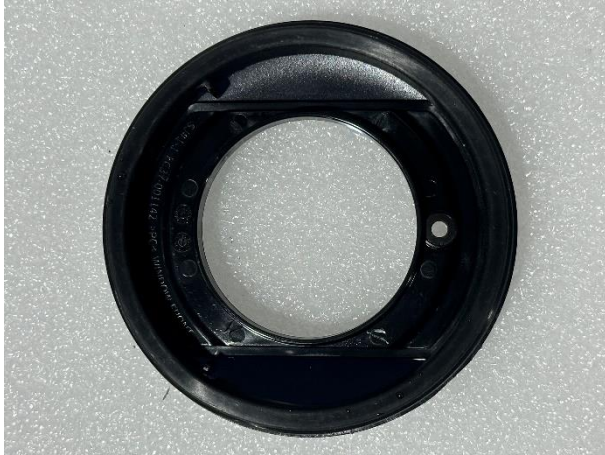
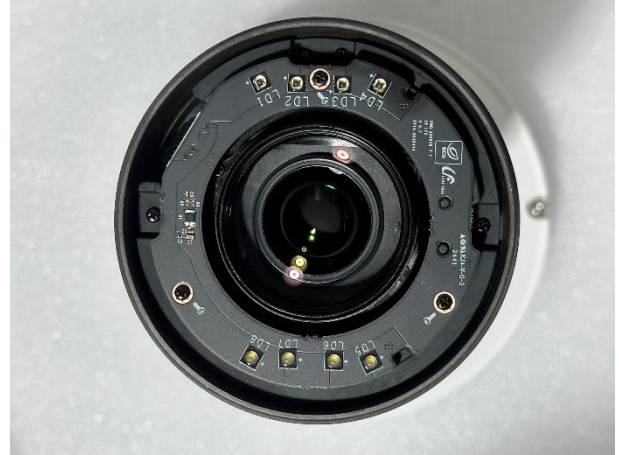
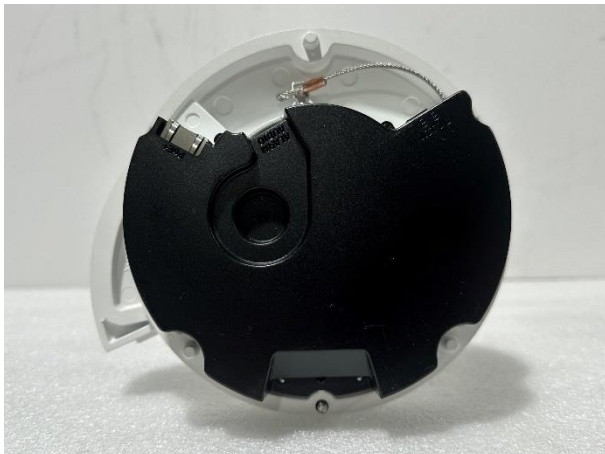
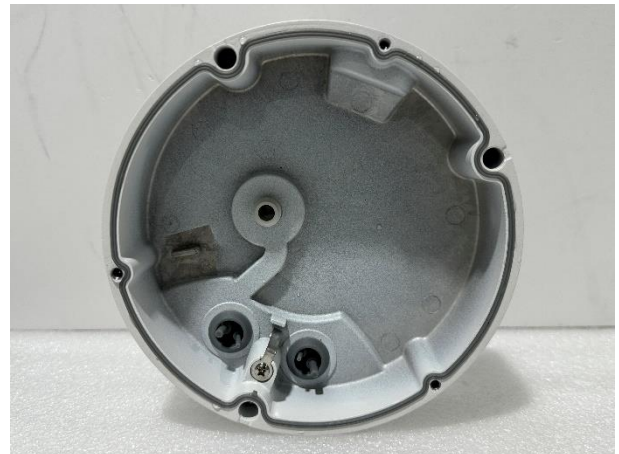
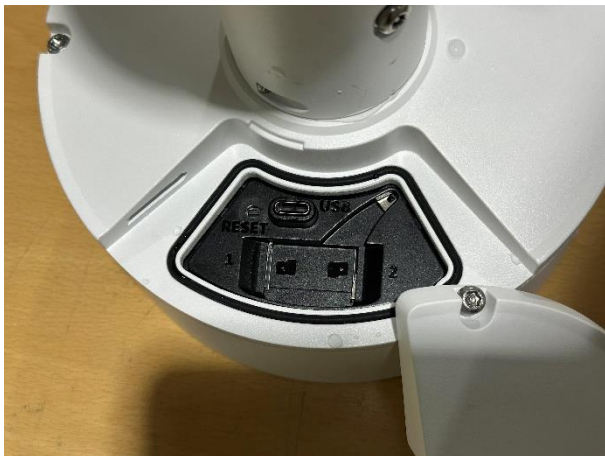
### 3.5.2 Product internal images after test [The second characteristic numeral test]

| IP code | Evaluation Criteria | Test Results | Remark |
|---|---|---|---|
| IP X6 | No ingress of water | Normal | - |
