# TEST REPORT

Report No.:  
CTK-2023-02939  
Page (1) / (20) pages

: NETWORK CAMERA / PNO-A9311R

: IEC 60529:1989 +A1:1999+A2:2013

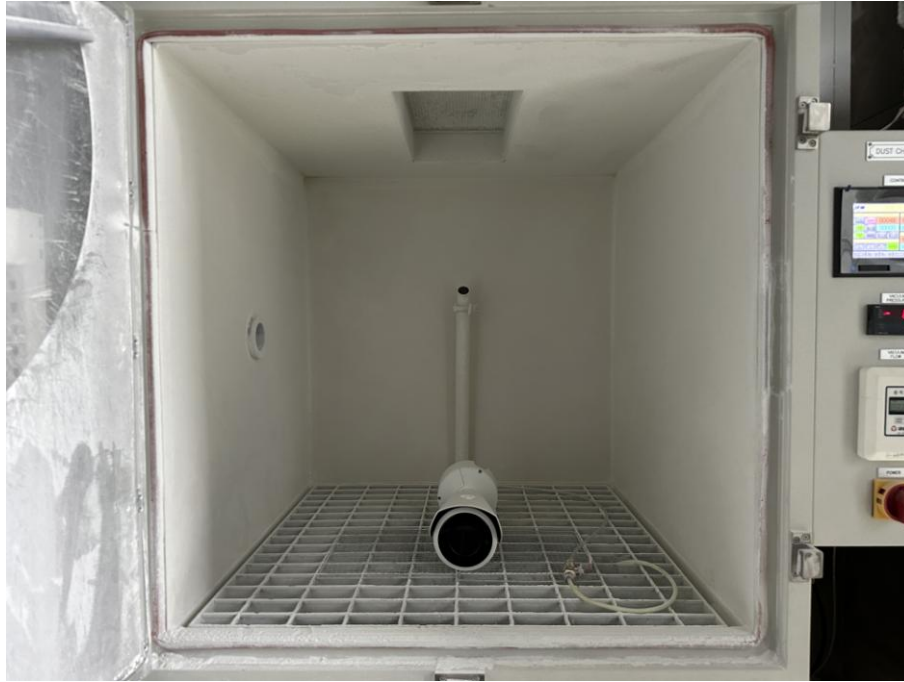
### < Photo 3 > The First Characteristic Numeral Test

| IP Code | Remark |
|---|---|
| IP 6X | No penetration of probe.<br>No ingress of dust. |

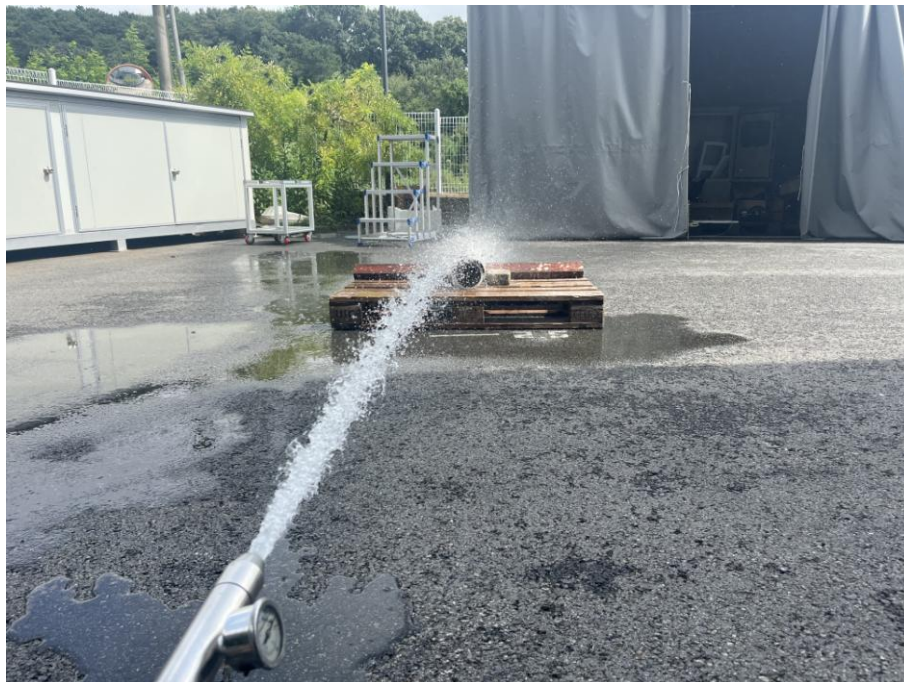
### < Photo 4 > The Second Characteristic Numeral Test

| IP Code | Remark |
|---|---|
| IP X6 | No ingress of water. |
