# TEST REPORT

: NETWORK CAMERA / PNV-A6081R-E2T

: KS C IEC 60529:2013

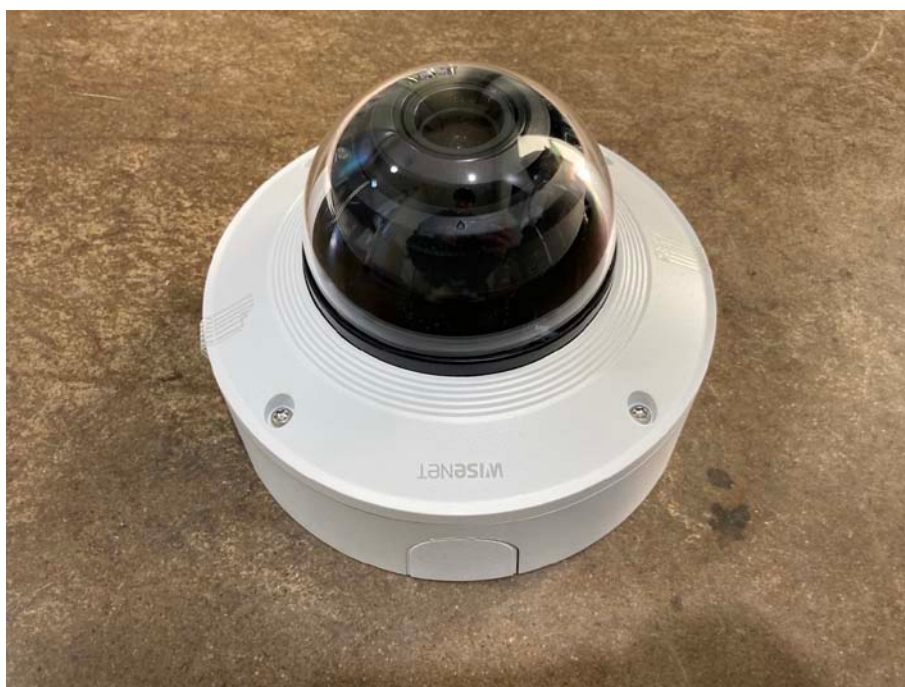
#### < Photo 1 > Product Front View

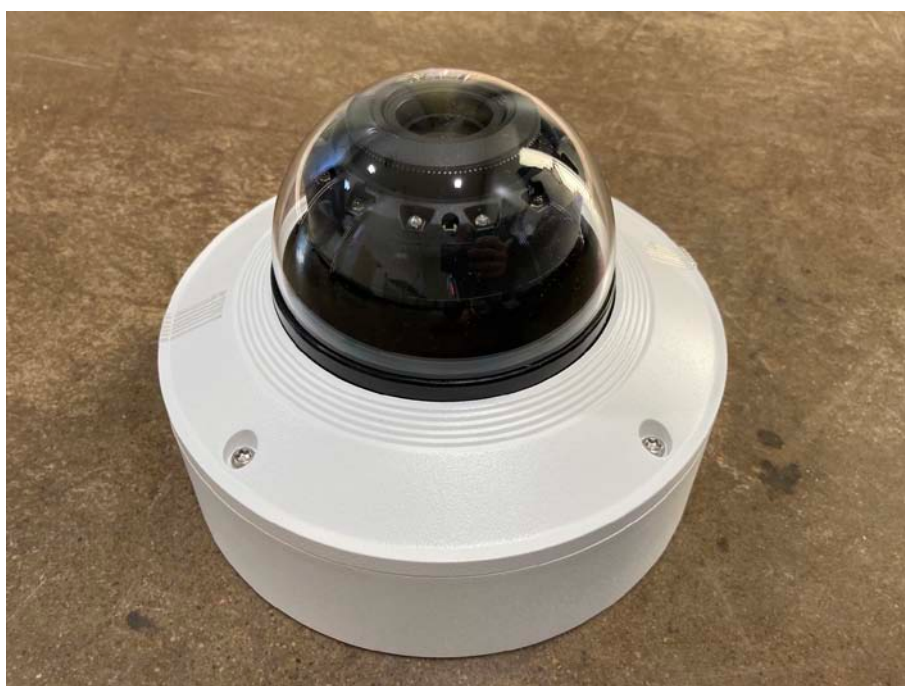
#### < Photo 2 > Product Rear View

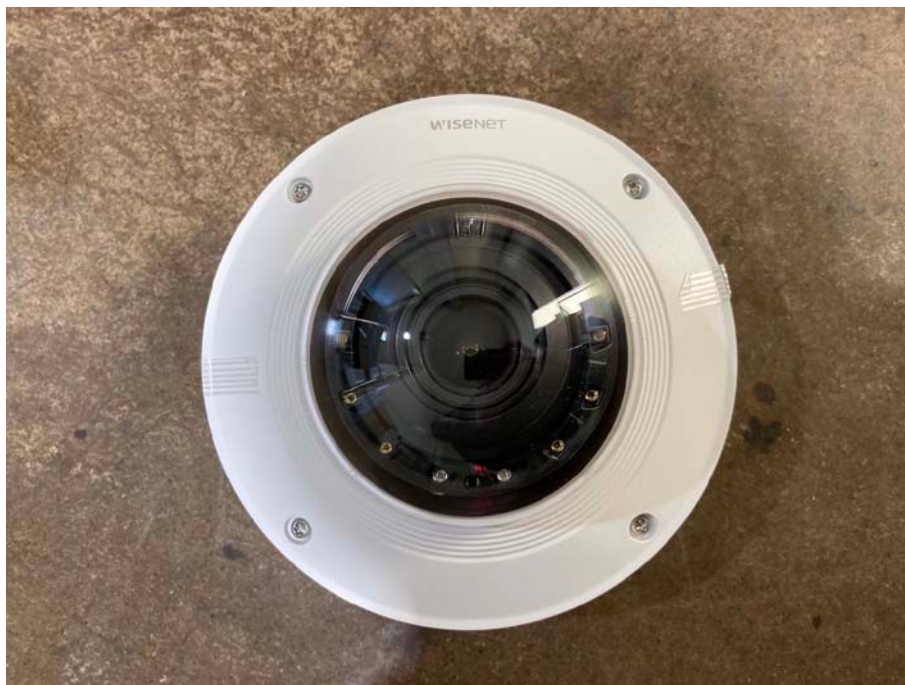
**< Photo 3 > Product Top View**

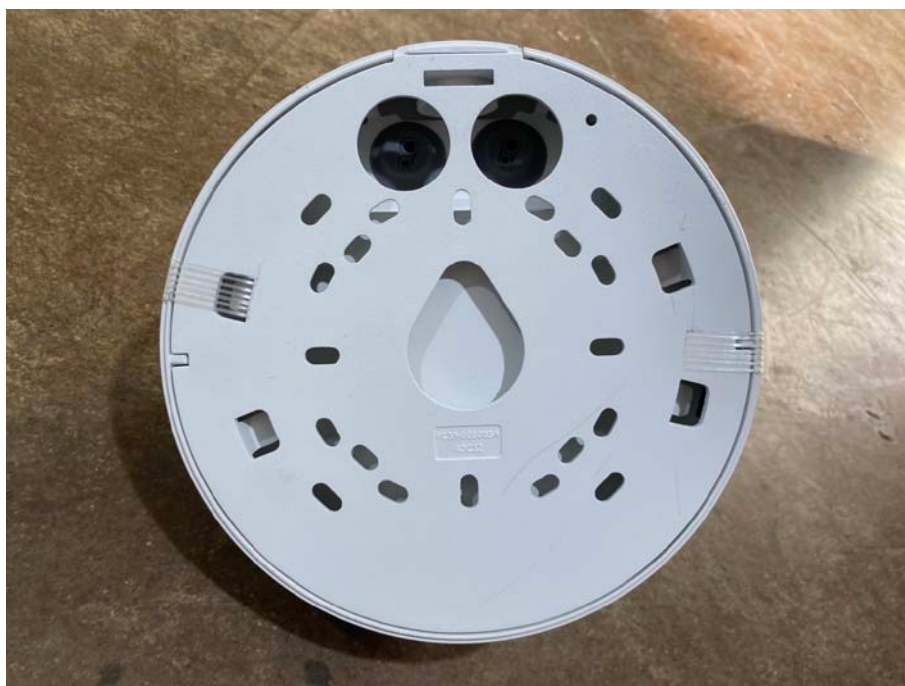
**< Photo 4 > Product Bottem View**

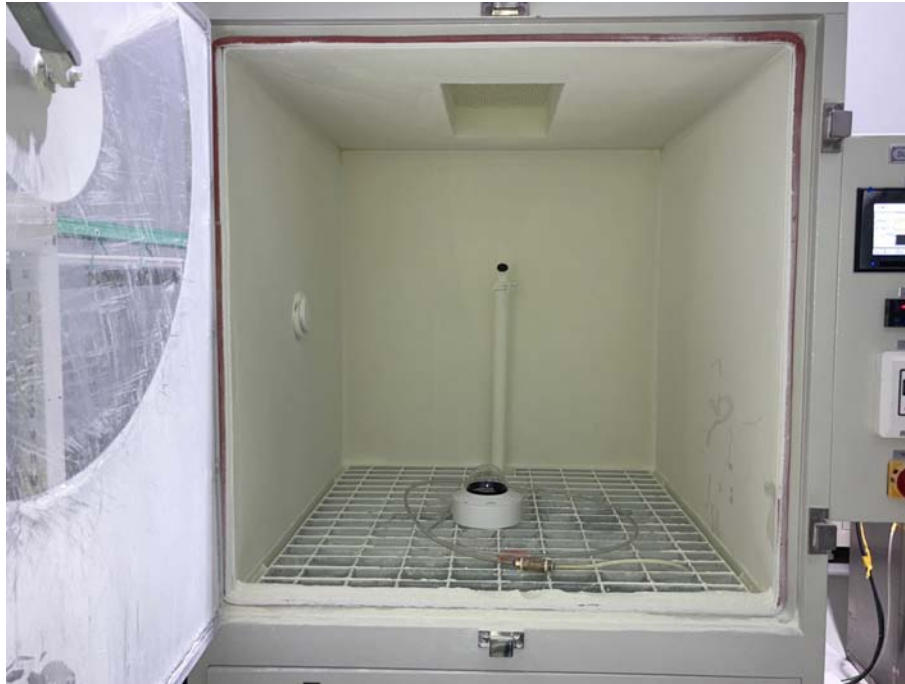
### < Photo 5 > The First Characteristic Numeral Test

| First characteristic numeral | Degree of protection | Application |
|---|---|---|
| 6 | Protected against access to hazardous parts with a wire.<br>The access probe of 1.0 mmØ, shall not penetrate.<br>Test force: 1 N ± 10 % | <input checked="" type="checkbox"/> |

| First characteristic numeral | Degree of protection | Application |
|---|---|---|
| 6 | <p>In Dust Testing Equipment, the test sample has to have no ingress of dust after testing atmospheric pressure present condition for 8 hr.</p> <p>(Talcum powder have to go through the measured sieve by <math>\Phi</math> 50 <math>\mu</math>m wire that are spacing 75 <math>\mu</math>m in squared, per volume and union Talcum powder have to be 2 kg/m<sup>3</sup>)</p> <p>Products in volume .....: <b>5 079.48 cm<sup>3</sup> → 5.08 L</b></p> <p>Target intake volume (Products in volume 80) .....: <b>406.36 L</b></p> <p>Suction volume (Max product in volume 60) .....: <b>304.77 LPH → 5.08 LPM</b></p> <p>Actual Suction volume .....: <b>5.08 L</b></p> <p>Suction pressure (Up to 2 kPa) .....: <b>2 kPa</b></p> <p>Test time (Up to 8 time) .....: <b>8 hr</b></p> | <input checked="" type="checkbox"/> |

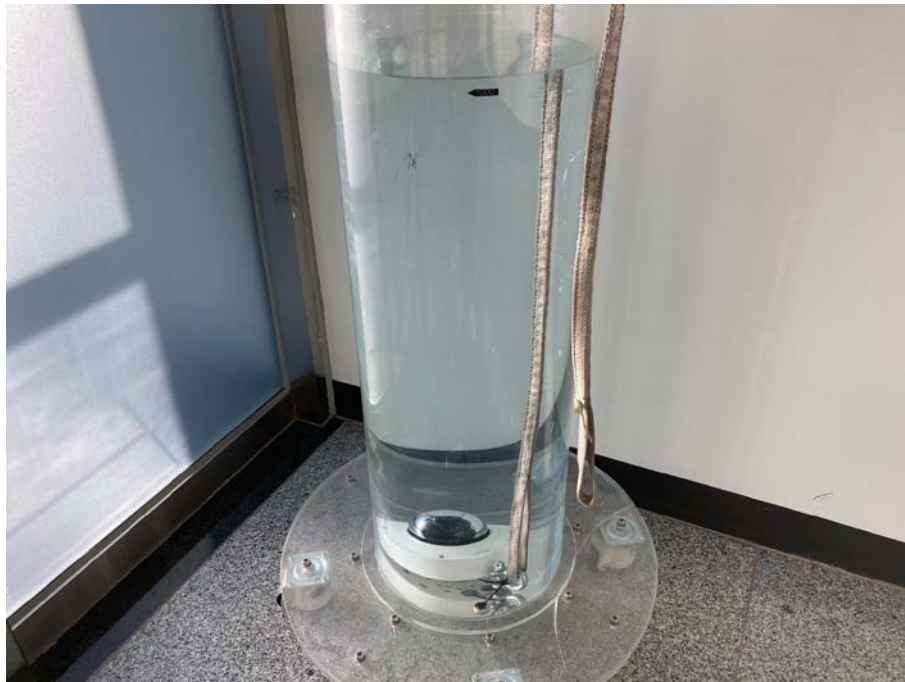
### < Photo 6 > The Second Characteristic Numeral Test

| Second characteristic numeral | Degrees of protection | Application |
|---|---|---|
| 7 | <p>Sink the product in the water by the Pressure and Time according to regulation and the product must not be harmed.</p> <p>Immersion tank water-level on enclosure with:</p> <p><input type="checkbox"/> height equal to or greater than 850 mm: the highest point of enclosures located 0.15 m below the surface of the water</p> <p><input checked="" type="checkbox"/> height less than 850 mm: the lowest point of enclosures located 1 m below the surface of the water</p> <p>Duration of test: 30 min</p> | <input checked="" type="checkbox"/> |

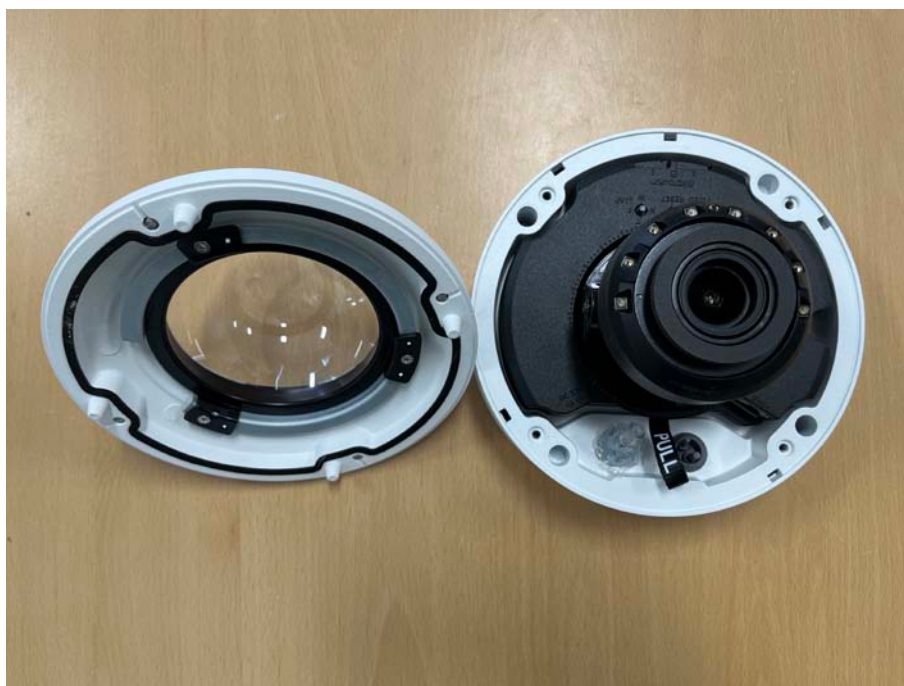
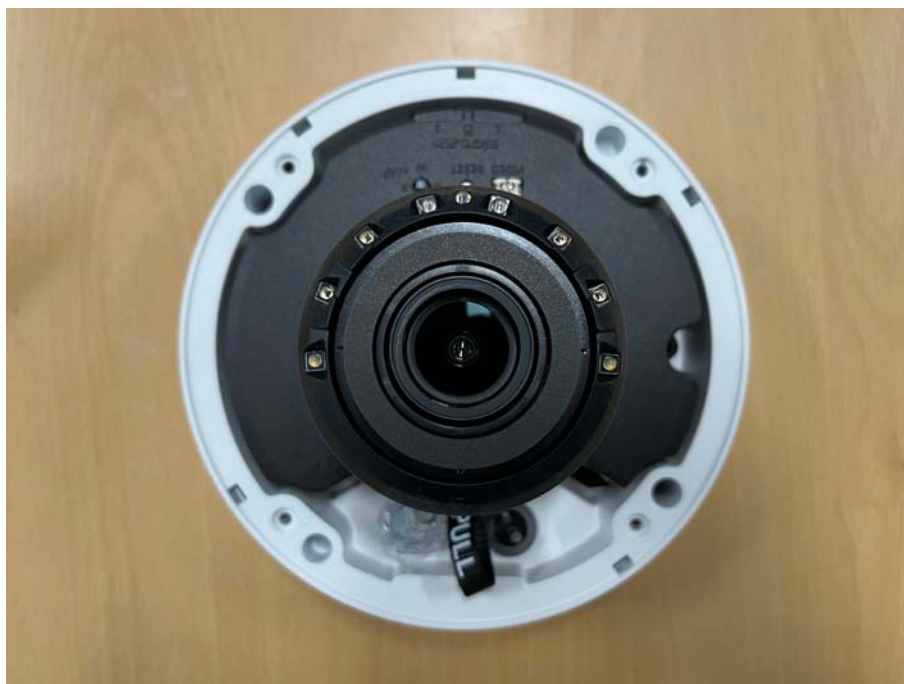
### < Photo 7 > The First Characteristic Numeral Test

| IP Code | Remark |
|---|---|
| IP 6X | No penetration of probe<br>No ingress of dust |

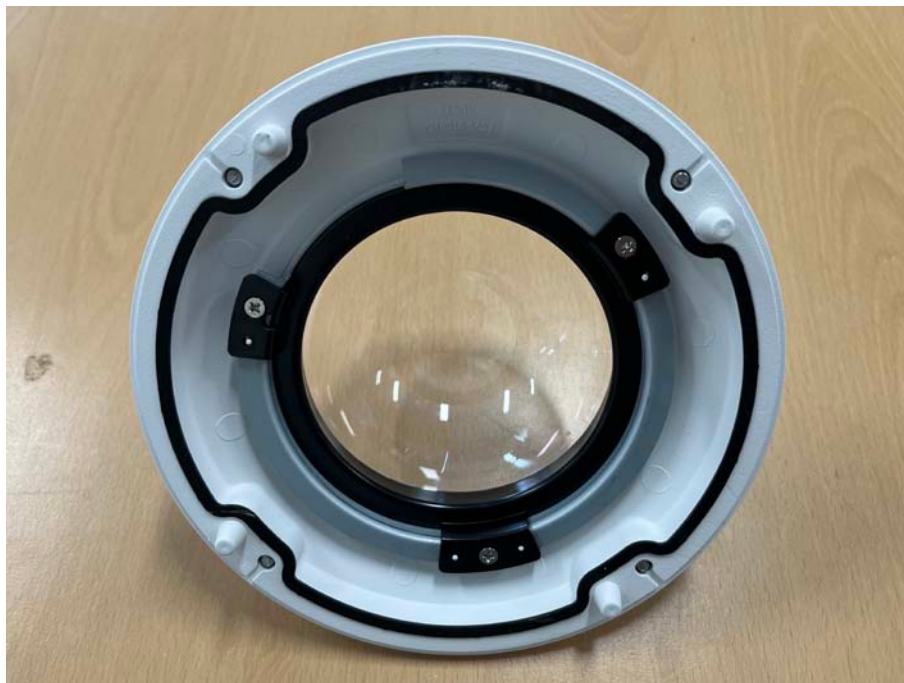
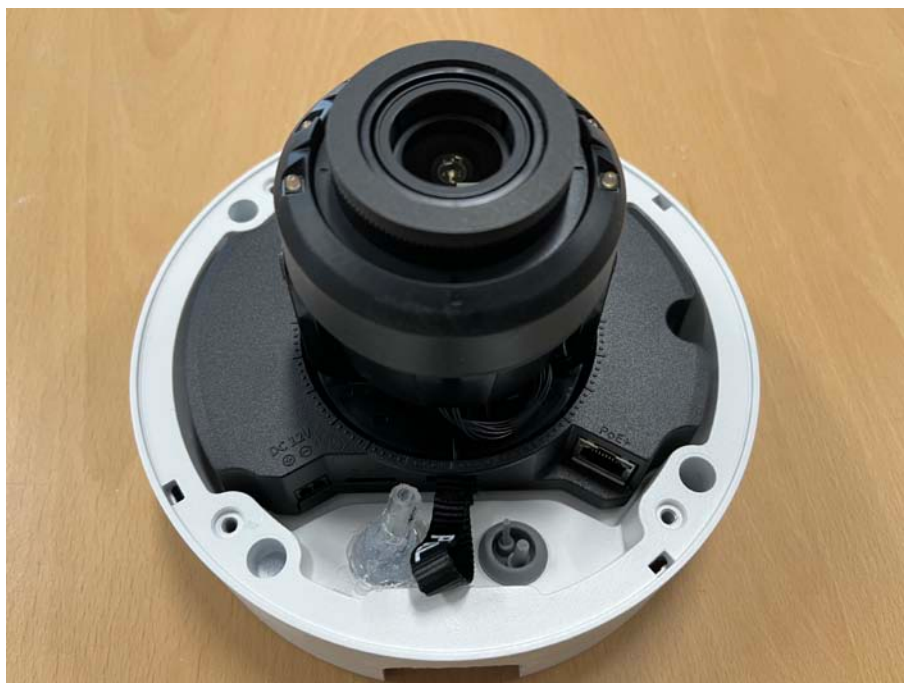
**< Photo 9 > The First Characteristic Numeral Test**

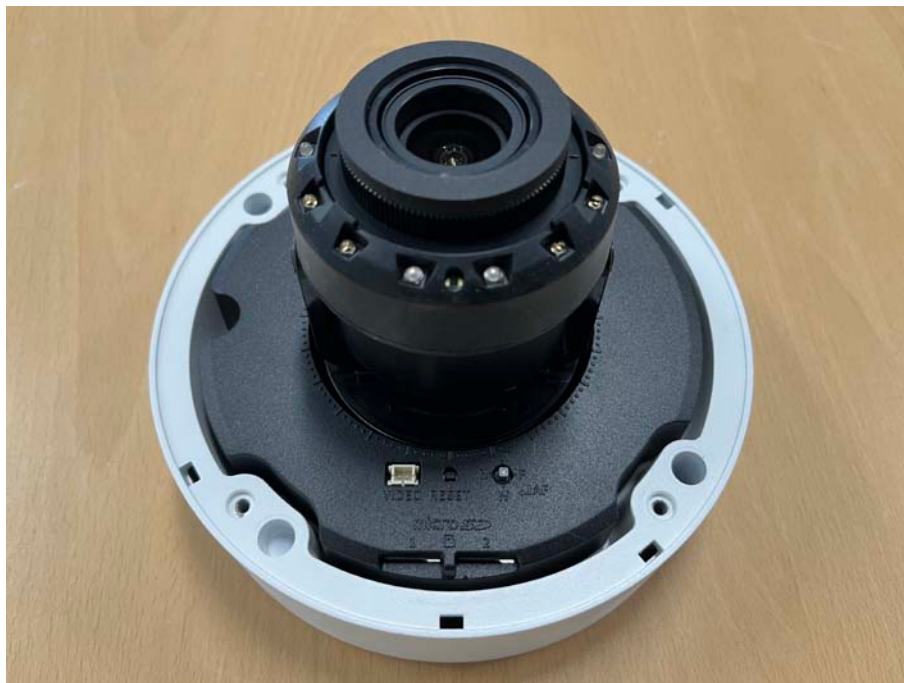
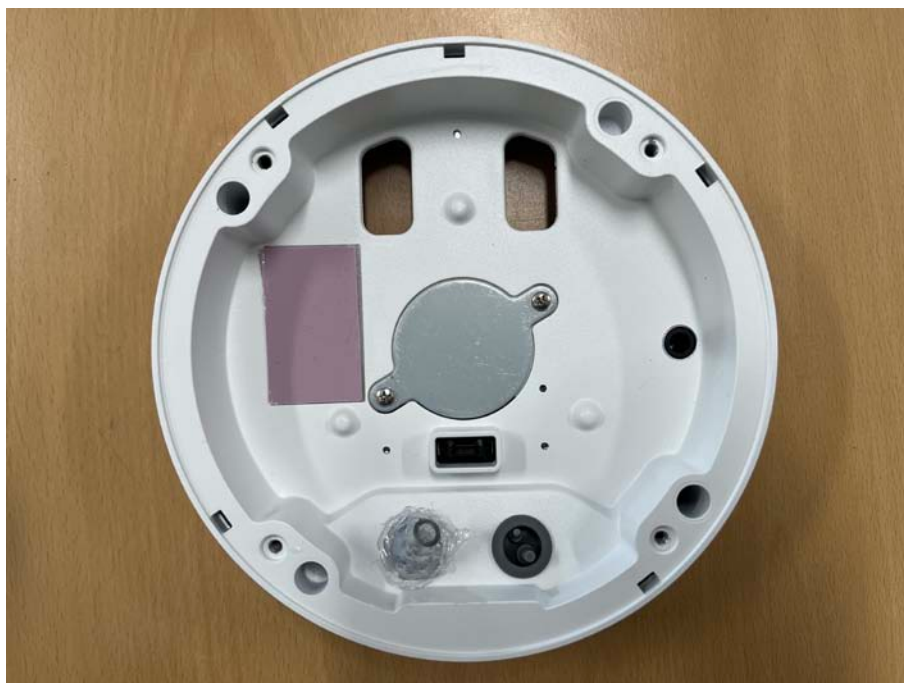
**< Photo 11 > The First Characteristic Numeral Test**

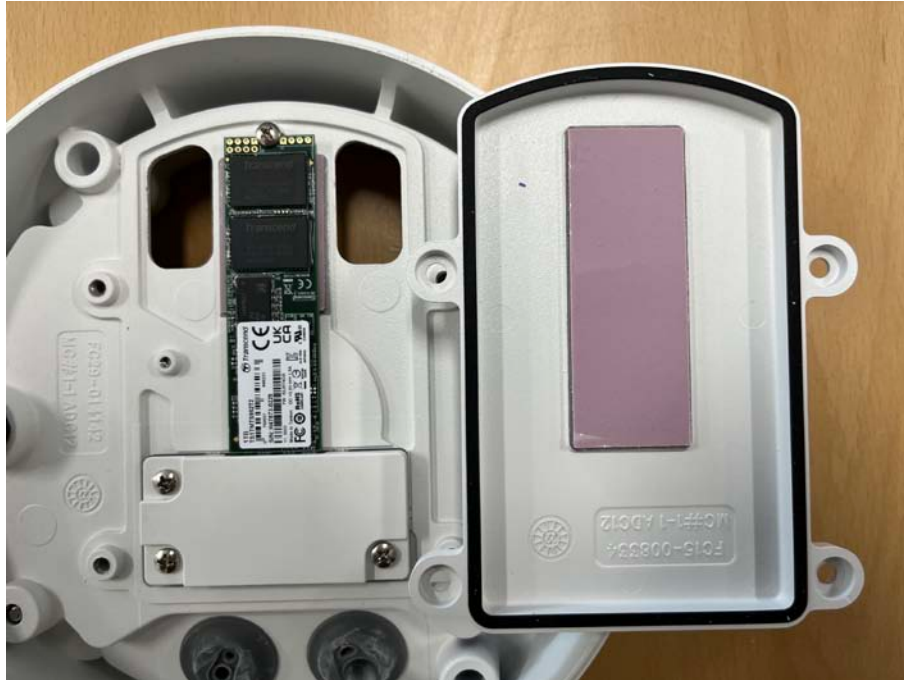
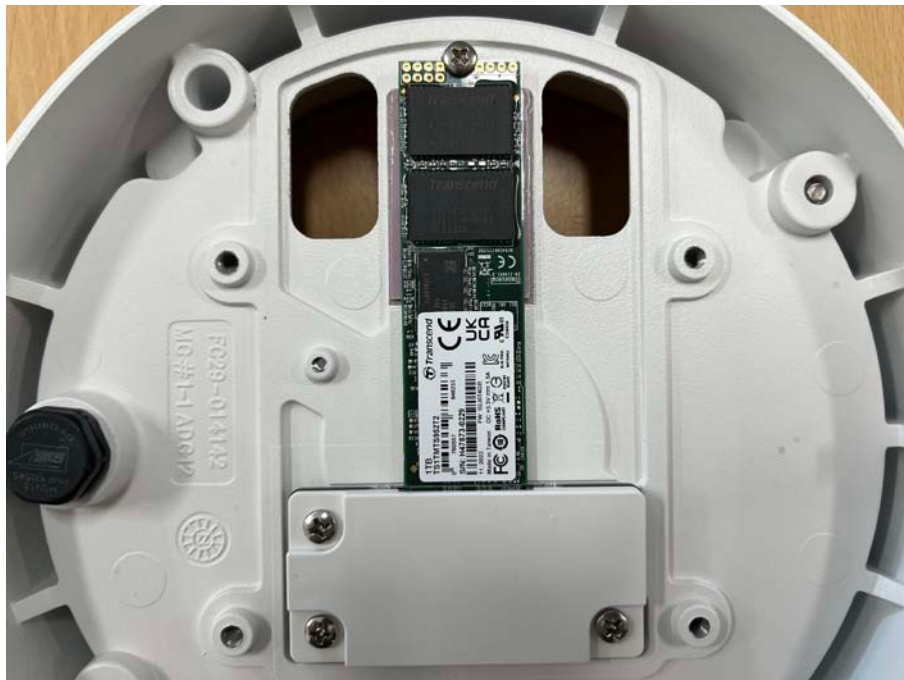
**< Photo 13 > The First Characteristic Numeral Test**

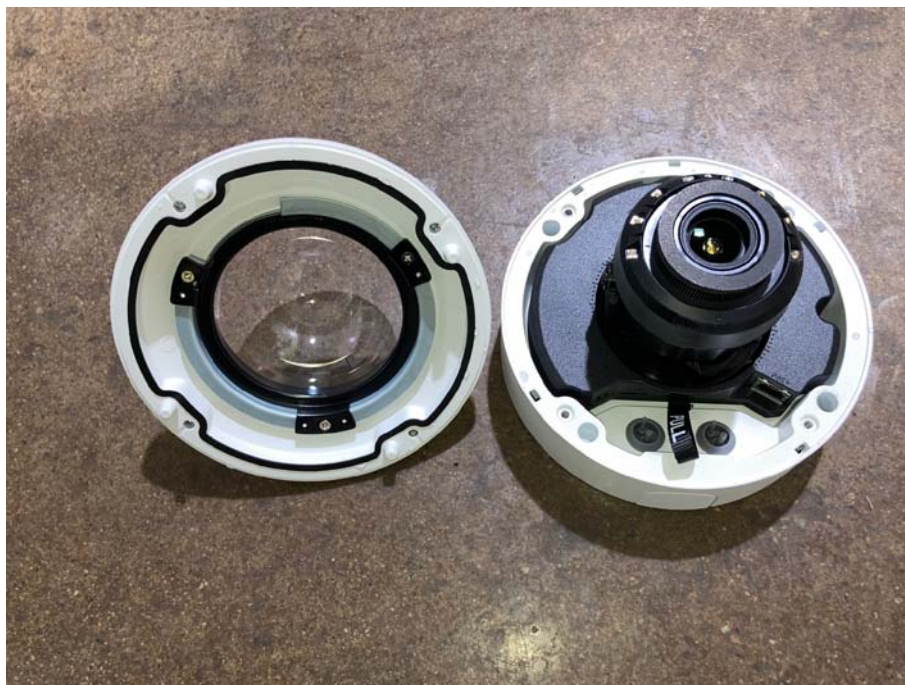
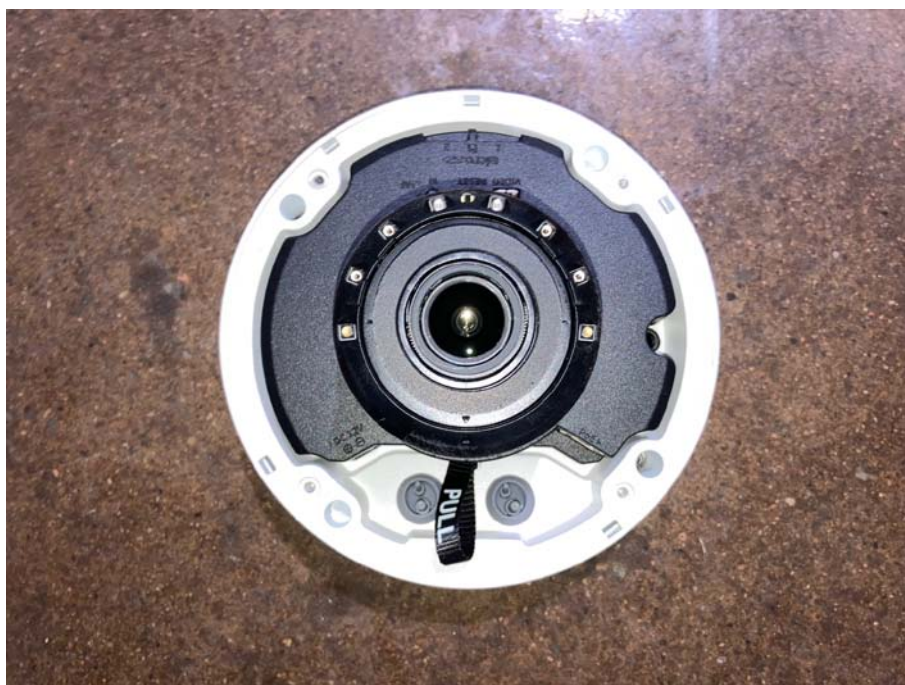
**< Photo 15 > The Second Characteristic Numeral Test**

| IP Code | Remark |
|---|---|
| IP X7 | No ingress of water. |

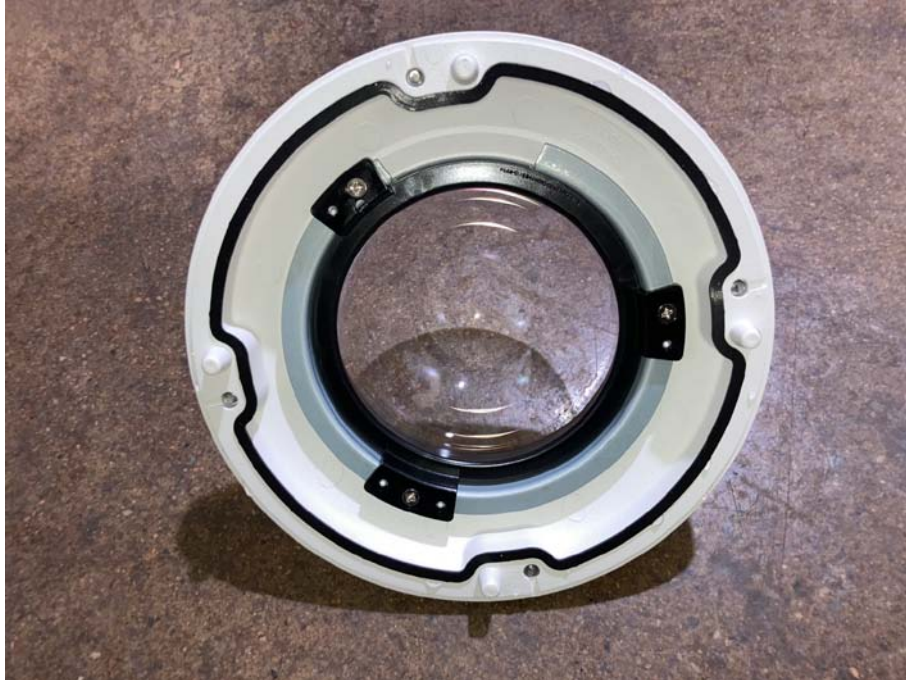
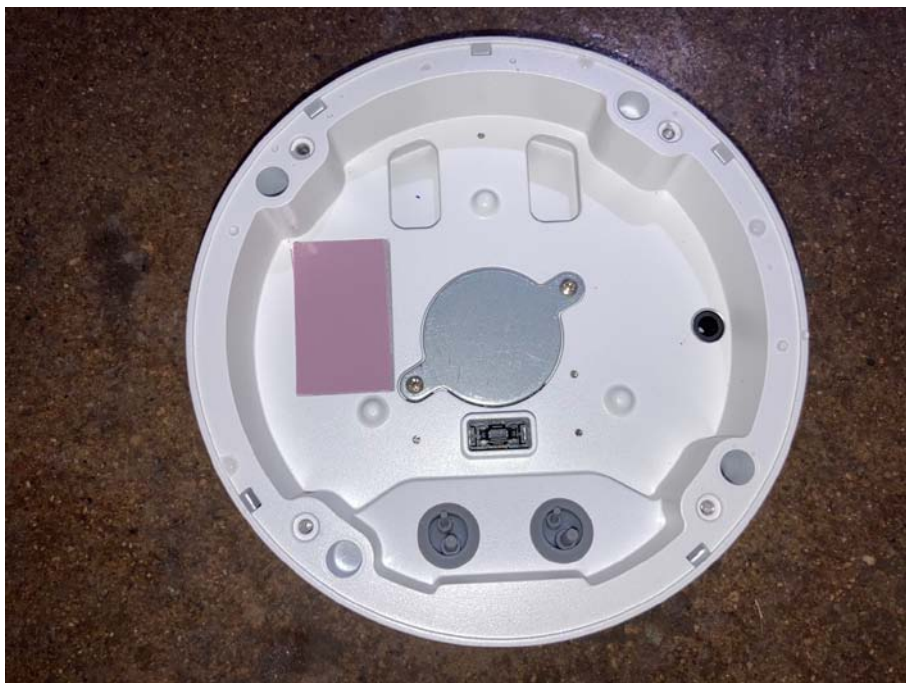
**< Photo 17 > The Second Characteristic Numeral Test**
