# TEST REPORT

REPORT No.:  
CTK-2025-00756  
Page (1) / (13) pages

NETWORK CAMERA / QNF-C9010V

IEC 62262:2002+AMD1:2021

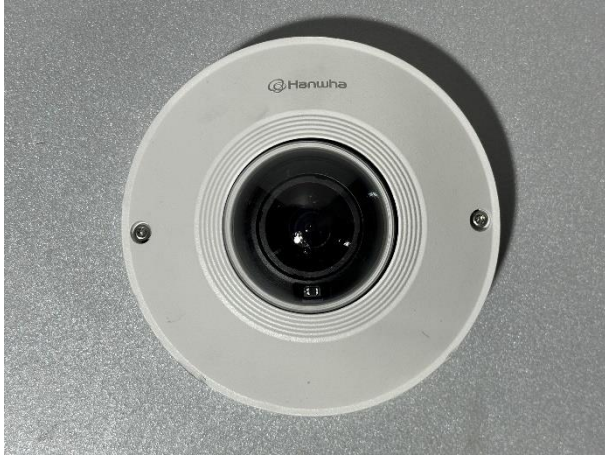
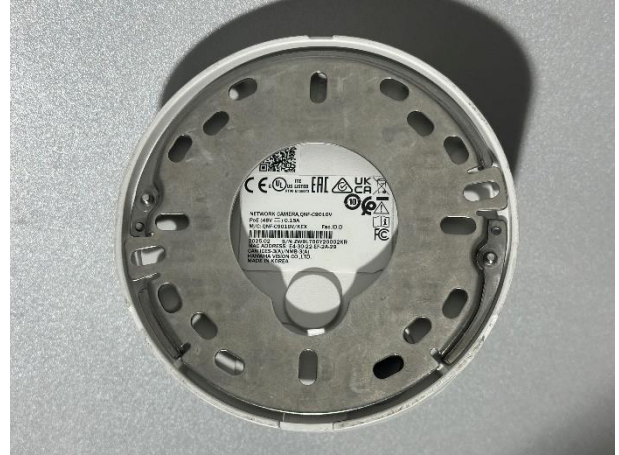
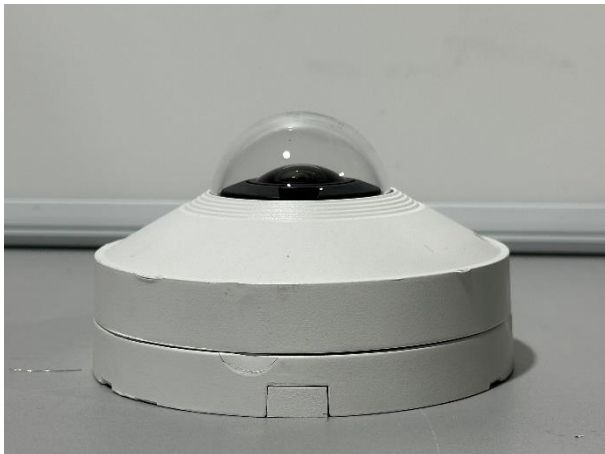
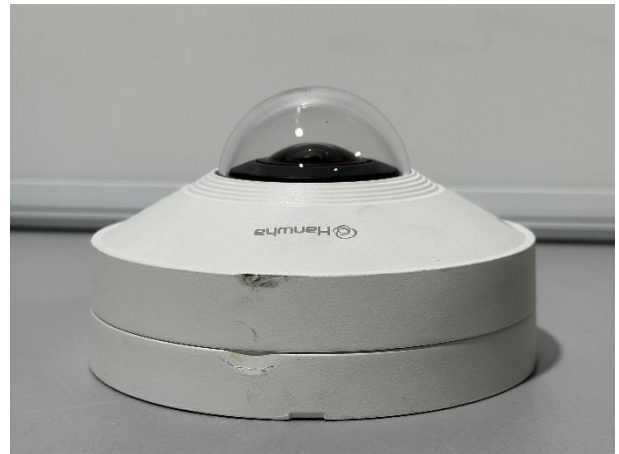
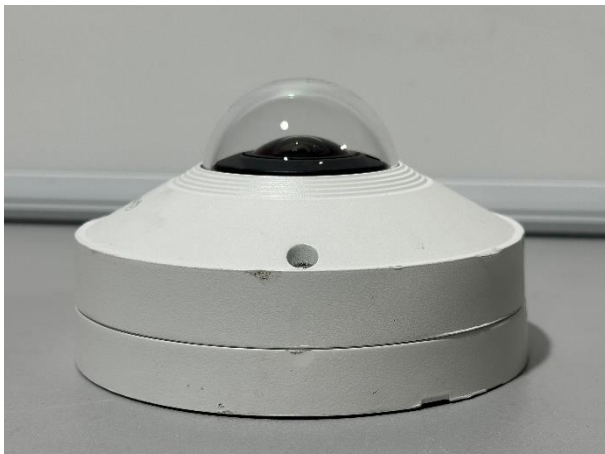
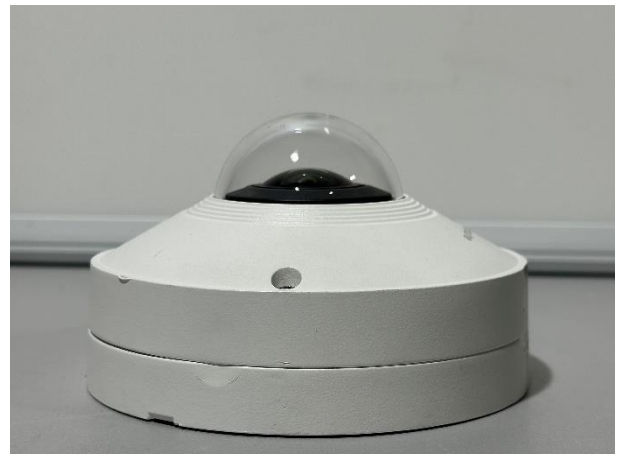
### 3.5.2 Post-test product images

| Evaluation Criteria | Test Results | Remark |
|---|---|---|
| Visual Inspection | Some scratches were generated on the outside of the product. | - |

※ Refer to the product photos after the completion of testing in section 3.5.2
