# TEST REPORT

Report No.:  
CTK-2024-00520  
Page (1) / (16) pages

: NETWORK CAMERA / QNV-C9083R

: IEC 60529:1989 +A1:1999+A2:2013

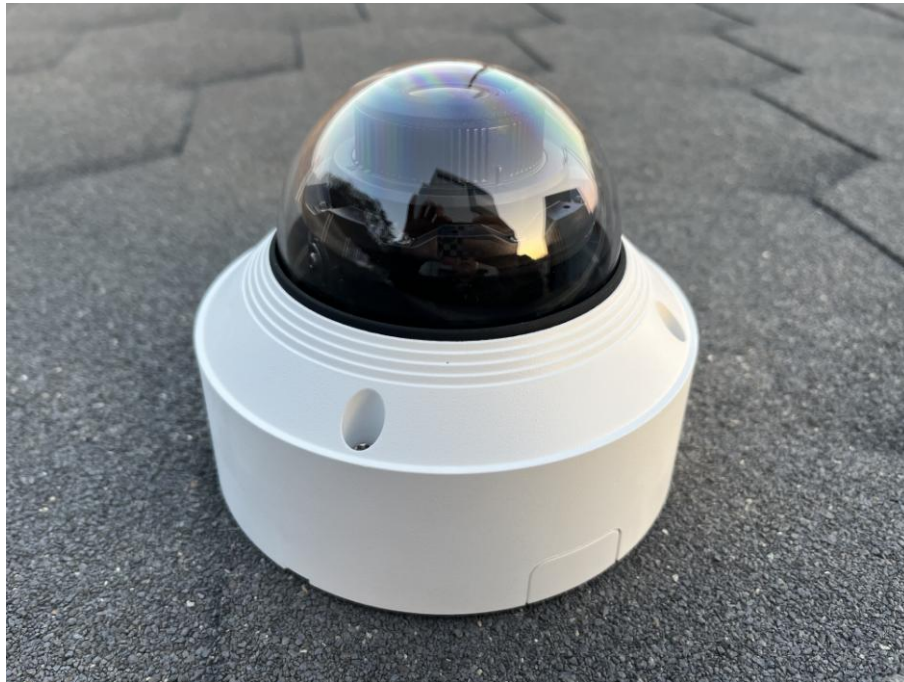
#### < Photo 1 > Product Front View

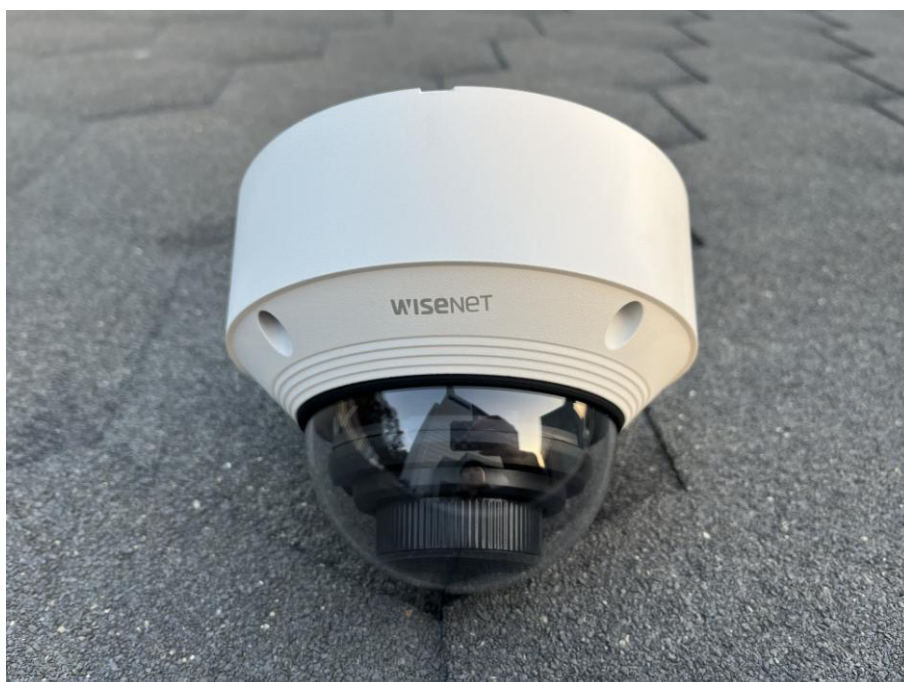
#### < Photo 2 > Product Rear View

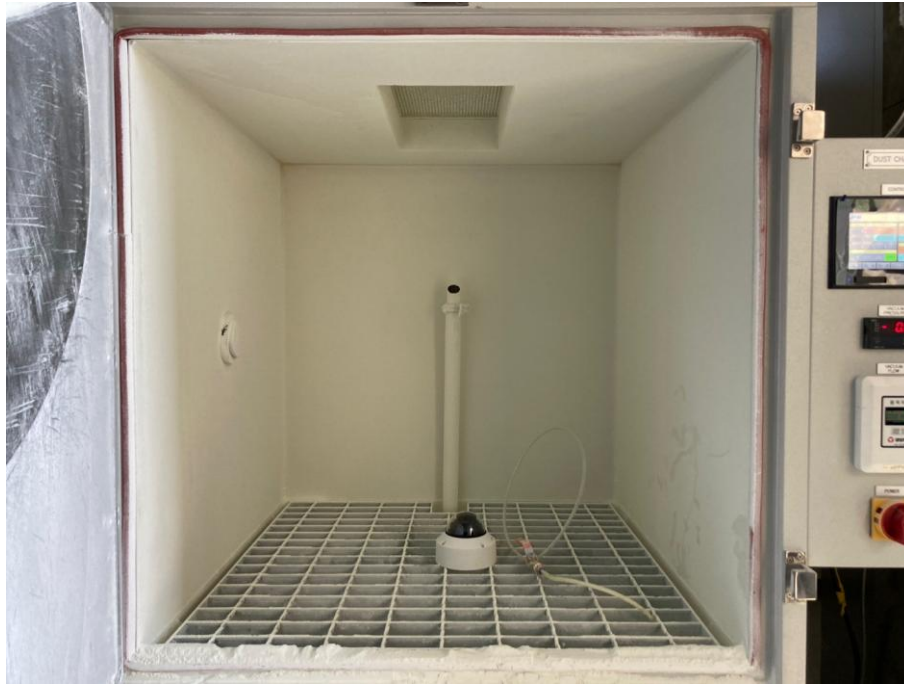
### < Photo 3 > The First Characteristic Test

| First characteristic numeral | Degree of protection | Application |
|---|---|---|
| 6 | Protected against access to hazardous parts with a wire.<br>The access probe of 1.0 mmØ, shall not penetrate.<br>Test force: 1 N ± 10 % | <input checked="" type="checkbox"/> |

| First characteristic numeral | Degree of protection | Application |
|---|---|---|
| 6 | <p>In Dust Testing Equipment, the test sample has to have no ingress of dust after testing atmospheric pressure present condition for 8 hr.</p> <p>(Talcum powder have to go through the measured sieve by <math>\Phi</math> 50 um wire that are spacing 75 um in squared, per volume and union Talcum powder have to be 2 kg/m<sup>3</sup>)</p> <p>Products in volume .....: <b>2 159.92 cm<sup>3</sup> → 2.16 L</b></p> <p>Target intake volume (Products in volume 80) .....: <b>172.79 L</b></p> <p>Suction volume (Max product in volume 60) .....: <b>129.6 LPH → 2.16 LPM</b></p> <p>Actual Suction volume .....: <b>2.16 L</b></p> <p>Suction pressure (Up to 2 kPa) .....: <b>2 kPa</b></p> <p>Test time (Up to 8 time) .....: <b>8 hr</b></p> | ☒ |

| IP Code | Remark |
|---|---|
| IP 6X | No penetration of probe<br>No ingress of dust |

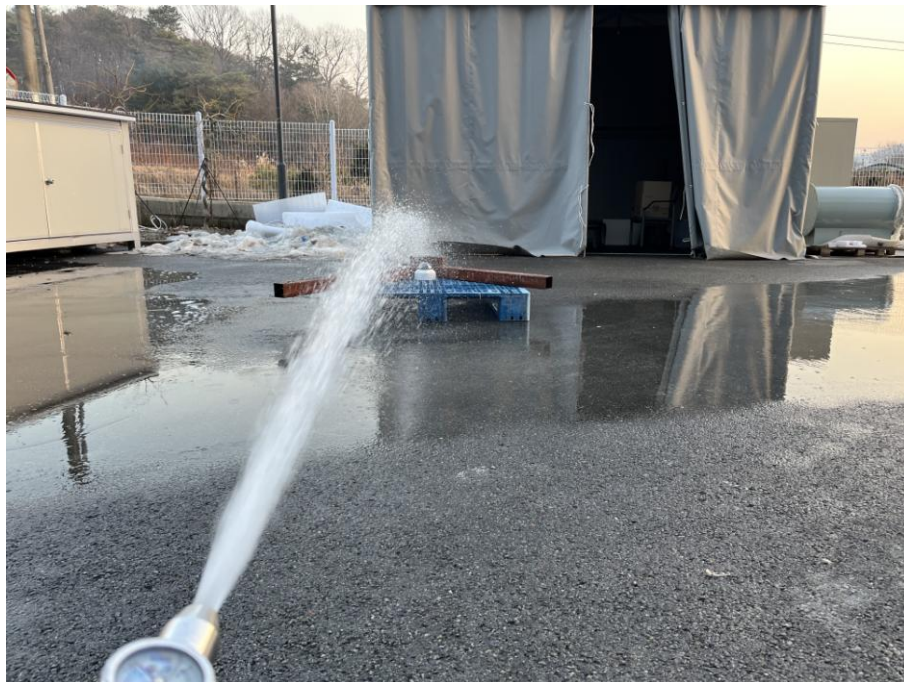
### < Photo 4 > The Second Characteristic Test

| Second characteristic numeral | Degrees of protection | Application |
|---|---|---|
| 6 | <p>The product must not be harmed in any direction even strong jet water.</p> <p>Water jet hose nozzle Fig.6, Nozzle 12.5 mm diameter</p> <p>Water flow rate: 100 l/min ± 5 % : <b>100 LPM</b></p> <p>Distance: 2.5 m to 3 m: <b>3 m</b></p> <p>Duration of test: 1 min/m<sup>2</sup> at least 3 min: <b>3 min</b></p> | ☒ |

| IP Code | Remark |
|---|---|
| IP X6 | No ingress of water. |

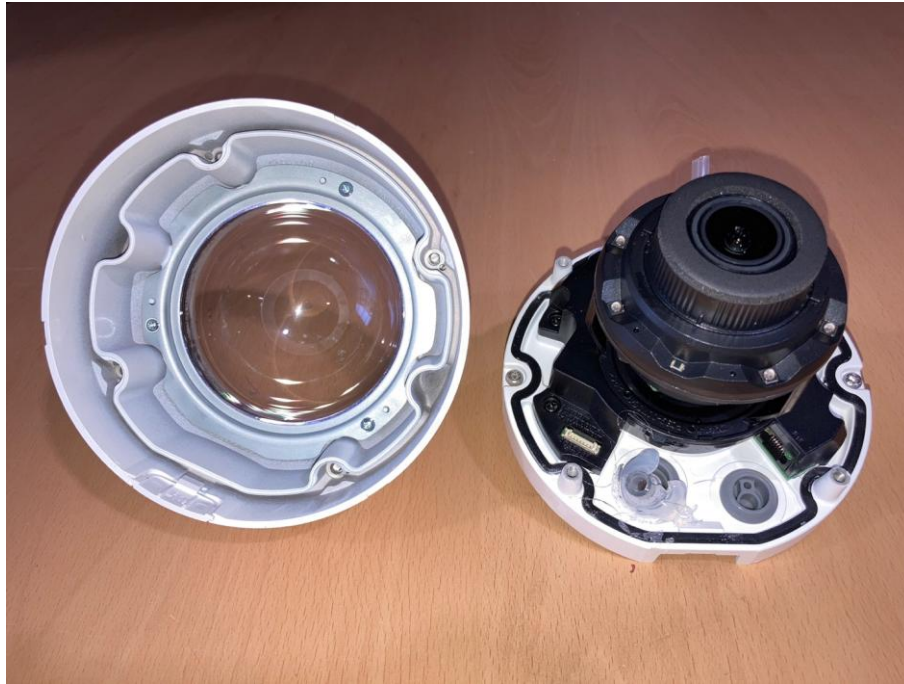
### < Photo 5 > The First Characteristic Test

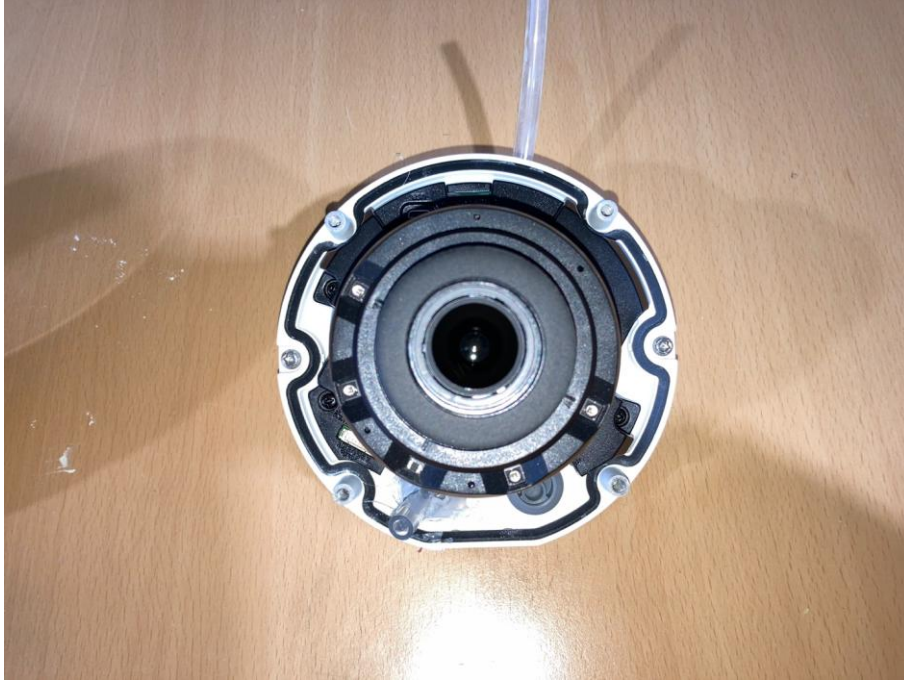
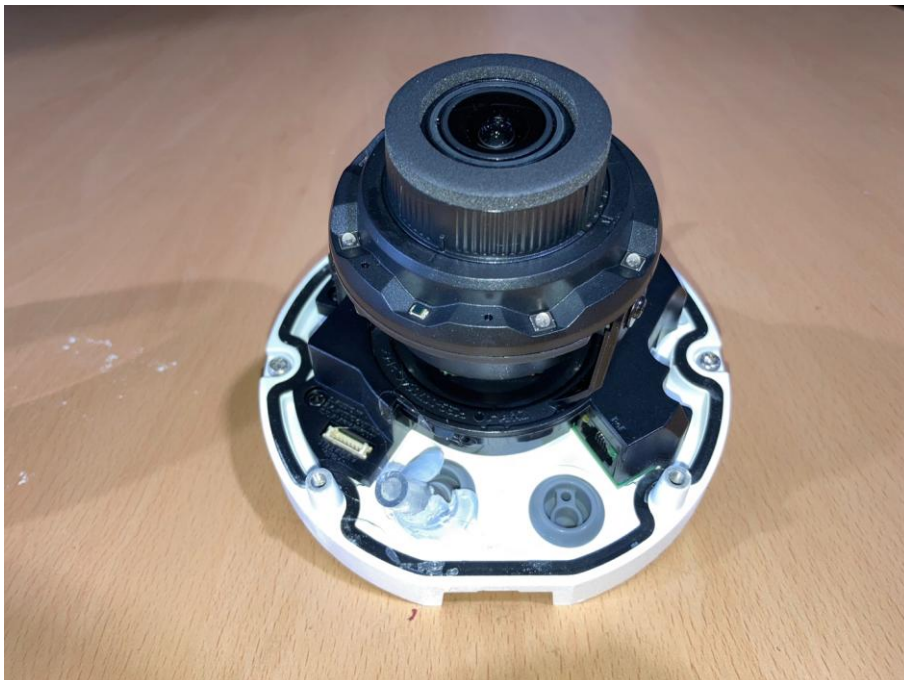
**< Photo 7 > The First Characteristic Test**

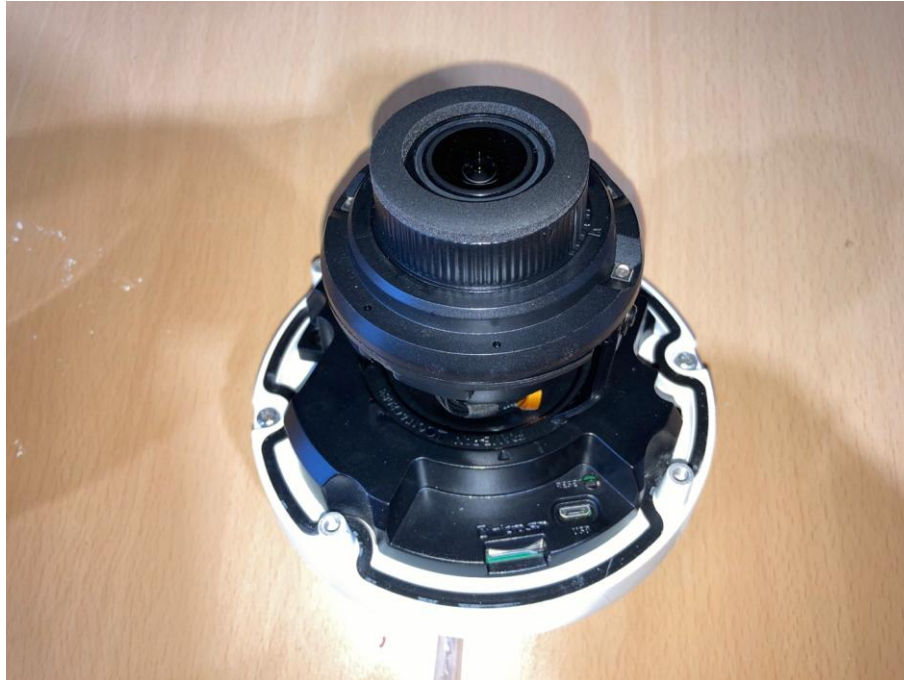
**< Photo 9 > The First Characteristic Test**

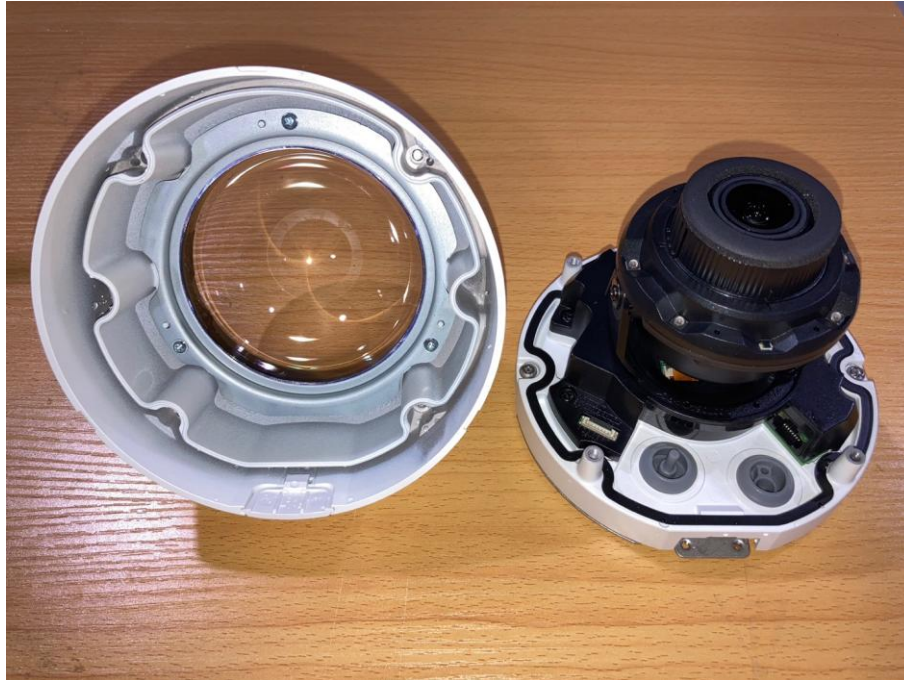
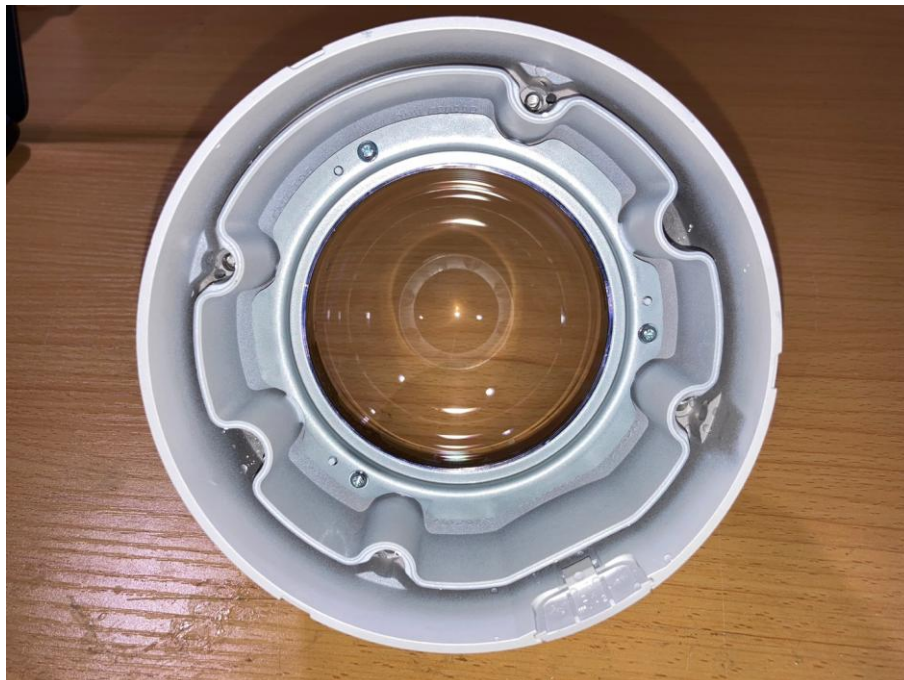
**< Photo 10 > The Second Characteristic Test**

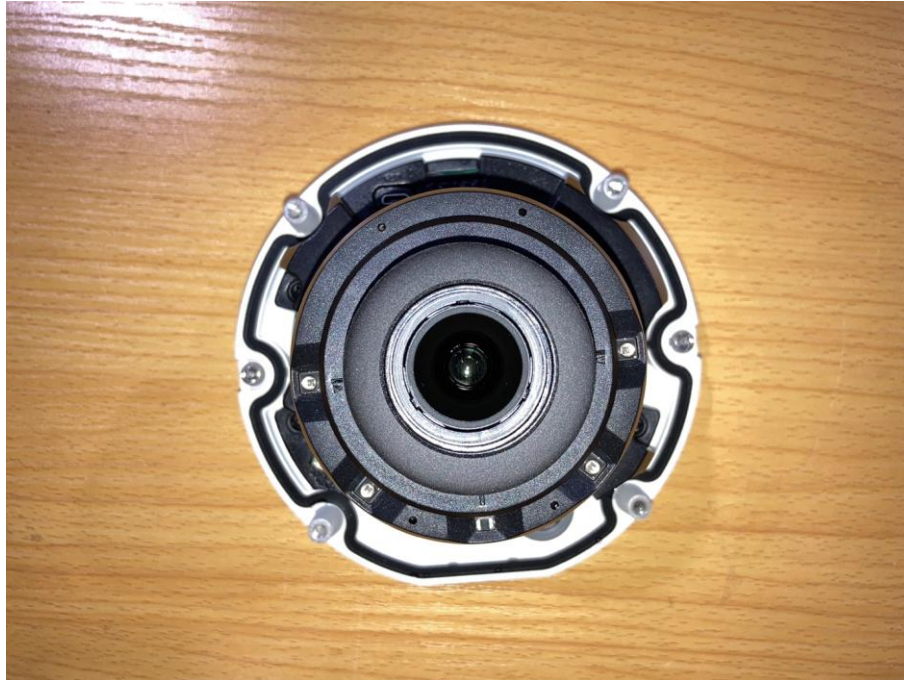
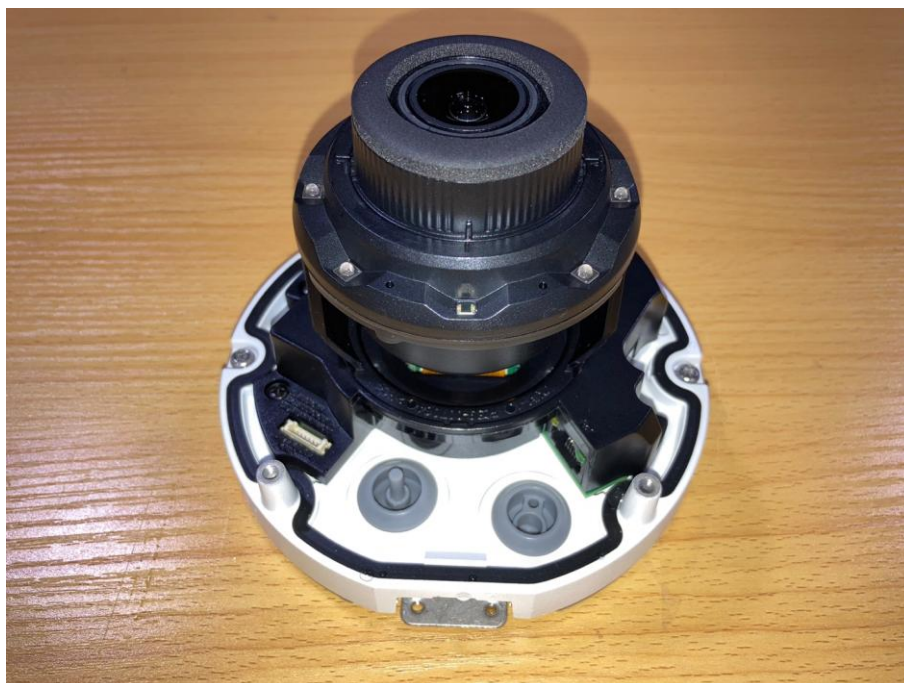
**< Photo 12 > The Second Characteristic Test**

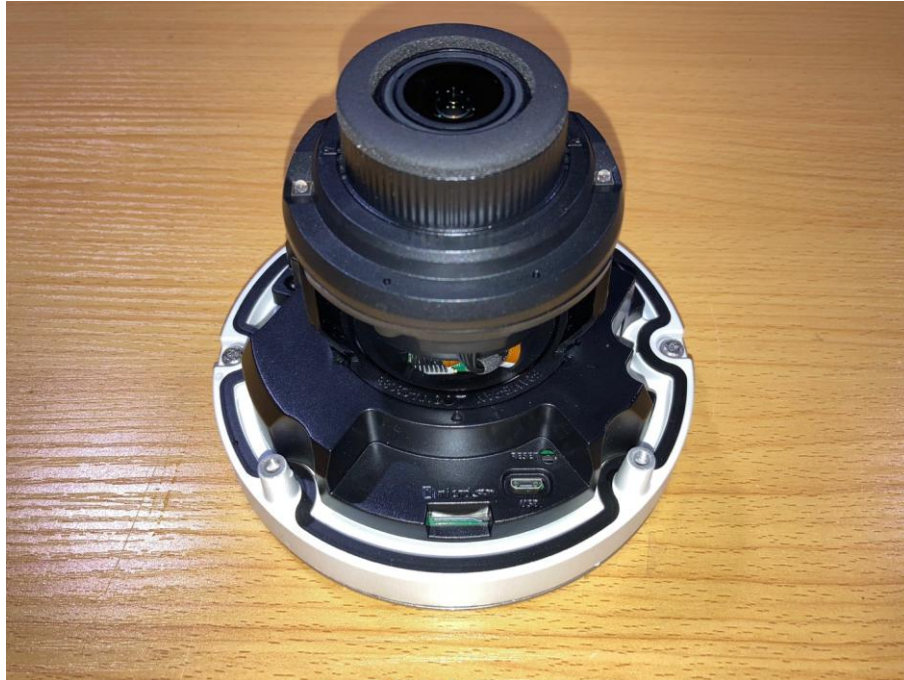
**< Photo 14 > The Second Characteristic Test**
