# TEST REPORT

Report No.:  
CTK-2023-00797  
Page (1) / (13) pages

: NETWORK CAMERA / QNV-C9011R

: IEC 60529:1989 +A1:1999+A2:2013

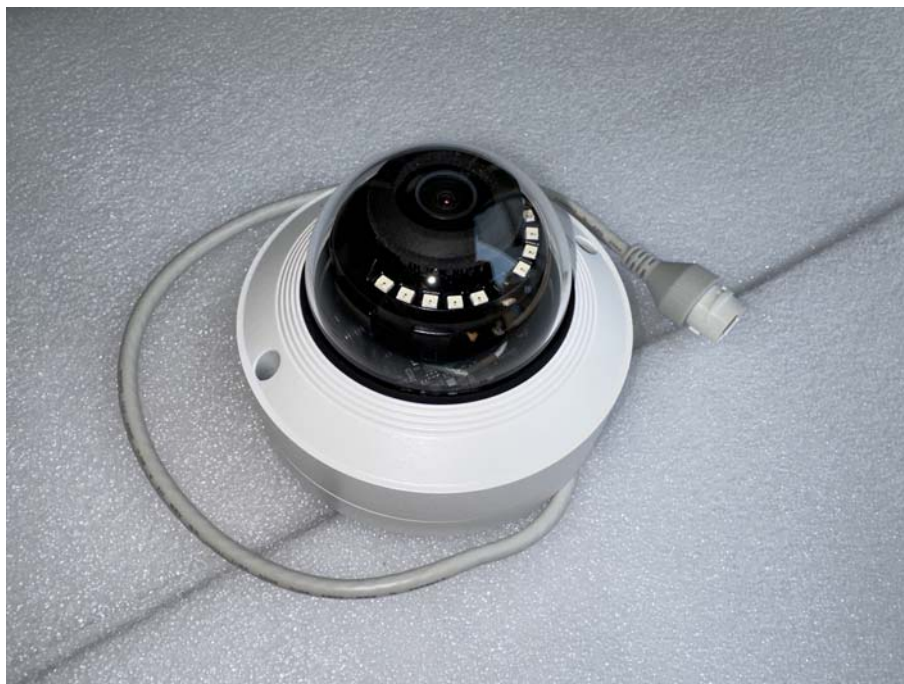
#### < Photo 1 > Product Front View

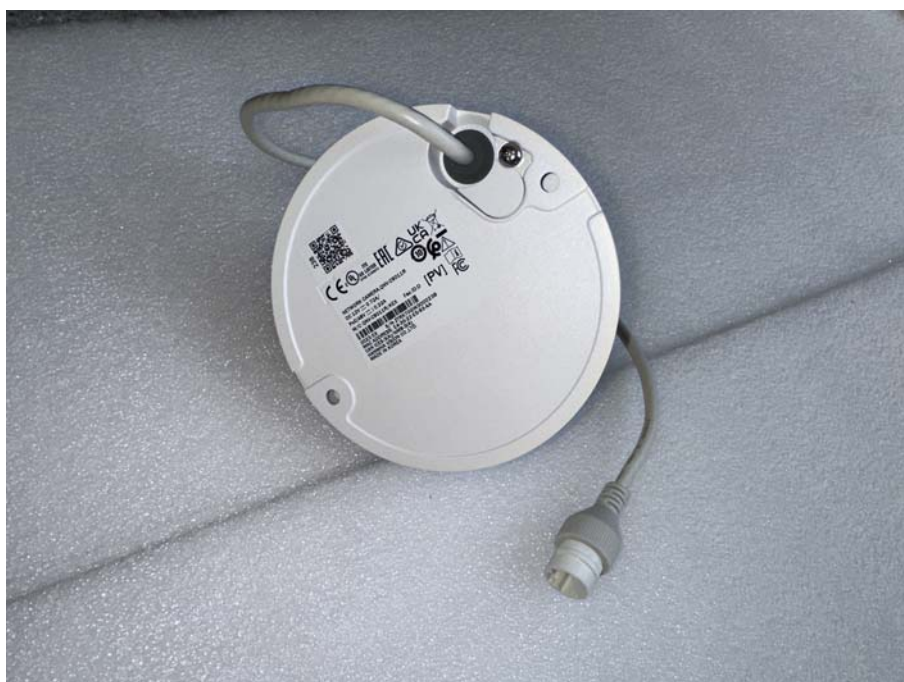
#### < Photo 2 > Product Rear View

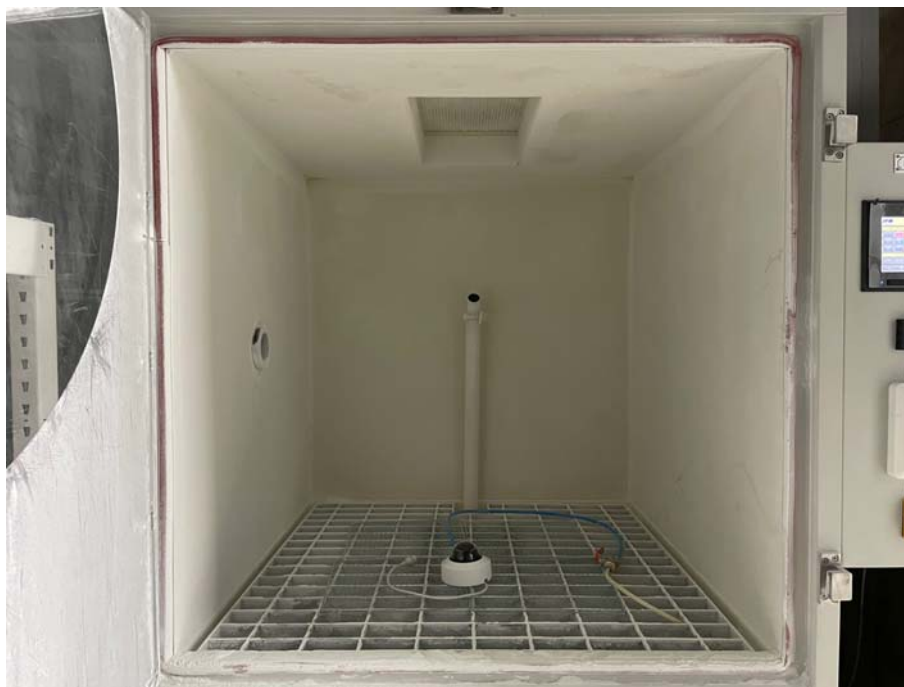
### < Photo 3 > The First Characteristic Numeral Test

| First characteristic numeral | Degree of protection | Application |
|---|---|---|
| 6 | Protected against access to hazardous parts with a wire.<br>The access probe of 1.0 mmØ, shall not penetrate.<br>Test force: 1 N ± 10 % | <input checked="" type="checkbox"/> |

| First characteristic numeral | Degree of protection | Application |
|---|---|---|
| 6 | <p>In Dust Testing Equipment, the test sample has to have no ingress of dust after testing atmospheric pressure present condition for 8 hr.</p> <p>(Talcum powder have to go through the measured sieve by <math>\Phi</math> 50 <math>\mu</math>m wire that are spacing 75 <math>\mu</math>m in squared, per volume and union Talcum powder have to be 2 kg/m<sup>3</sup>)</p> <p>Products in volume ..... <b>931.7 cm<sup>3</sup> → 0.93 L</b></p> <p>Target intake volume (Products in volume 80) ..... <b>74.54 L</b></p> <p>Suction volume (Max product in volume 60) ..... <b>55.90 LPH → 0.93 LPM</b></p> <p>Actual Suction volume ..... <b>0.93 L</b></p> <p>Suction pressure (Up to 2 kPa) ..... <b>2 kPa</b></p> <p>Test time (Up to 8 time) ..... <b>8 hr</b></p> | ☒ |

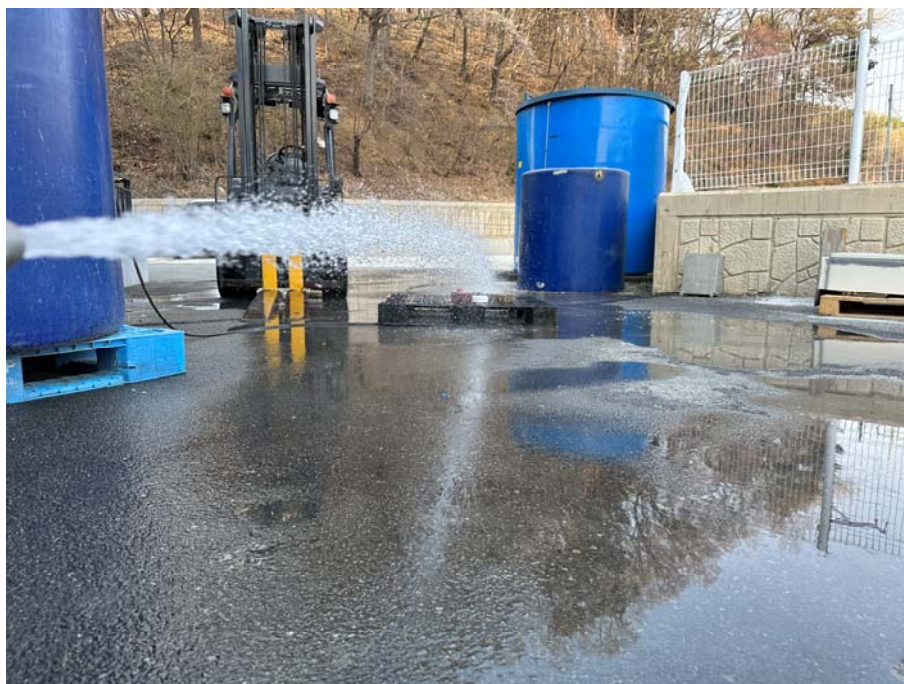
### < Photo 4 > The Second Characteristic Numeral Test

| Second characteristic numeral | Degrees of protection | Application |
|---|---|---|
| 6 | <p>The product must not be harmed in any direction even strong jet water.</p> <p>Water jet hose nozzle Fig.6, Nozzle 12.5 mm diameter</p> <p>Water flow rate: 100 l/min <math>\pm</math> 5 % : <b>100 LPM</b></p> <p>Distance: 2.5 m to 3 m: <b>3 m</b></p> <p>Duration of test: 1 min/m<sup>2</sup> at least 3 min: <b>3 min</b></p> | ☒ |

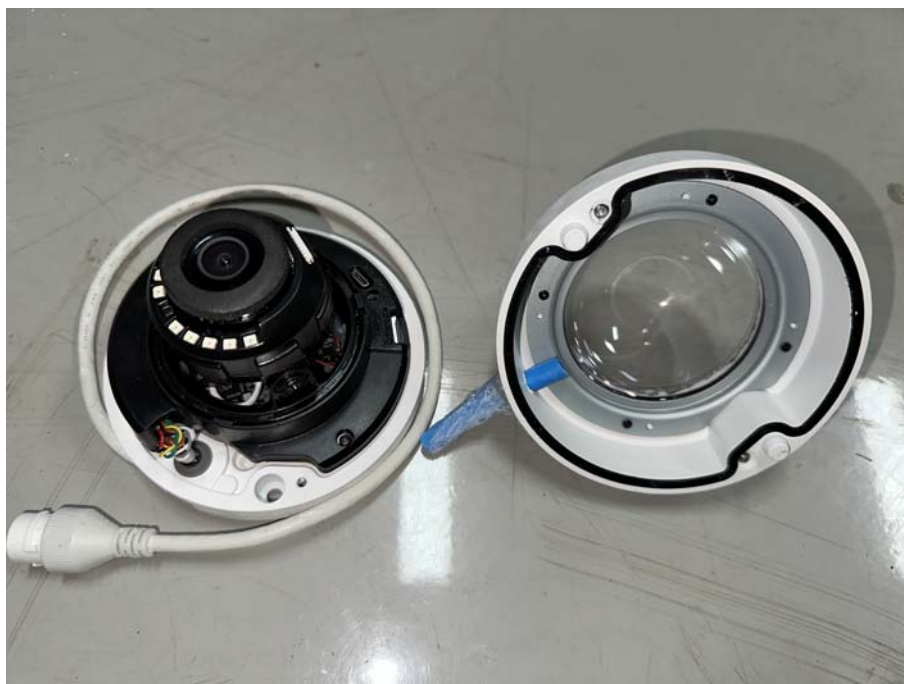
### < Photo 5 > The First Characteristic Numeral Test

| IP Code | Remark |
|---|---|
| IP 6X | No penetration of probe<br>No ingress of dust |

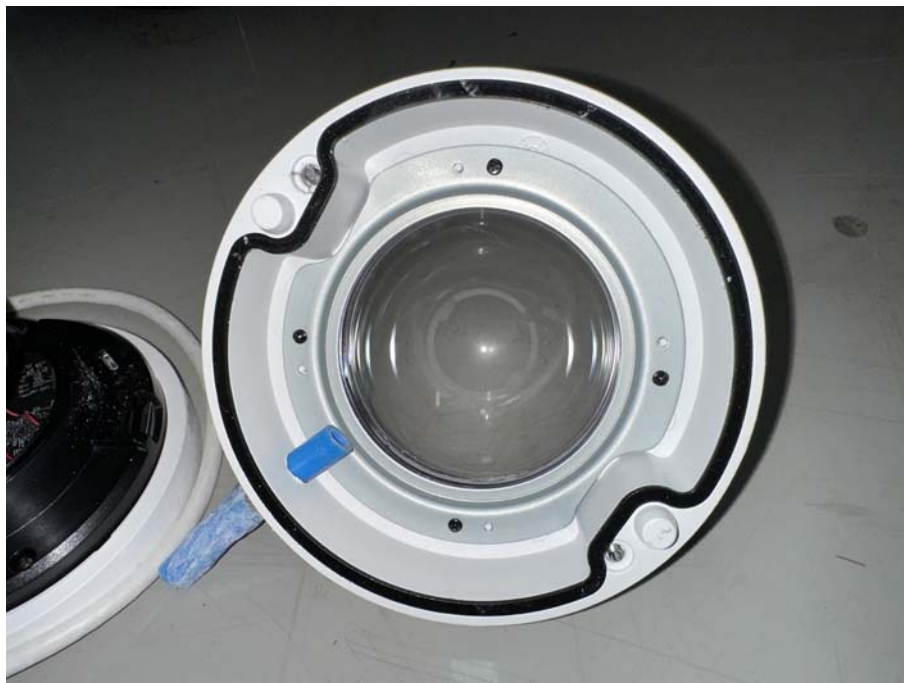
**< Photo 7 > The First Characteristic Numeral Test**

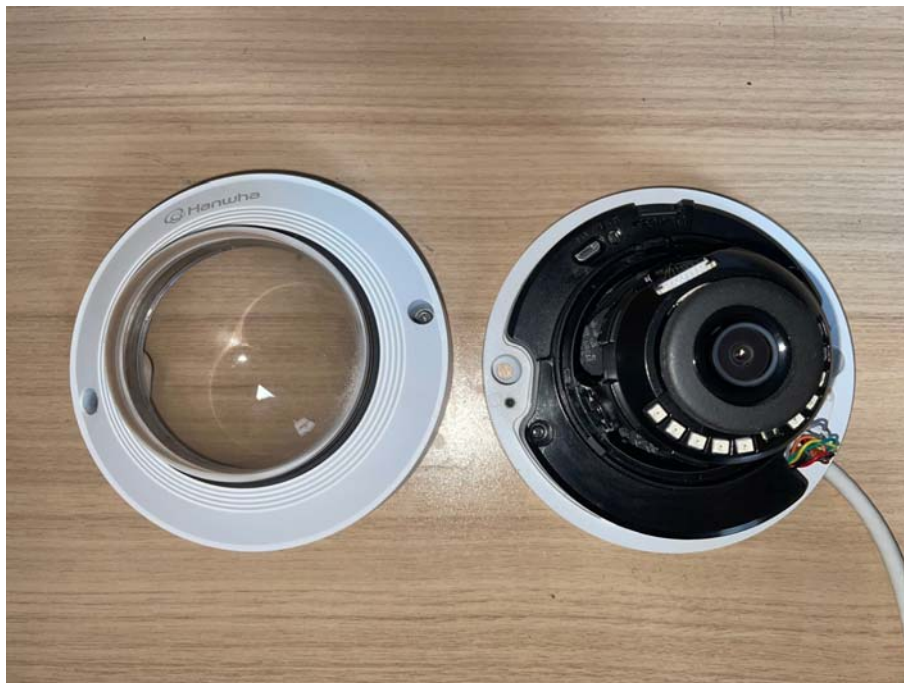
**< Photo 8 > The Second Characteristic Numeral Test**

| IP Code | Remark |
|---|---|
| IP X6 | No ingress of water. |

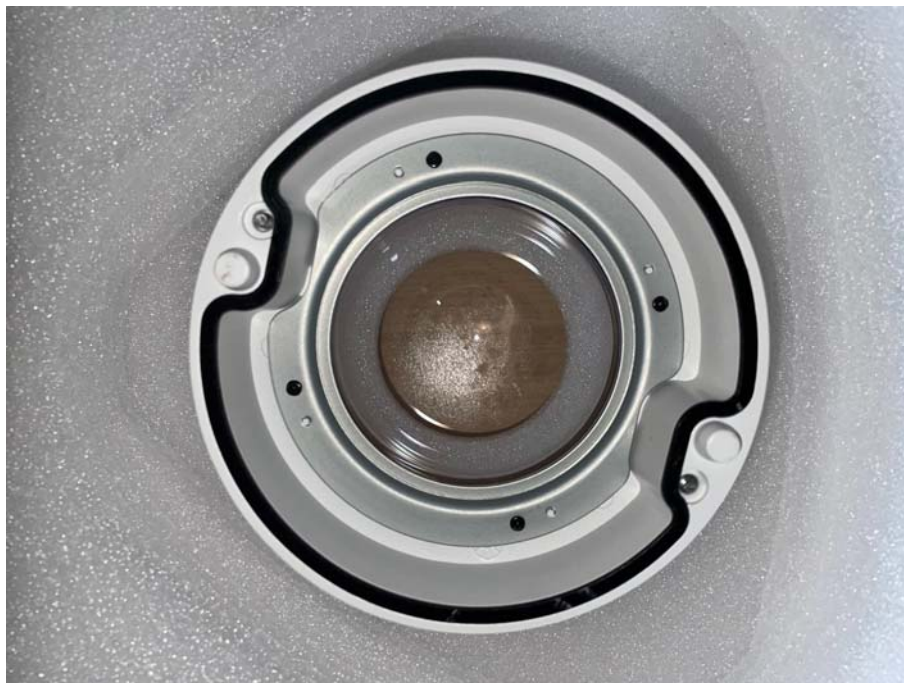
**< Photo 10 > The Second Characteristic Numeral Test**
