# TEST REPORT

Report No.:  
CTK-2023-00302  
Page (1) / (16) pages

: NETWORK CAMERA / QNV-C9083R

: IEC 60529:1989 +A1:1999+A2:2013

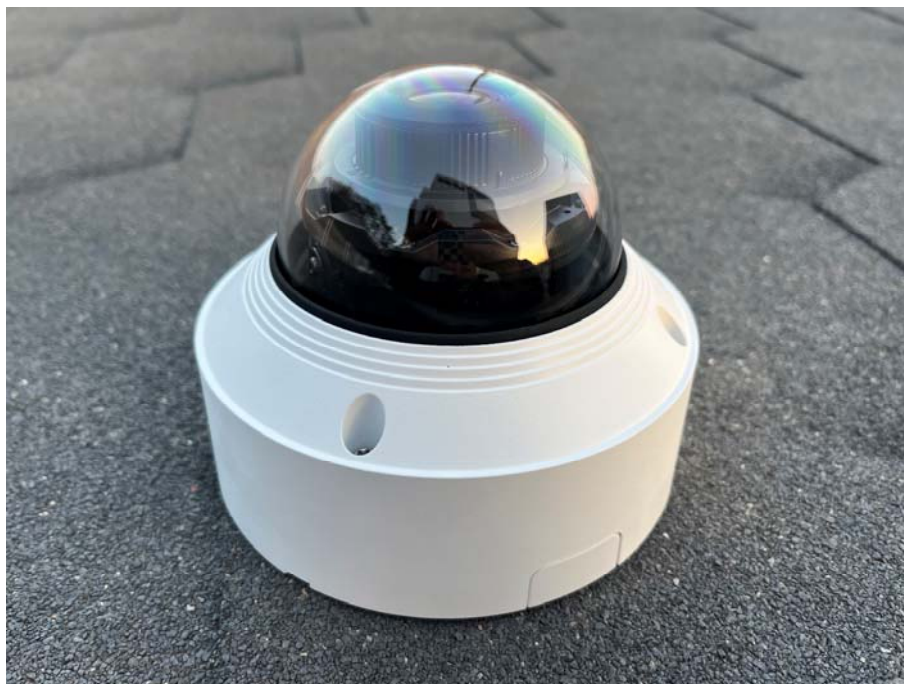
#### < Photo 1 > Product Front View

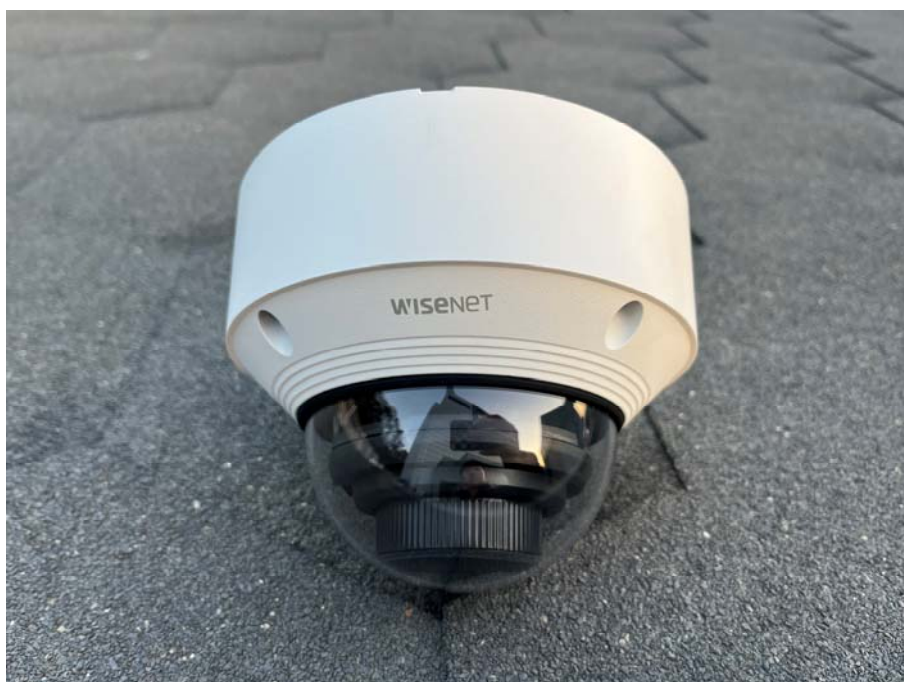
#### < Photo 2 > Product Rear View

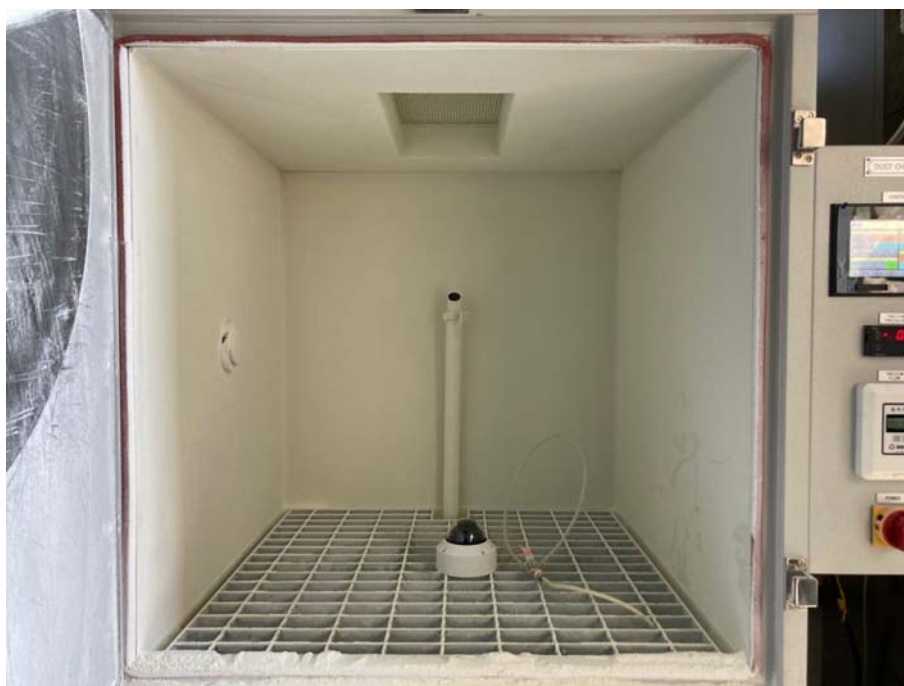
### < Photo 3 > The First Characteristic Test

| First characteristic numeral | Degree of protection | Application |
|---|---|---|
| 6 | Protected against access to hazardous parts with a wire.<br>The access probe of 1.0 mmØ, shall not penetrate.<br>Test force: 1 N ± 10 % | <input checked="" type="checkbox"/> |

| IP Code | Remark |
|---|---|
| IP 6X | No penetration of probe<br>No ingress of dust |

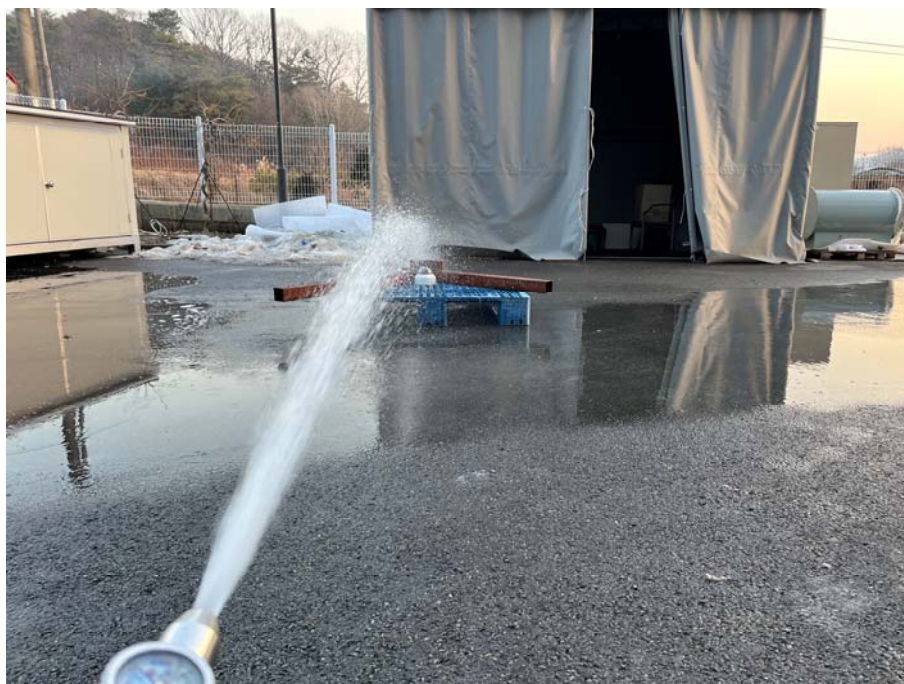
### < Photo 4 > The Second Characteristic Test

| Second characteristic numeral | Degrees of protection | Application |
|---|---|---|
| 6 | <p>The product must not be harmed in any direction even strong jet water.</p> <p>Water jet hose nozzle Fig.6, Nozzle 12.5 mm diameter</p> <p>Water flow rate: 100 l/min <math>\pm</math> 5 % : <b>100 LPM</b></p> <p>Distance: 2.5 m to 3 m: <b>3 m</b></p> <p>Duration of test: 1 min/m<sup>2</sup> at least 3 min: <b>3 min</b></p> | ☒ |

| IP Code | Remark |
|---|---|
| IP X6 | No ingress of water. |

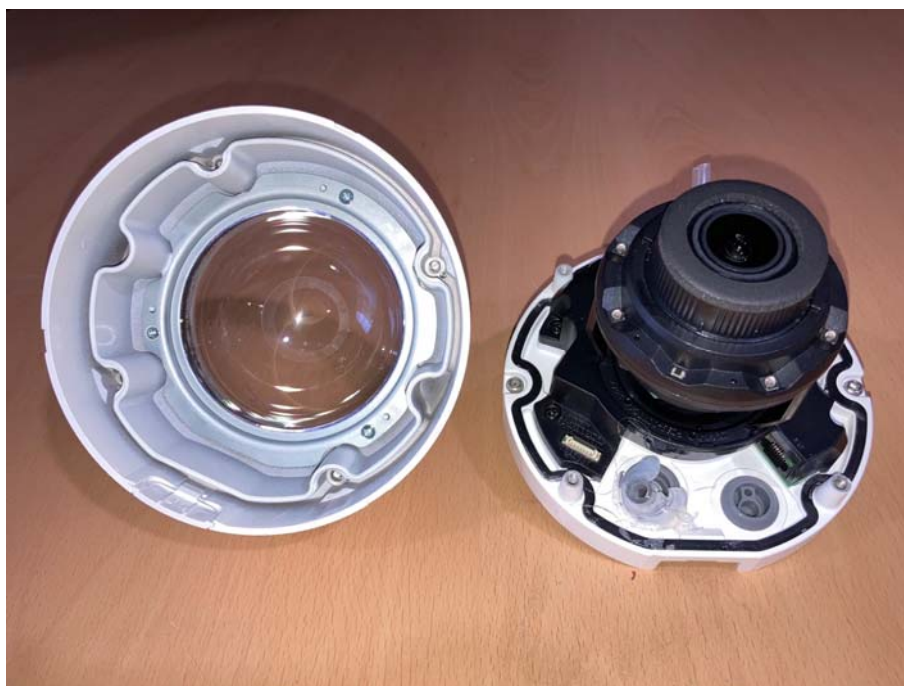
### < Photo 5 > The First Characteristic Test

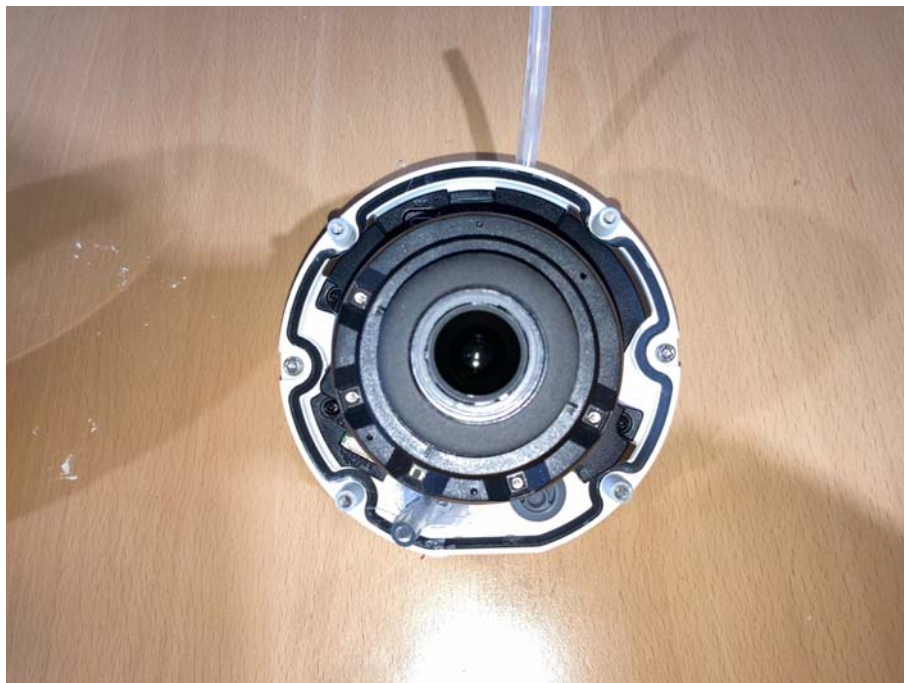
**< Photo 7 > The First Characteristic Test**

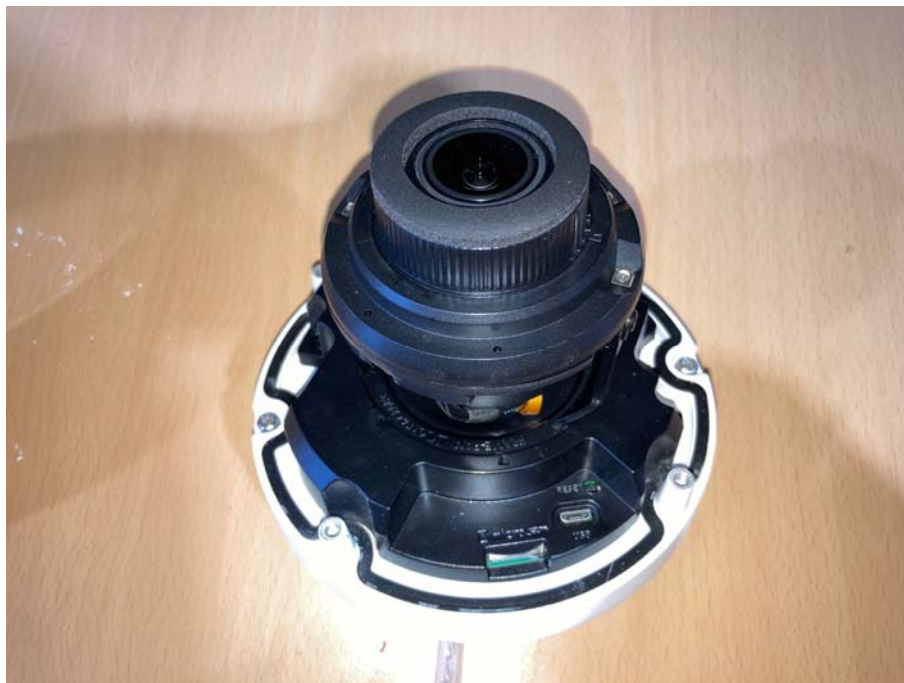
**< Photo 9 > The First Characteristic Test**

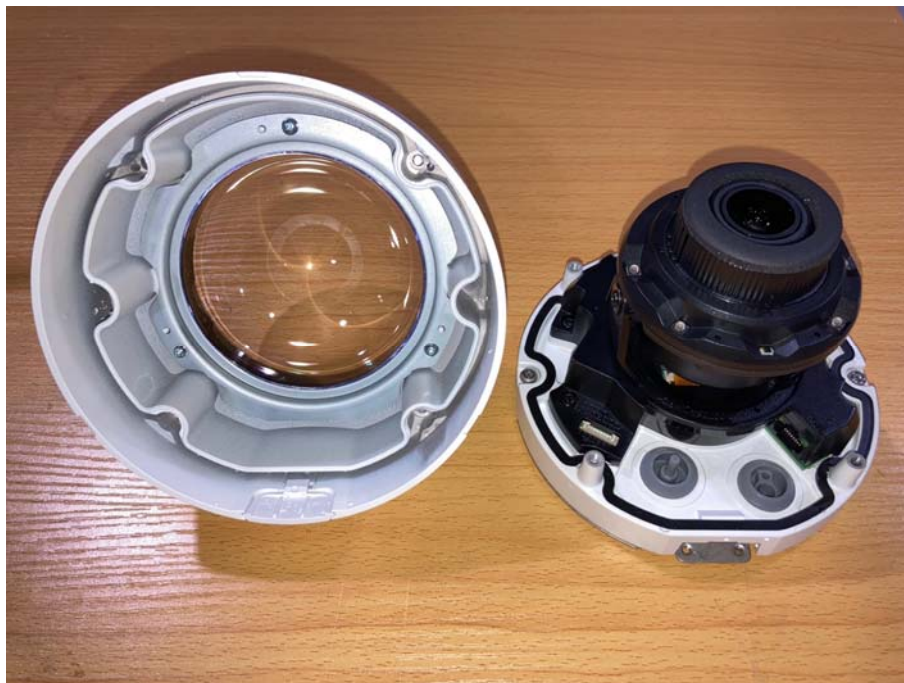
**< Photo 10 > The Second Characteristic Test**

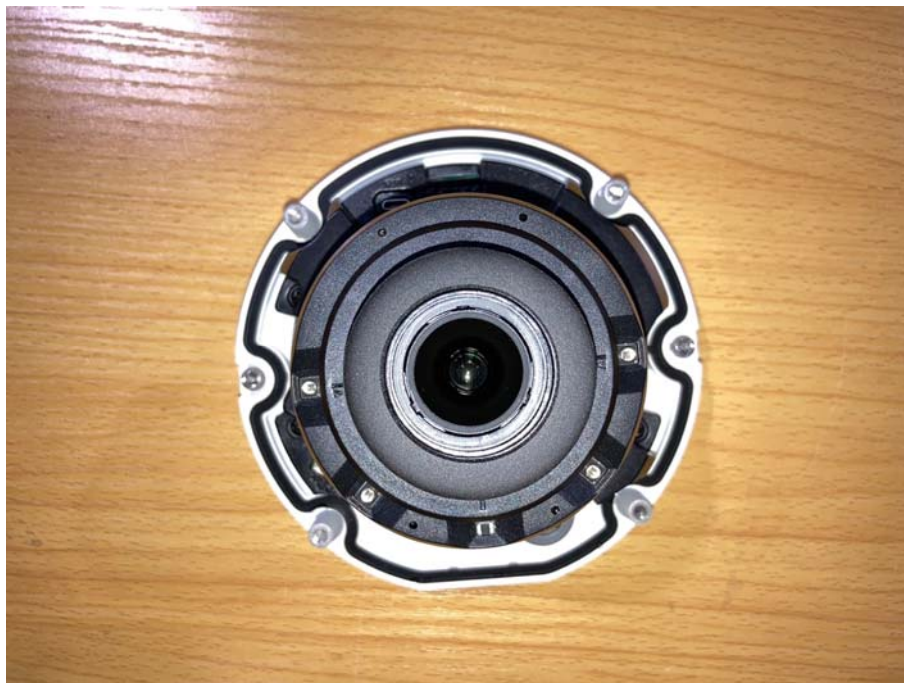
**< Photo 12 > The Second Characteristic Test**

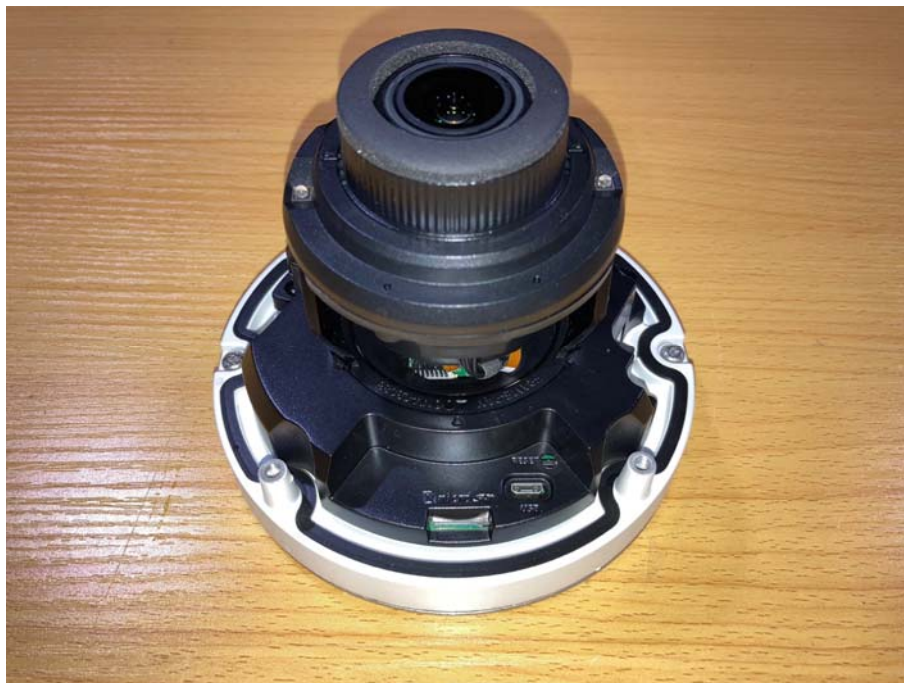
**< Photo 14 > The Second Characteristic Test**
