# TEST REPORT

Report No.:  
CTK-2023-02054  
Page (1) / (14) pages

: Back Box / SBO-140WW

7. Test Standard (Method) used : IEC 60529:1989 +A1:1999+A2:2013

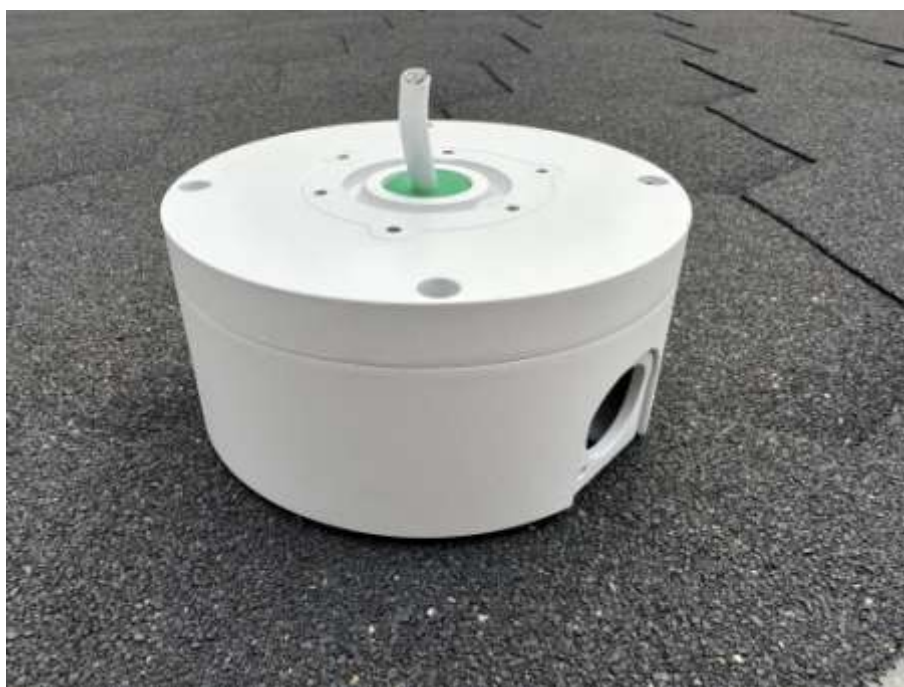
< Photo 1 > Product Front View

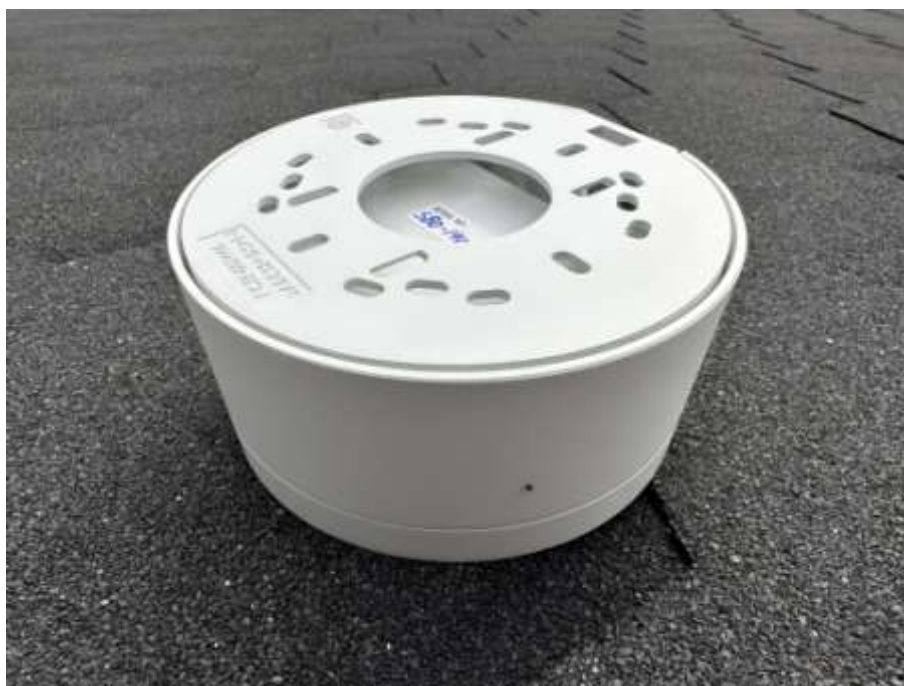
< Photo 2 > Product Rear View

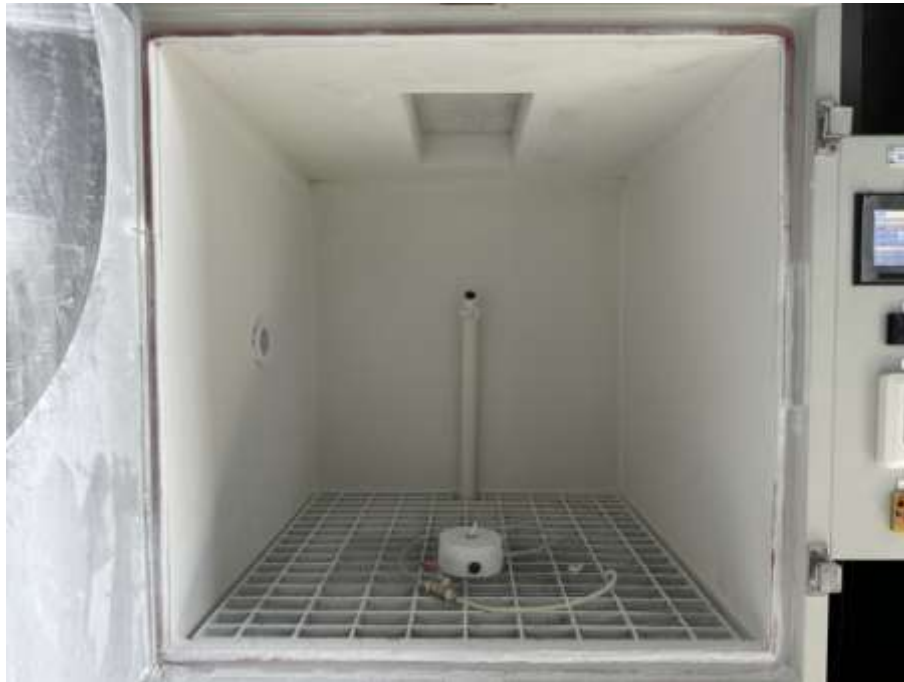
### < Photo 3 > The First Characteristic Numeral Test

| First characteristic numeral | Degree of protection | Application |
|---|---|---|
| 6 | Protected against access to hazardous parts with a wire.<br>The access probe of 1.0 mmØ, shall not penetrate.<br>Test force: 1 N ± 10 % | <input checked="" type="checkbox"/> |

| IP Code | Remark |
|---|---|
| IP 6X | No penetration of probe.<br>No ingress of dust. |

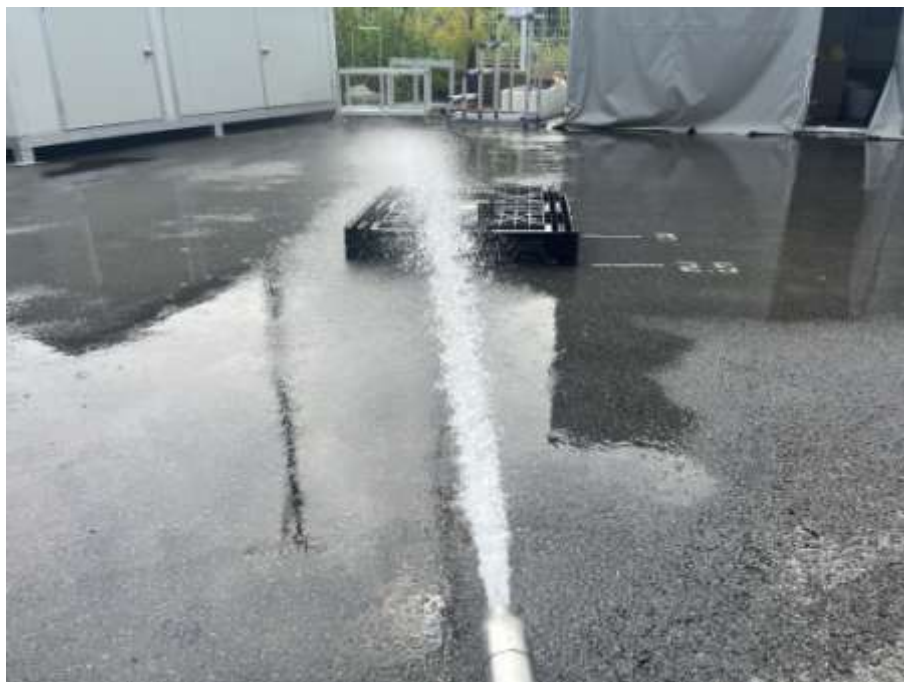
### < Photo 4 > The Second Characteristic Numeral Test

| Second characteristic numeral | Degrees of protection | Application |
|---|---|---|
| 6 | <p>The product must not be harmed in any direction even strong jet water.</p> <p>Water jet hose nozzle Fig.6, Nozzle 12.5 mm diameter</p> <p>Water flow rate: 100 l/min <math>\pm</math> 5 % : <b>100 LPM</b></p> <p>Distance: 2.5 m to 3 m: <b>3 m</b></p> <p>Duration of test: 1 min/m<sup>2</sup> at least 3 min: <b>3 min</b></p> | <input checked="" type="checkbox"/> |

| IP Code | Remark |
|---|---|
| IP X6 | No ingress of water. |

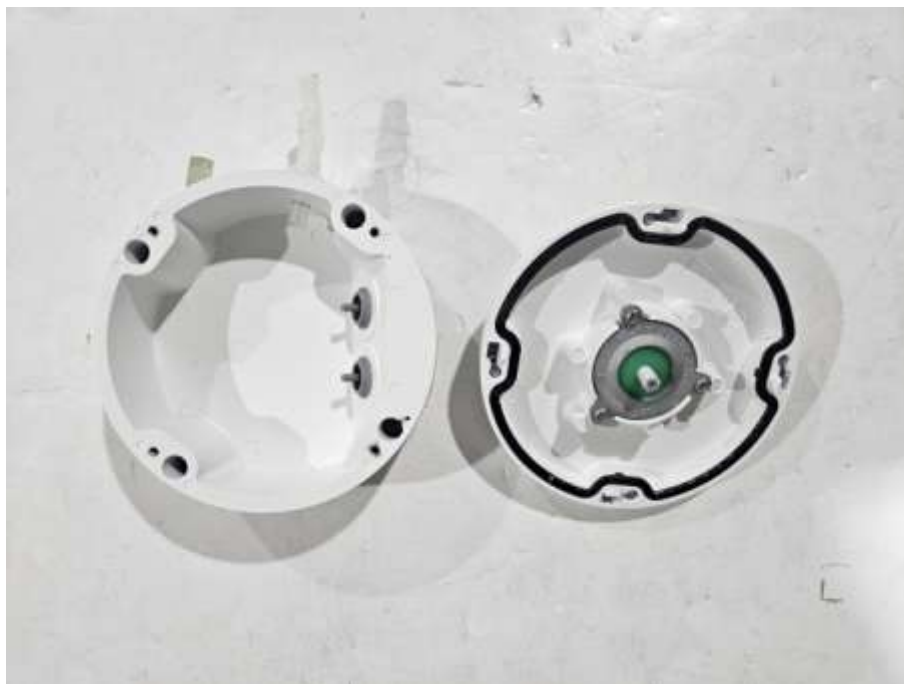
### < Photo 5 > The First Characteristic Numeral Test

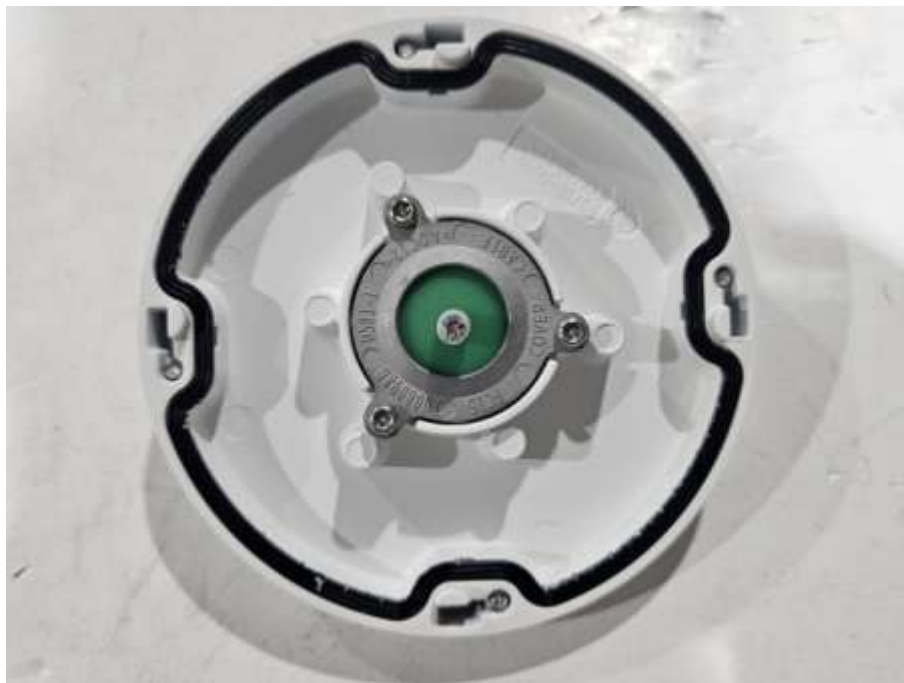
**< Photo 7 > The First Characteristic Numeral Test**

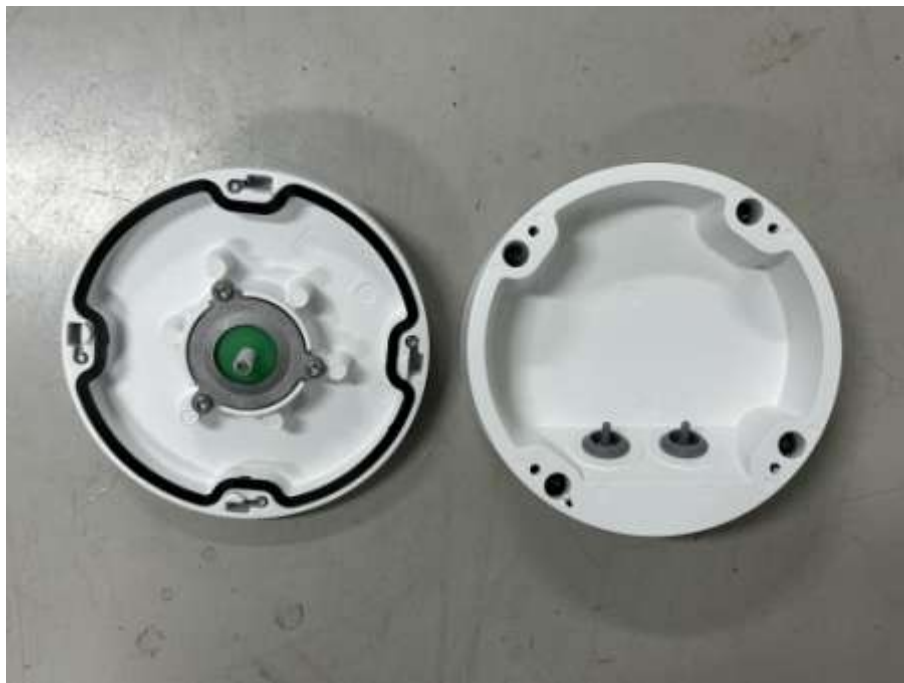
**< Photo 8 > The Second Characteristic Numeral Test**

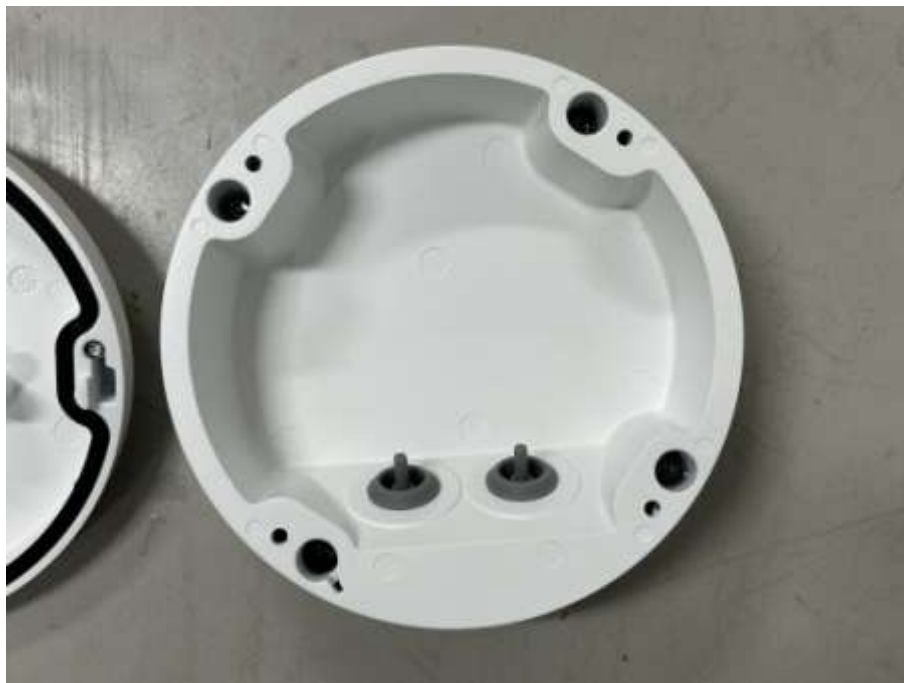
**< Photo 10 > The Second Characteristic Numeral Test**
