# TEST REPORT

Report No.:  
CTK-2023-00297  
Page (1) / (14) pages

: HORN SPEAKER / SPA-H100W

7. Test Standard (Method) used : KS C IEC 60529:2013

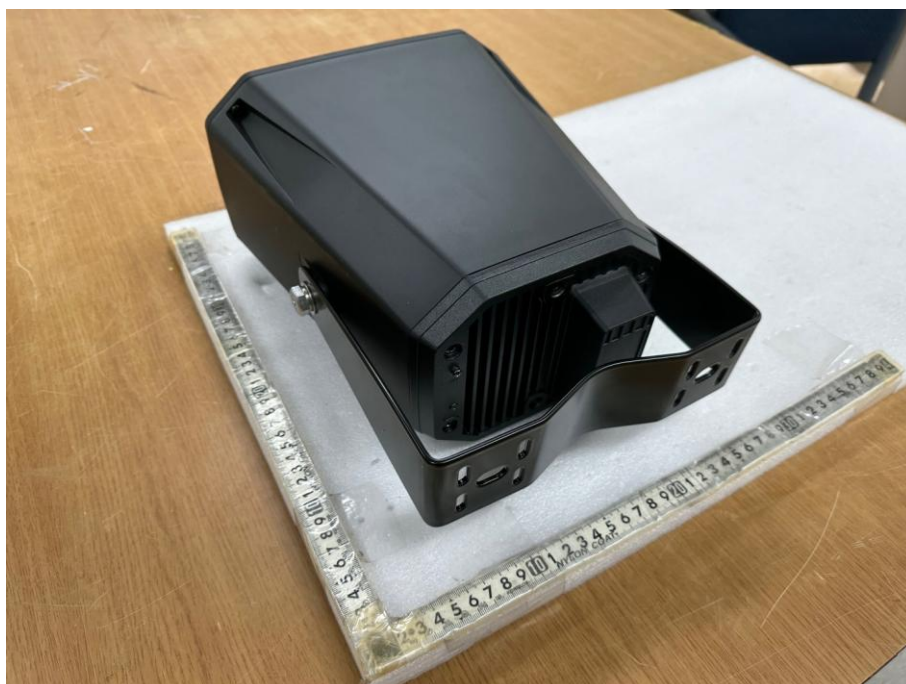
#### < Photo 2 > Product Rear View

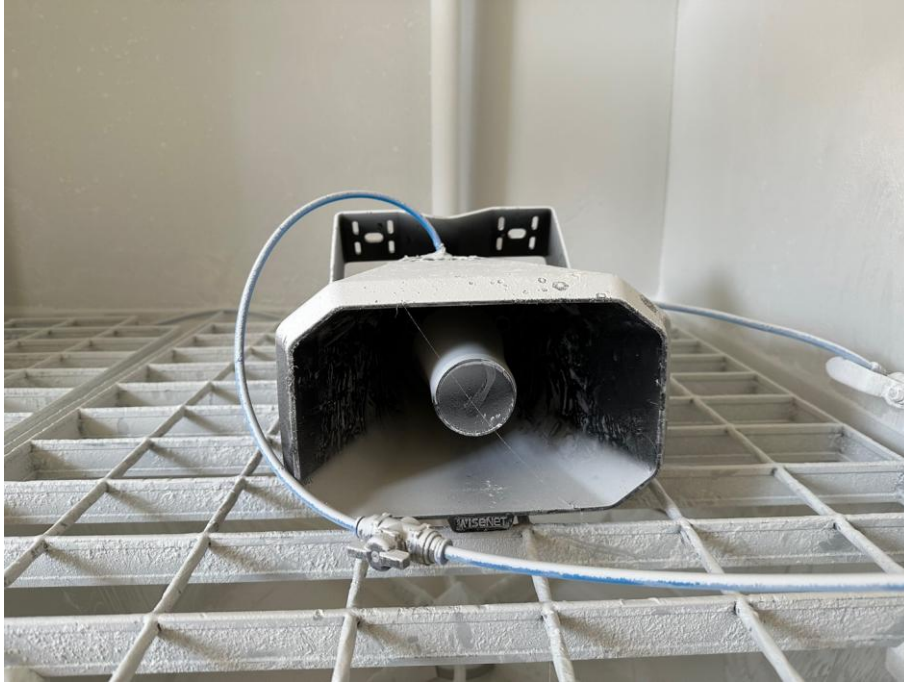
### < Photo 3 > The First Characteristic Numeral Test

| First characteristic numeral | Degree of protection | Application |
|---|---|---|
| 6 | Protected against access to hazardous parts with a wire.<br>The access probe of 1.0 mmØ, shall not penetrate.<br>Test force: 1 N ± 10 % | <input checked="" type="checkbox"/> |

| First characteristic numeral | Degree of protection | Application |
|---|---|---|
| 6 | In Dust Testing Equipment, the test sample has to have no ingress of dust after testing atmospheric pressure present condition for 8 hr.<br>(Talcum powder have to go through the measured sieve by Φ 50 um wire that are spacing 75 um in squared, per volume and union Talcum powder have to be 2 kg/m <sup>3</sup> )<br><br>Products in volume .....: <b>19 202.88 cm<sup>3</sup> → 19.20 L</b> | <input checked="" type="checkbox"/> |

| IP Code | Remark |
|---|---|
| IP 6X | No penetration of probe<br>No ingress of dust |

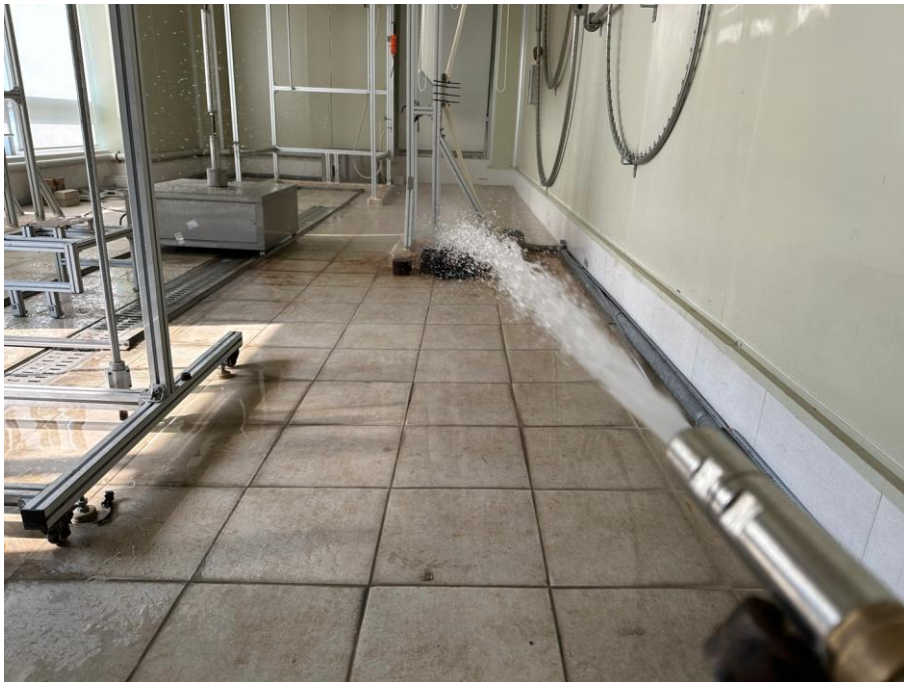
### < Photo 4 > The Second Characteristic Numeral Test

| Second characteristic numeral | Degrees of protection | Application |
|---|---|---|
| 6 | <p>The product must not be harmed in any direction even strong jet water.</p> <p>Water jet hose nozzle Fig.6, Nozzle 12.5 mm diameter</p> <p>Water flow rate: 100 l/min <math>\pm</math> 5 % : <b>100 LPM</b></p> <p>Distance: 2.5 m to 3 m: <b>3 m</b></p> <p>Duration of test: 1 min/m<sup>2</sup> at least 3 min: <b>3 min</b></p> | <input checked="" type="checkbox"/> |

| IP Code | Remark |
|---|---|
| IP X6 | No ingress of water. |

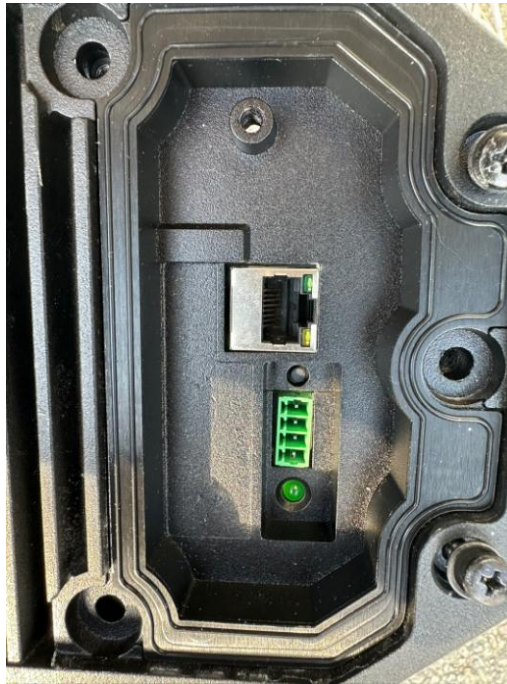
### < Photo 5 > The First Characteristic Numeral Test

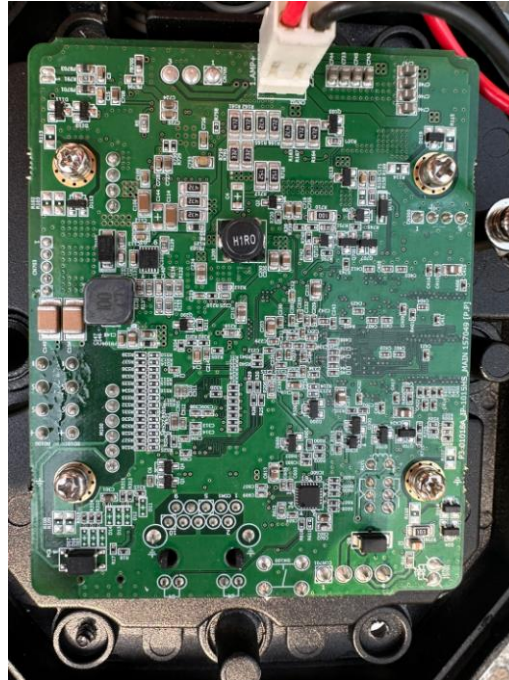
**< Photo 7 > The First Characteristic Numeral Test**

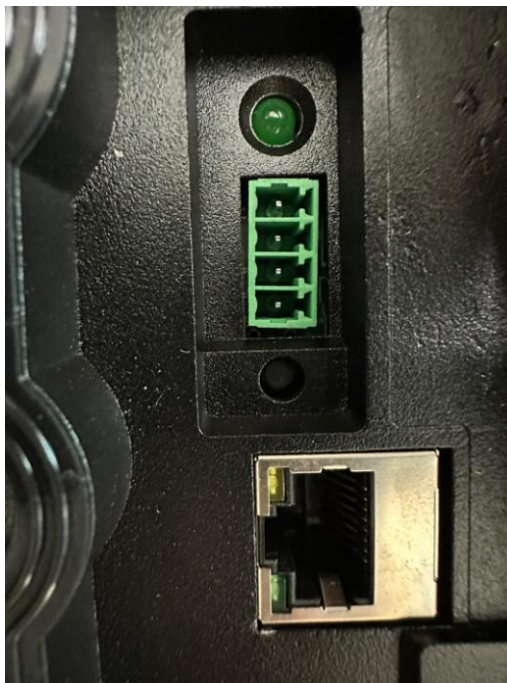
**< Photo 8 > The Second Characteristic Numeral Test**

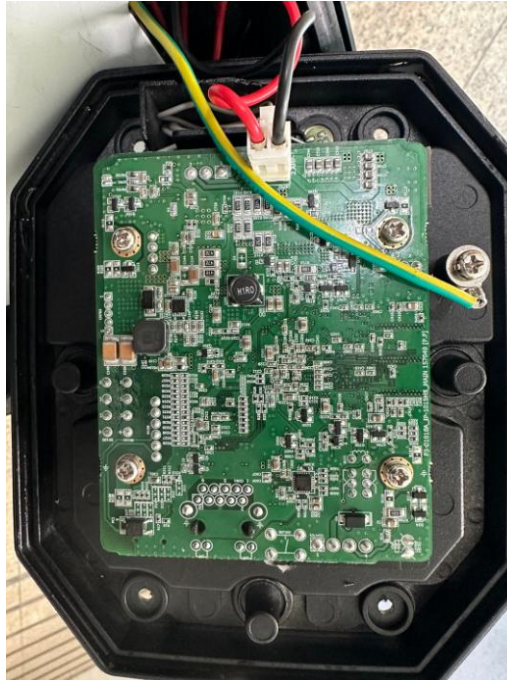
**< Photo 10 > The Second Characteristic Numeral Test**
