# TEST REPORT

REPORT No.:  
CTK-2025-01262  
Page (1) / (14) pages

Network Thermal Camera / TNO-C3050T

IEC 60529:1989 +A1:1999+A2:2013

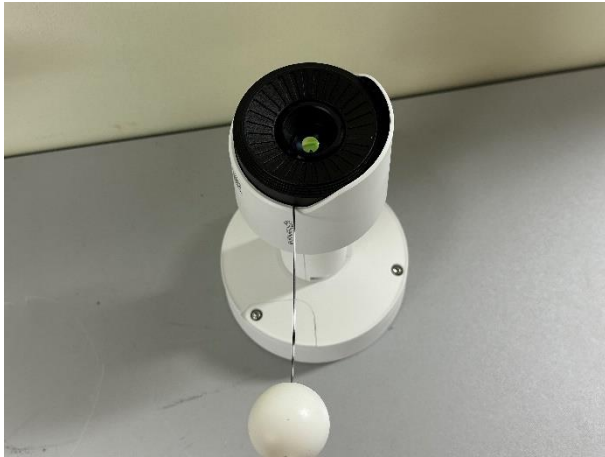
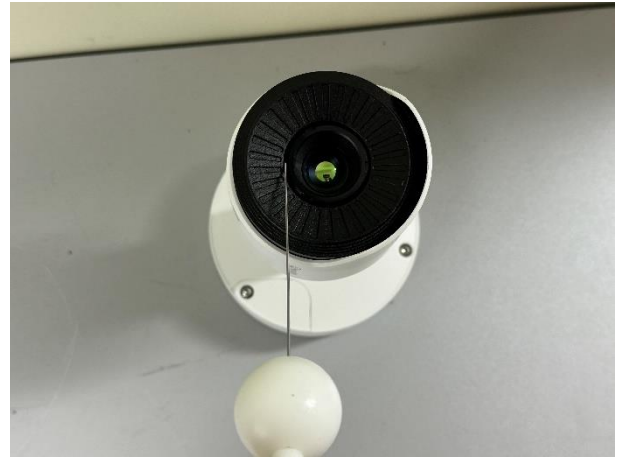
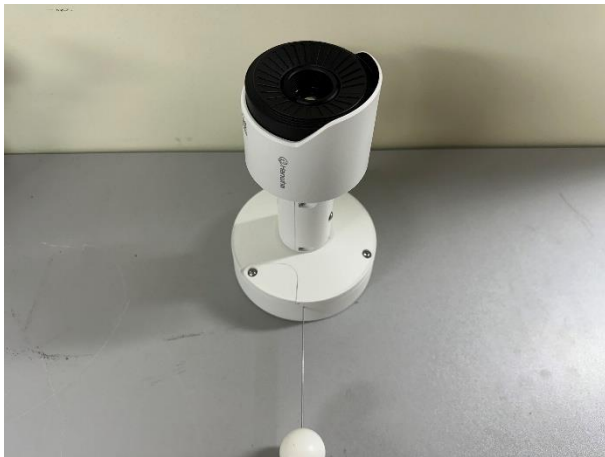
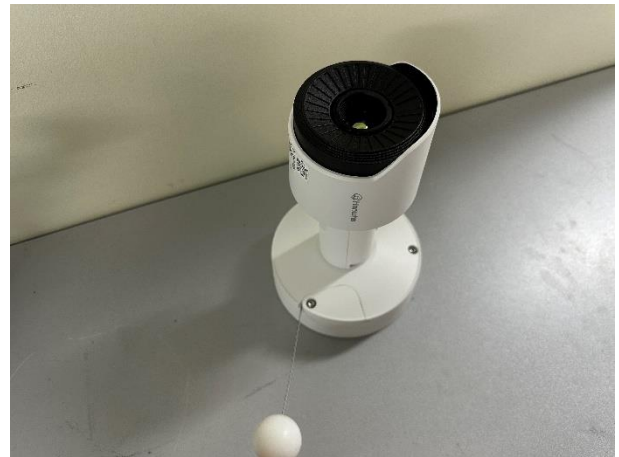
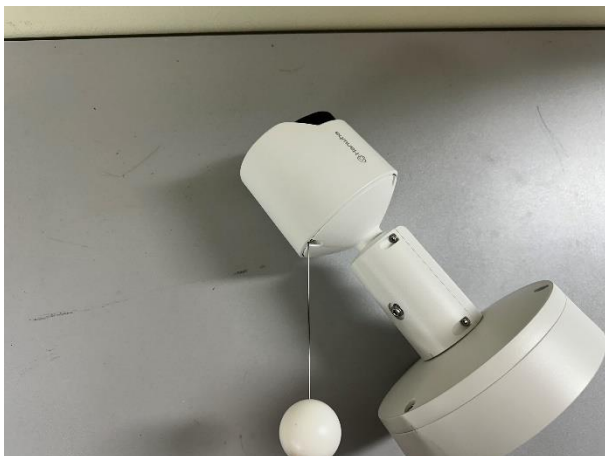
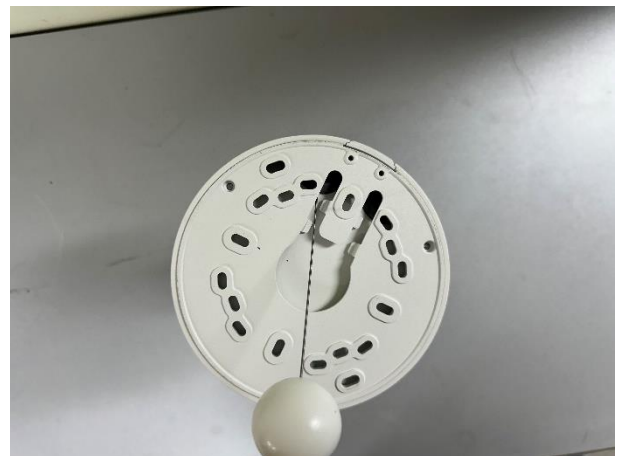
#### 3.3.1 Evidence of test setting (1)

| First characteristic numeral | Degree of protection | Application |
|---|---|---|
| 6 | Protected against access to hazardous parts with a wire.<br>The access probe of 1.0 mmØ, shall not penetrate.<br>Test force: 1 N ± 10 % | <input checked="" type="checkbox"/> |

Probe test

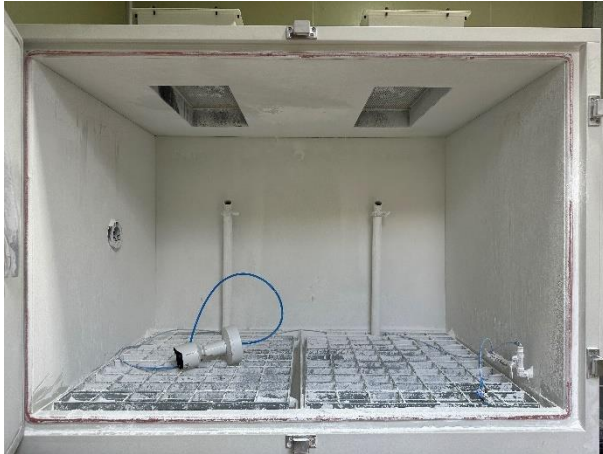
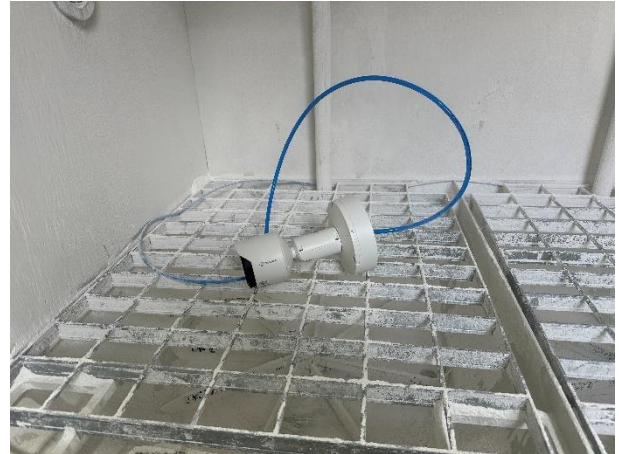
| First characteristic numeral | Degree of protection | Application |
|---|---|---|
| 6 | <p>In Dust Testing Equipment, the test sample must have no ingress of dust after testing atmospheric pressure present condition for 8 h.</p> <p>(The talcum powder must pass through a calibrated sieve with a 50 µm wire mesh, spaced at 75 µm intervals in a square pattern. Additionally, the bulk density of the talcum powder should be 2 kg/m<sup>3</sup>)</p> <p>Products in volume .....: <b>2 054.44 cm<sup>3</sup> → 2.05 L</b></p> <p>Target intake volume (Products in volume 80) : <b>164.35 L</b></p> <p>Suction volume (Max product in volume 60) ..: <b>123.27 LPH → 2.05 LPM</b></p> <p>Actual Suction volume .....: <b>2.05 L</b></p> <p>Suction pressure (Up to 2 kPa) .....: <b>1.78 kPa</b></p> <p>Test time (Up to 8 time) .....: <b>8 hr</b></p> | <input checked="" type="checkbox"/> |

Dust test

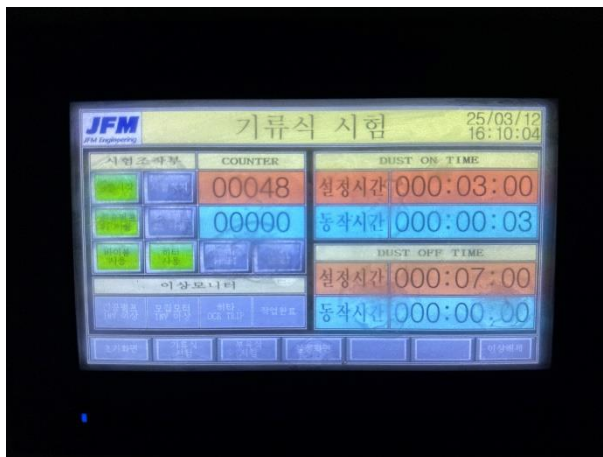
Dust test Monitor

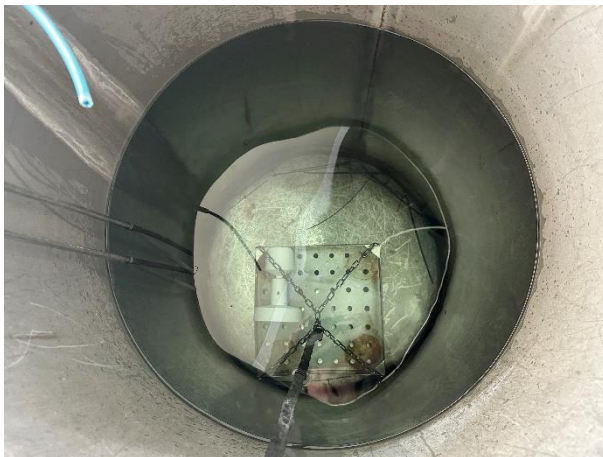
| Second characteristic numeral | Degrees of protection | Application |
|---|---|---|
| 7 | <p>Sink the product in the water by the Pressure and Time according to regulation and the product must not be harmed.</p> <p>Immersion tank water-level on enclosure with:</p> <p><input type="checkbox"/> height equal to or greater than 850 mm: the highest point of enclosures located 0.15 m below the surface of the water</p> <p><input checked="" type="checkbox"/> height less than 850 mm: the lowest point of enclosures located 1 m below the surface of the water</p> <p>Duration of test: 30 min</p> | <input checked="" type="checkbox"/> |

Water test

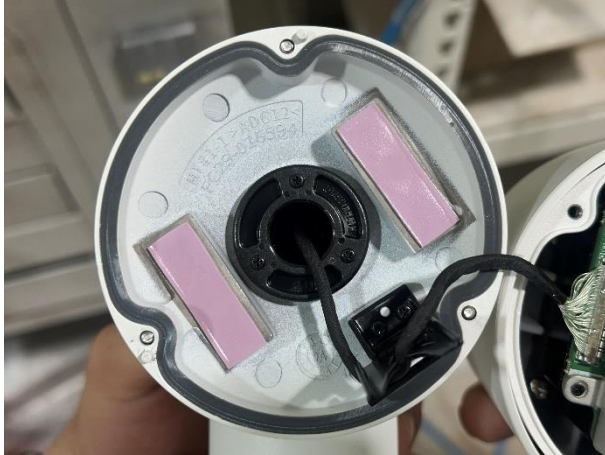
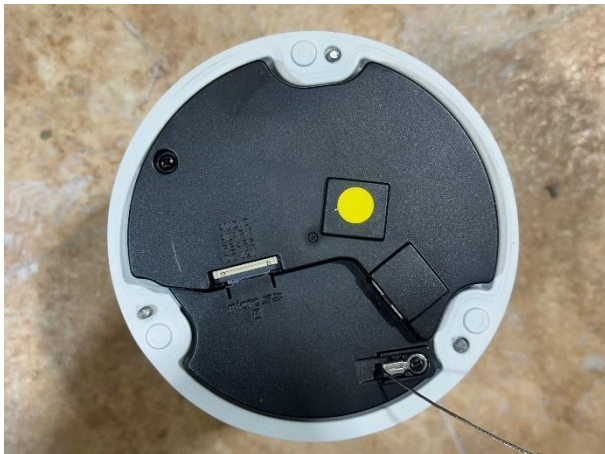
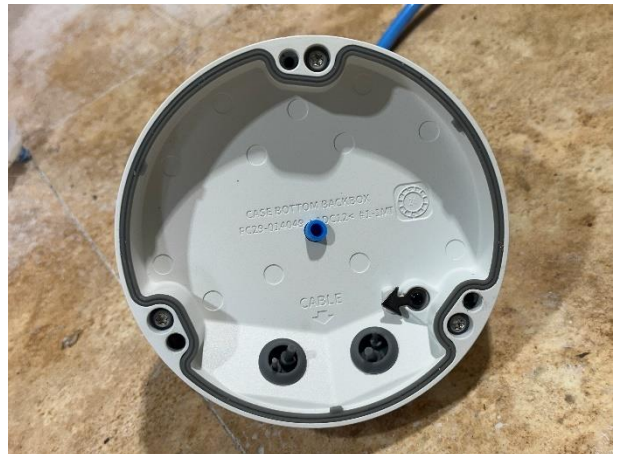
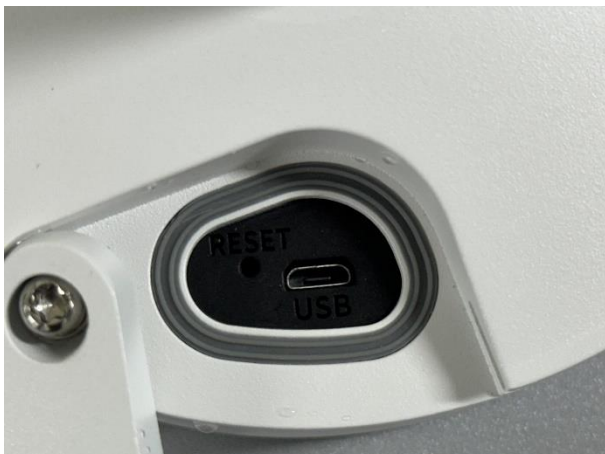
#### 3.5.1 Product internal images after test [The first characteristic numeral test]

| IP code | Evaluation Criteria | Test Results | Remark |
|---|---|---|---|
| IP 6X | No ingress of Probe | Normal | - |
| | No ingress of dust | Normal | - |

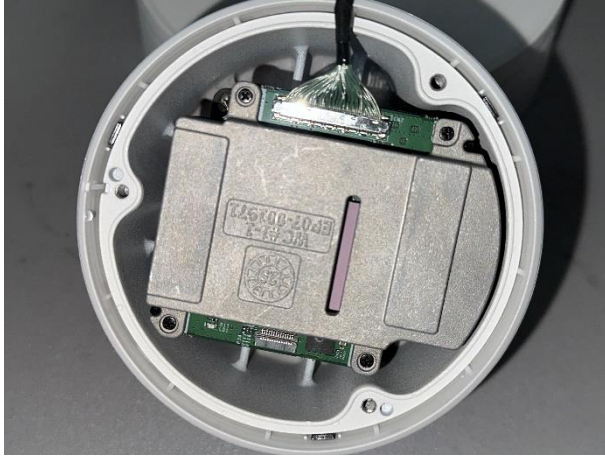
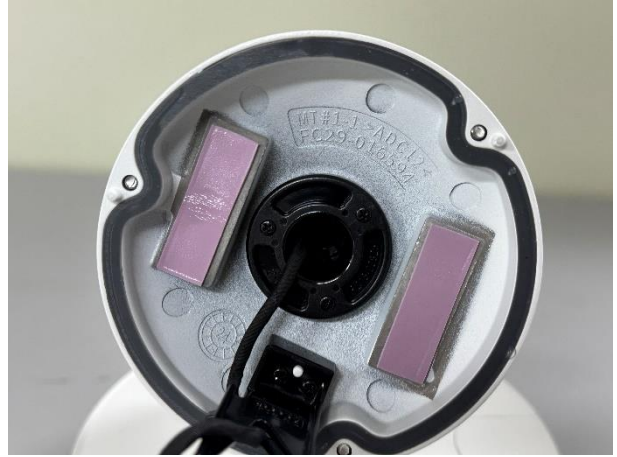
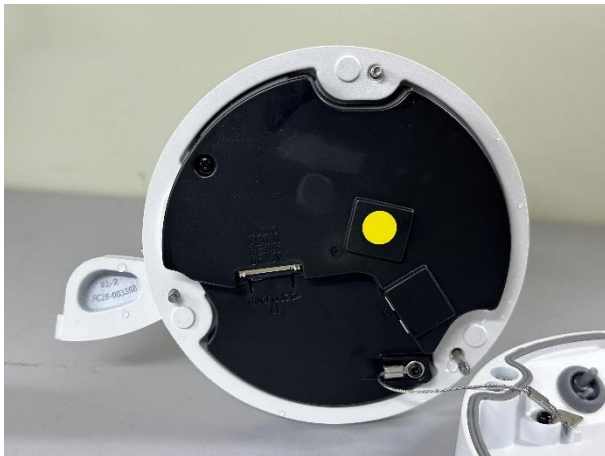
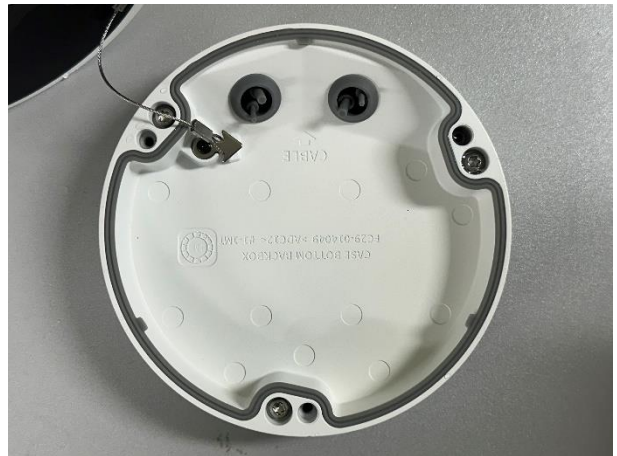
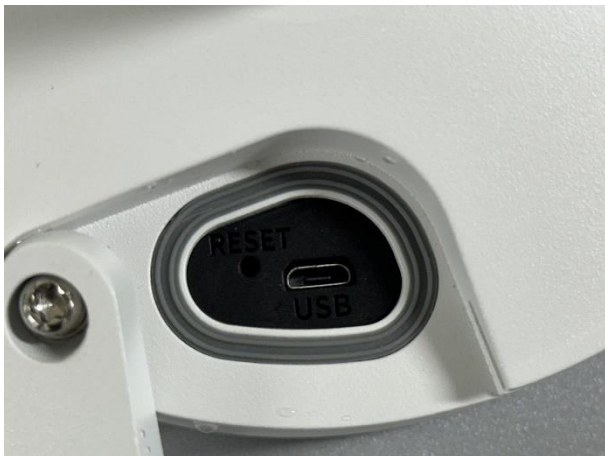
### 3.5.2 Product internal images after test [The second characteristic numeral test]

| IP code | Evaluation Criteria | Test Results | Remark |
|---|---|---|---|
| IP X7 | No ingress of water | Normal | - |
