# TEST REPORT

REPORT No.:  
CTK-2024-02200  
Page (1) / (15) pages

BARCODE READER / TNS-9050IBC

IEC 60529:1989 +A1:1999+A2:2013

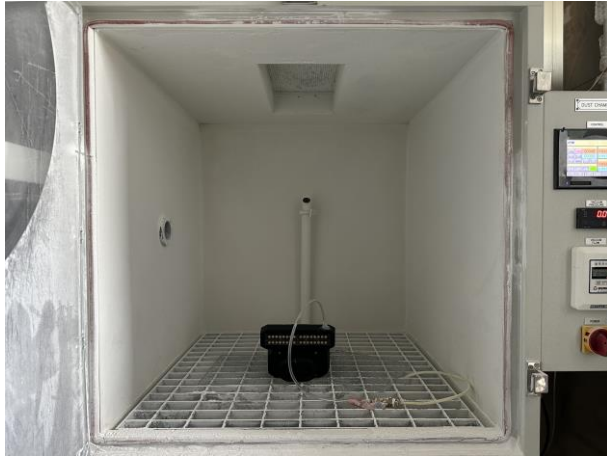
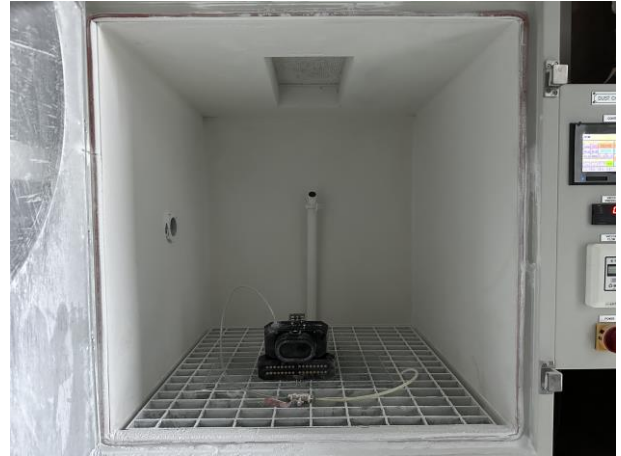
Dust test #1

| First characteristic numeral | Degree of protection | Application |
|---|---|---|
| 6 | <p>In Dust Testing Equipment, the test sample has to have no ingress of dust after testing atmospheric pressure present condition for 8 hr.</p> <p>(Talcum powder have to go through the measured sieve by <math>\Phi</math> 50 um wire that are spacing 75 um in squared, per volume and union Talcum powder have to be 2 kg/m<sup>3</sup>)</p> <p>Products in volume .....: <b>9 959.09 cm<sup>3</sup> → 9.96 L</b></p> <p>Target intake volume (Products in volume 80) .....: <b>796.73 L</b></p> <p>Suction volume (Max product in volume 60) .....: <b>597.55 LPH → 9.96 LPM</b></p> <p>Actual Suction volume .....: <b>9.96 L</b></p> <p>Suction pressure (Up to 2 kPa) .....: <b>2 kPa</b></p> <p>Test time (Up to 8 time) .....: <b>8 hr</b></p> | <input checked="" type="checkbox"/> |

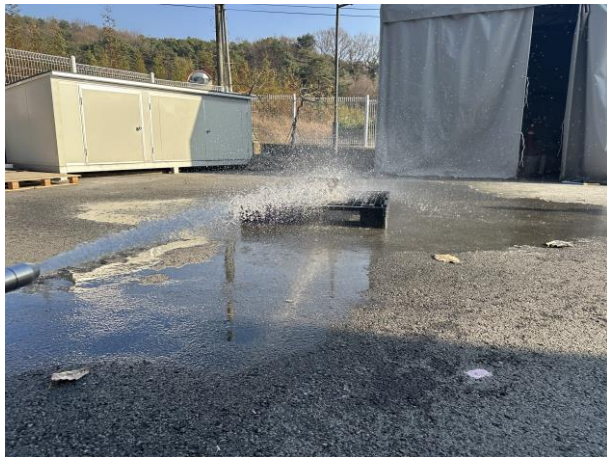
Water test

| Second characteristic numeral | Degrees of protection | Application |
|---|---|---|
| 6 | <p>The product must not be harmed in any direction even strong jet water.</p> <p>Water jet hose nozzle Fig.6, Nozzle 12.5 mm diameter</p> <p>Water flow rate: 100 l/min ± 5 % : <b>100 LPM</b></p> <p>Distance: 2.5 m to 3 m: <b>3 m</b></p> <p>Duration of test: 1 min/m<sup>2</sup> at least 3 min: <b>3 min</b></p> | <input checked="" type="checkbox"/> |

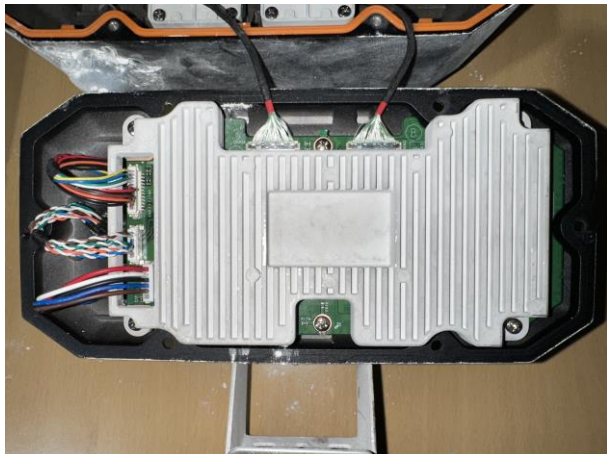
### 4.2.1 Product internal images after test [The First characteristic Numeral Test]

| IP code | Evaluation Criteria | Test Results | Remark |
|---|---|---|---|
| IP 6X | No penetration of probe. | <b>Normal</b> | - |
| | No ingress of dust. | <b>Normal</b> | - |

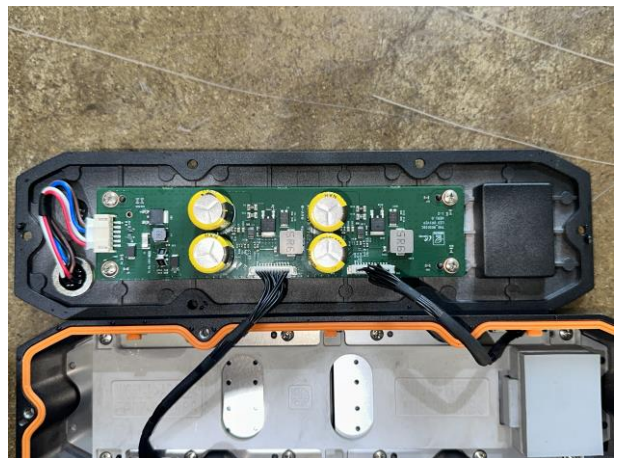
#### 4.2.2 Product internal images after test [The Second characteristic Numeral Test]

| IP code | Evaluation Criteria | Test Results | Remark |
|---|---|---|---|
| IP X6 | No ingress of water. | <b>Normal</b> | - |
