# TEST REPORT

Report No.:  
CTK-2023-02618  
Page (1) / (18) pages

: BARCODE READER / TNS-9050IBC

7. Test Standard (Method) used : IEC 60529:1989 +A1:1999+A2:2013

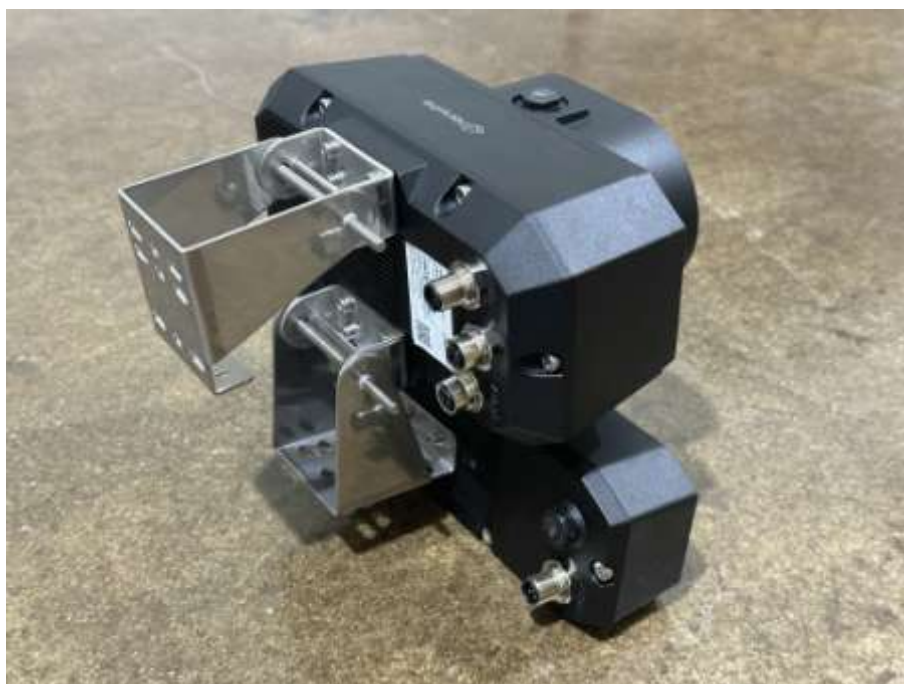
#### < Photo 2 > Product Rear View

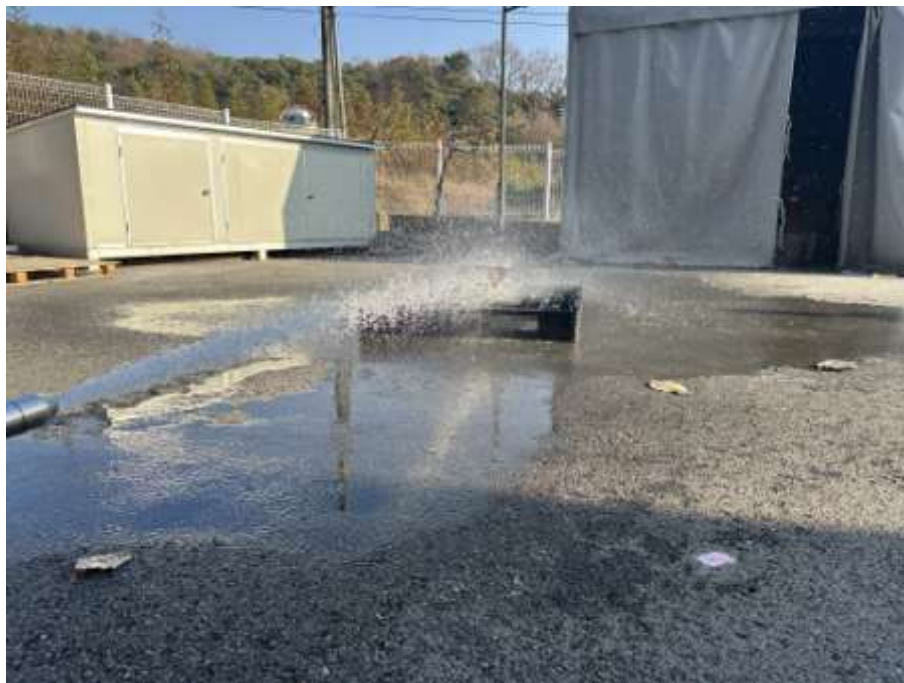
**< Photo 5 > The Second Characteristic Numeral Test**

| Second characteristic numeral | Degrees of protection | Application |
|---|---|---|
| 6 | <p>The product must not be harmed in any direction even strong jet water.</p> <p>Water jet hose nozzle Fig.6, Nozzle 12.5 mm diameter</p> <p>Water flow rate: 100 l/min <math>\pm</math> 5 % : <b>100 LPM</b></p> <p>Distance: 2.5 m to 3 m: <b>3 m</b></p> <p>Duration of test: 1 min/m<sup>2</sup> at least 3 min: <b>3 min</b></p> | <input checked="" type="checkbox"/> |

| IP Code | Remark |
|---|---|
| IP X6 | No ingress of water. |
