# TEST REPORT

Report No.:  
CTK-2023-00726  
Page (1) / (12) pages

: NETWORK CAMERA / TNV-C7013RC

: IEC 60529:1989 +A1:1999+A2:2013

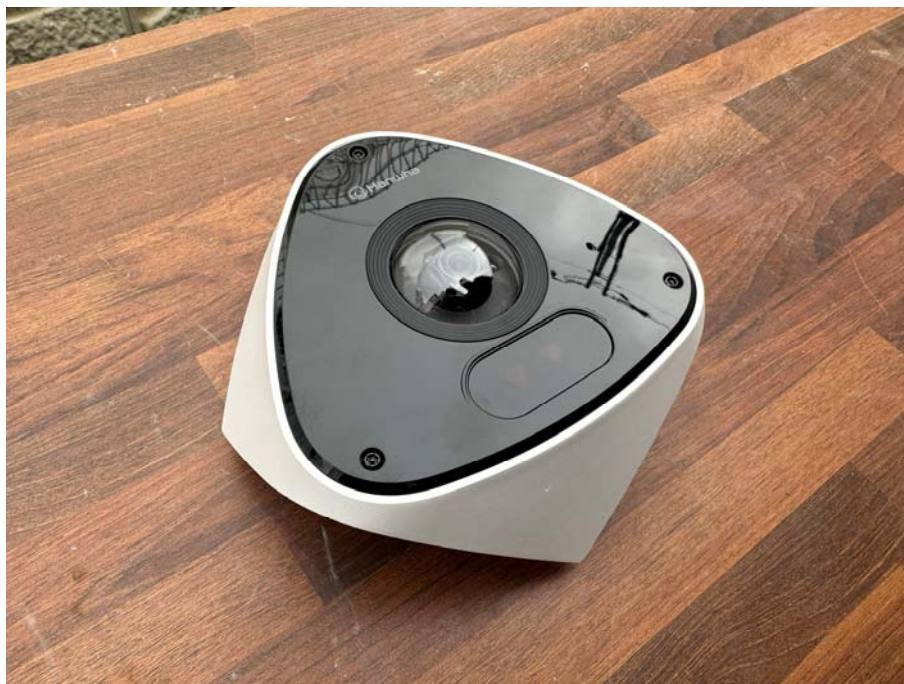
#### < Photo 1 > Product Front View

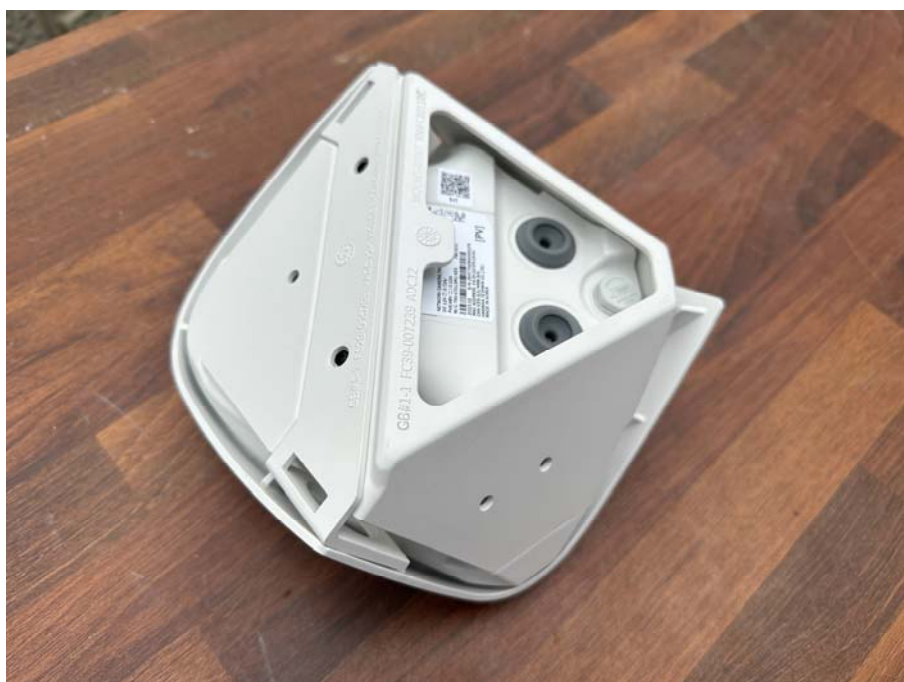
#### < Photo 2 > Product Rear View

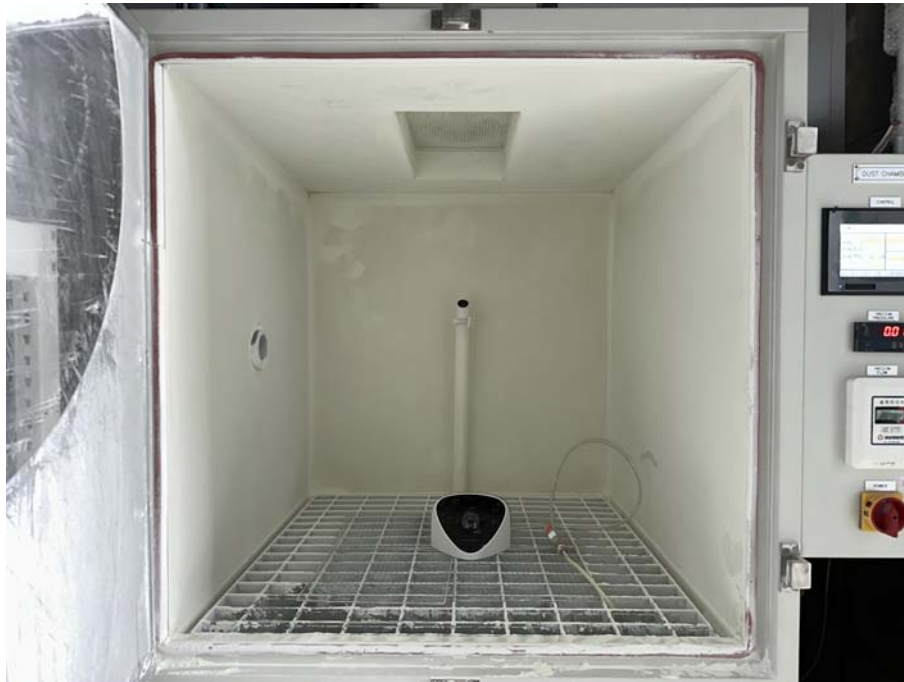
### < Photo 3 > The First Characteristic Numeral Test

| First characteristic numeral | Degree of protection | Application |
|---|---|---|
| 6 | Protected against access to hazardous parts with a wire.<br>The access probe of 1.0 mmØ, shall not penetrate.<br>Test force: 1 N ± 10 % | <input checked="" type="checkbox"/> |

| First characteristic numeral | Degree of protection | Application |
|---|---|---|
| 6 | <p>In Dust Testing Equipment, the test sample has to have no ingress of dust after testing atmospheric pressure present condition for 8 hr.</p> <p>(Talcum powder have to go through the measured sieve by <math>\Phi</math> 50 um wire that are spacing 75 um in squared, per volume and union Talcum powder have to be 2 kg/m<sup>3</sup>)</p> <p>Products in volume ..... <b>4 128.10 cm<sup>3</sup> → 4.13 L</b></p> <p>Target intake volume (Products in volume 80) ..... <b>330.25 L</b></p> <p>Suction volume (Max product in volume 60) ..... <b>247.69 LPH → 4.13 LPM</b></p> <p>Actual Suction volume ..... <b>4.13 L</b></p> <p>Suction pressure (Up to 2 kPa) ..... <b>2 kPa</b></p> <p>Test time (Up to 8 time) ..... <b>8 hr</b></p> | ☒ |

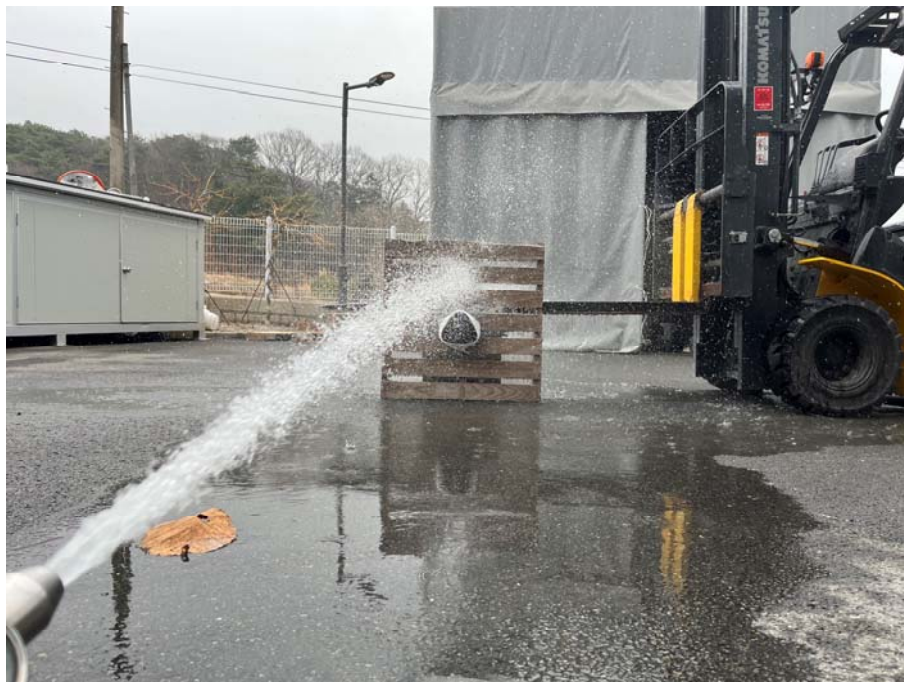
### < Photo 4 > The Second Characteristic Numeral Test

| Second characteristic numeral | Degrees of protection | Application |
|---|---|---|
| 6 | <p>The product must not be harmed in any direction even strong jet water.</p> <p>Water jet hose nozzle Fig.6, Nozzle 12.5 mm diameter</p> <p>Water flow rate: 100 l/min ± 5 % : <b>100 LPM</b></p> <p>Distance: 2.5 m to 3 m: <b>3 m</b></p> <p>Duration of test: 1 min/m<sup>2</sup> at least 3 min: <b>3 min</b></p> | ☒ |

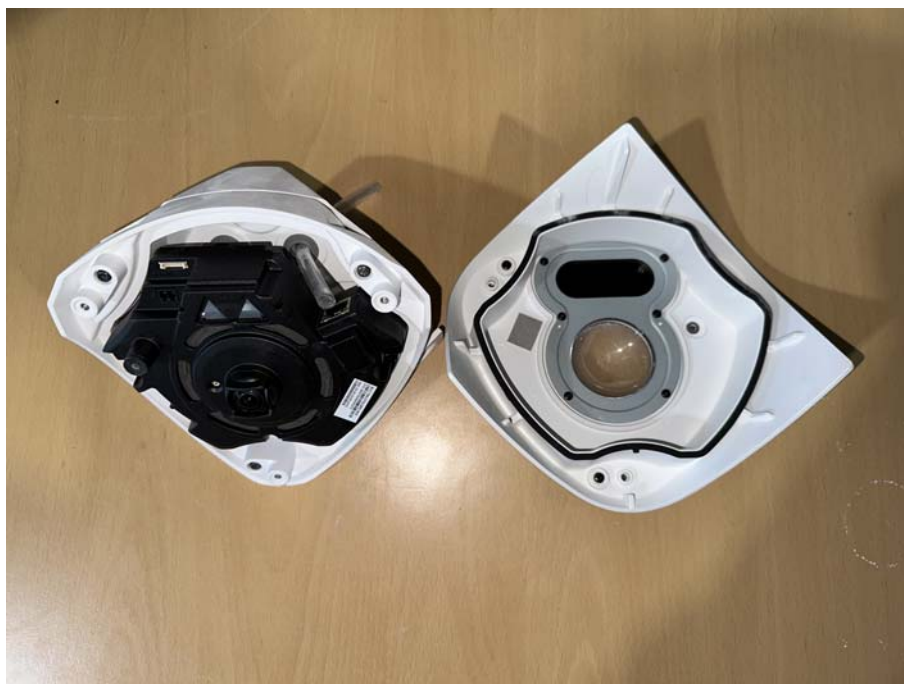
### < Photo 5 > The First Characteristic Numeral Test

| IP Code | Remark |
|---|---|
| IP 6X | No penetration of probe<br>No ingress of dust |

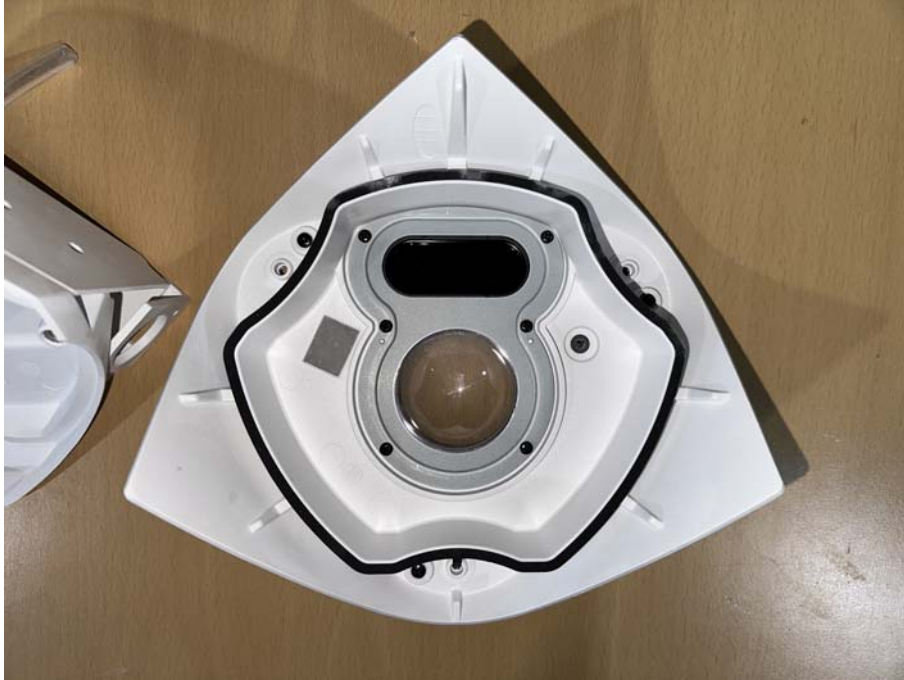
**< Photo 7 > The First Characteristic Numeral Test**

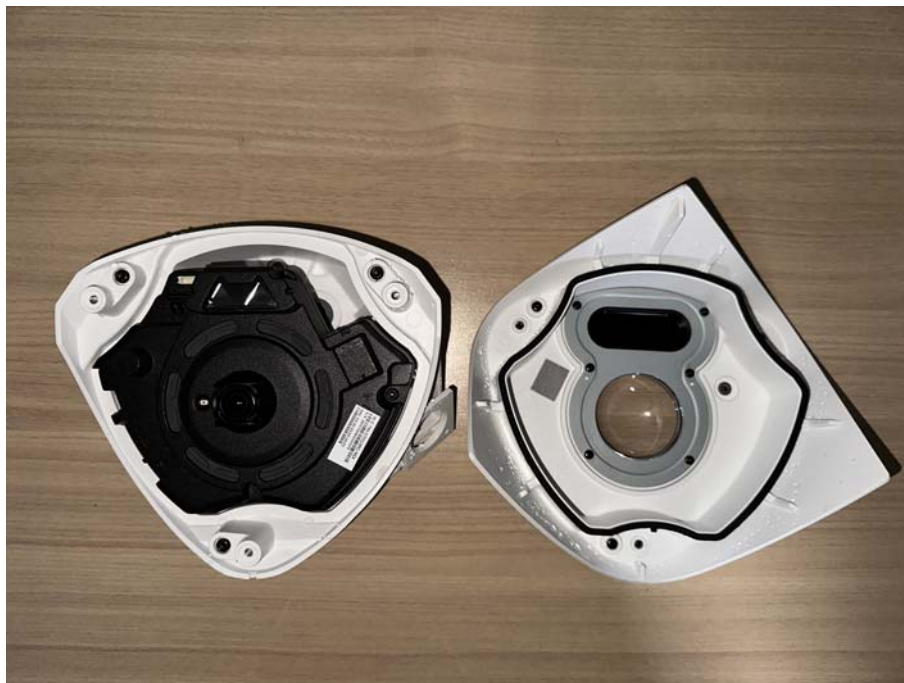
**< Photo 8 > The Second Characteristic Numeral Test**

| IP Code | Remark |
|---|---|
| IP X6 | No ingress of water. |
