## 시험 성적서 TEST REPORT

성적서 번호: STC-B17-208-01  
(Report No.)  
페이지(Page of) : ( 1 )/(총 7 )

### 3. 시험대상 품목 : 자동차번호판식별 카메라

### 5. 시험 방법/항목 : IEC 60529 Ed. 2.2: 2013 / IP66

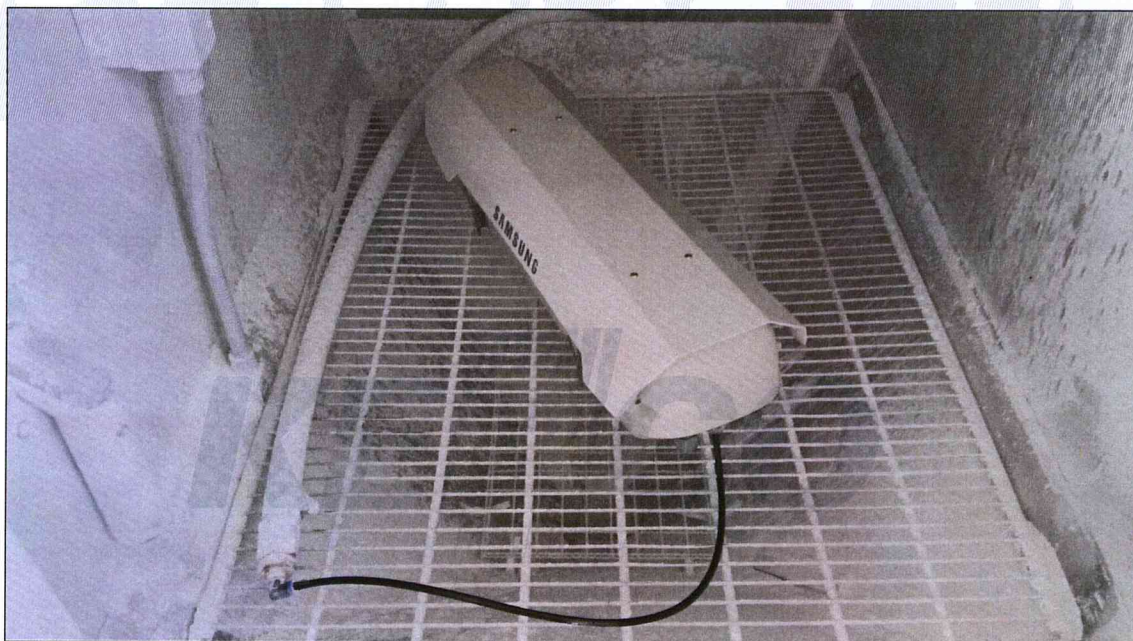
[Before the Test]

### 1) Dust Test

- ☐ If an extraction rate of 40 to 60 volumes per hour is obtained the duration of the test is 2 h
- ☒ If, with a maximum depression of 2 kPa (20 mbar), the extraction rate is less than 40 volumes per hour, the test is continued until 80 volumes have been drawn through, or a period of 8 h has elapsed.

The protection is satisfactory if no deposit of dust is observable inside the enclosure at the end of the test.

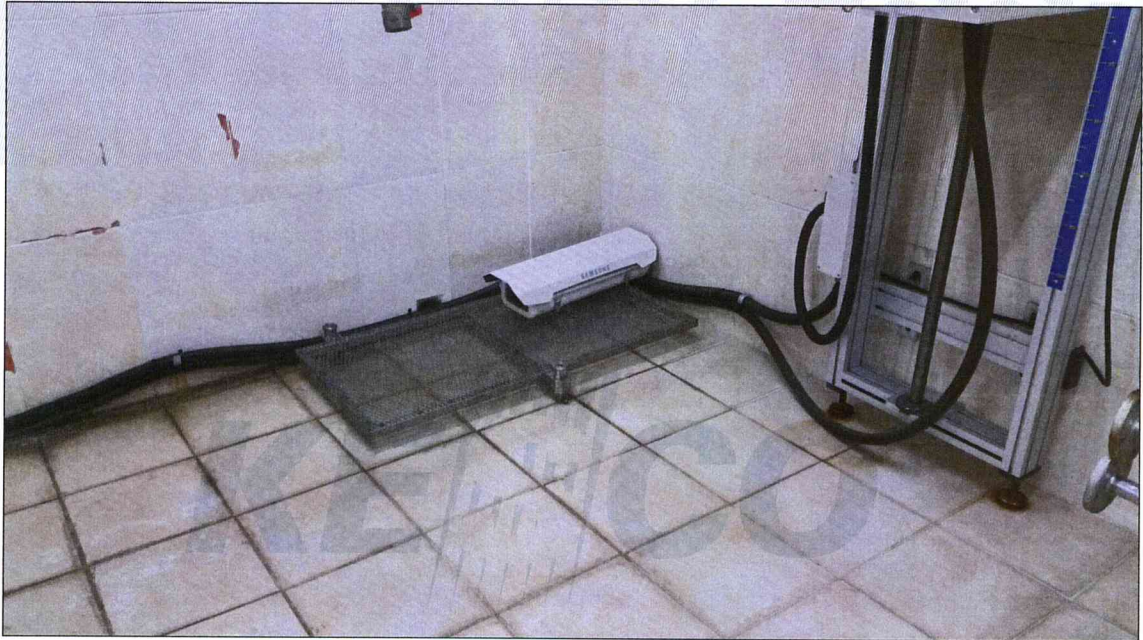
[Before the Test]

## 2) Water Test

- The test was made by spraying the enclosure from all practicable directions with a stream of water from a standard test nozzle.
- Nozzle internal diameter: 12.5 mm.
- Delivery rate: 100 L/min  $\pm$  5 %.
- Water pressure: to be adjusted to achieve the specified delivery rate.
- Test duration per square metre of enclosure surface area likely to be sprayed: 1 min
- Minimum test duration: 3 min
- Distance from the nozzle to the enclosure surface: between 2.5 m and 3 m
