# TEST REPORT

REPORT No.:  
CTK-2025-00633  
Page (1) / (14) pages

NETWORK CAMERA / XNO-A9084R

IEC 60529:1989 +A1:1999+A2:2013

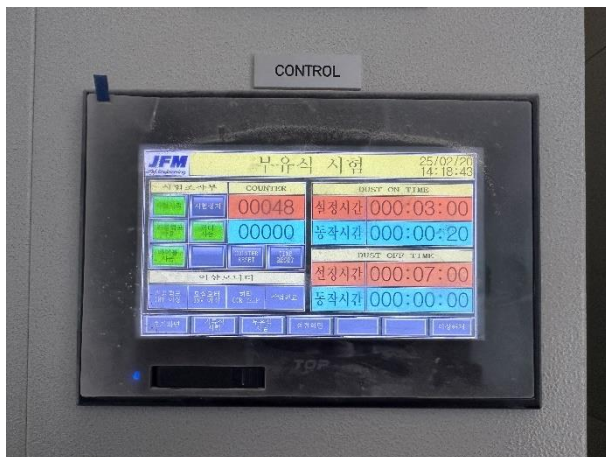
Dust test Monitor

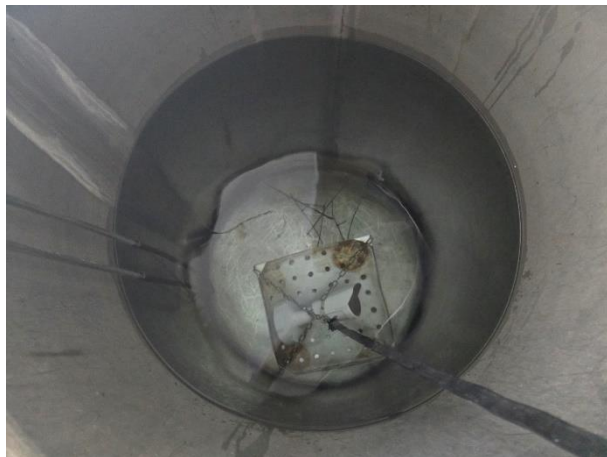
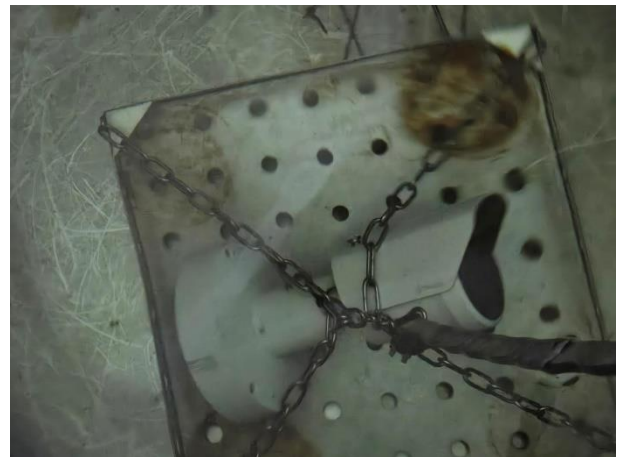
| Second characteristic numeral | Degrees of protection | Application |
|---|---|---|
| 7 | <p>Sink the product in the water by the Pressure and Time according to regulation and the product must not be harmed.</p> <p>Immersion tank water-level on enclosure with:</p> <p><input type="checkbox"/> height equal to or greater than 850 mm: the highest point of enclosures located 0.15 m below the surface of the water</p> <p><input checked="" type="checkbox"/> height less than 850 mm: the lowest point of enclosures located 1 m below the surface of the water</p> <p>Duration of test: 30 min</p> | <input checked="" type="checkbox"/> |

Water test
