# TEST REPORT

1. **Report Number** KR18-YSM0003
2. **Applicant**
  - Name Hanwha Techwin Co.,LTD
  - Address 1204, Changwon-daero, Seongsan-gu, Changwon-si, Gyeongsangnam-do, Korea
  - Date of Receipt January. 17. 2018
3. **Manufacturer**
  - Name Hanwha Techwin Co.,LTD
  - Address 1204, Changwon-daero, Seongsan-gu, Changwon-si, Gyeongsangnam-do, Korea
4. **Use of Report** For Quality management
5. **Test item description**
  - Product Name Network Camera
  - Model Name SNV-L6013R\*, SNV-L6014RM\*, SNV-L6014RM\*, **XNV-6012\***, **XNV-6012M\***, **XNV-6022R\***, **XNV-6022RM\*** (\*N:NTSC/ P:PAL)
6. **Test method used** IEC 62262 and IEC 60068-2-75
7. **Date of Test** March 16, 2016
8. **Environment**
  - Temperature ( 15 ~ 35 ) °C
  - Relative Humidity ( 25 ~ 75 ) % R.H
9. **Test Results** ☒ Pass ☐ Fail

| Division | Specification |
|---|---|
| Function | Network Camera (Indoor) |

#### 3.1 IK10 Impacts Test

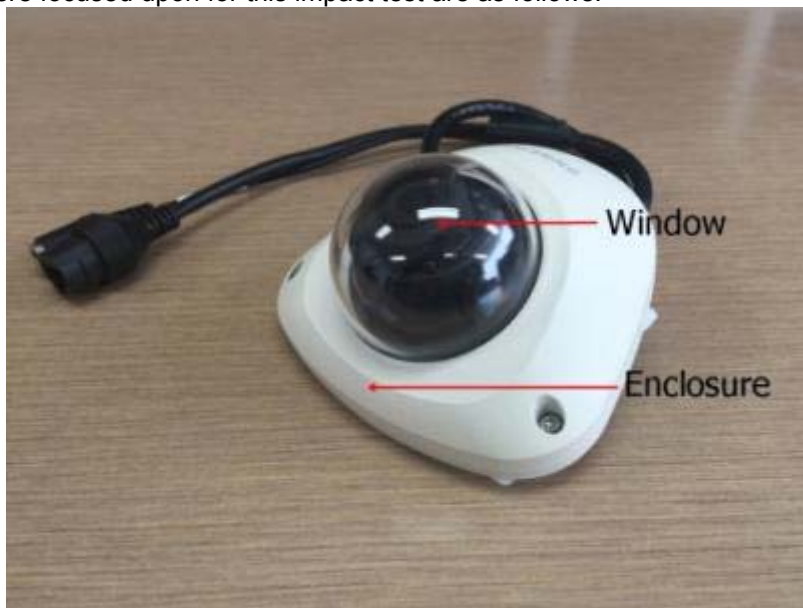
6) Drop Zones:

The areas that were focused upon for this impact test are as follows:

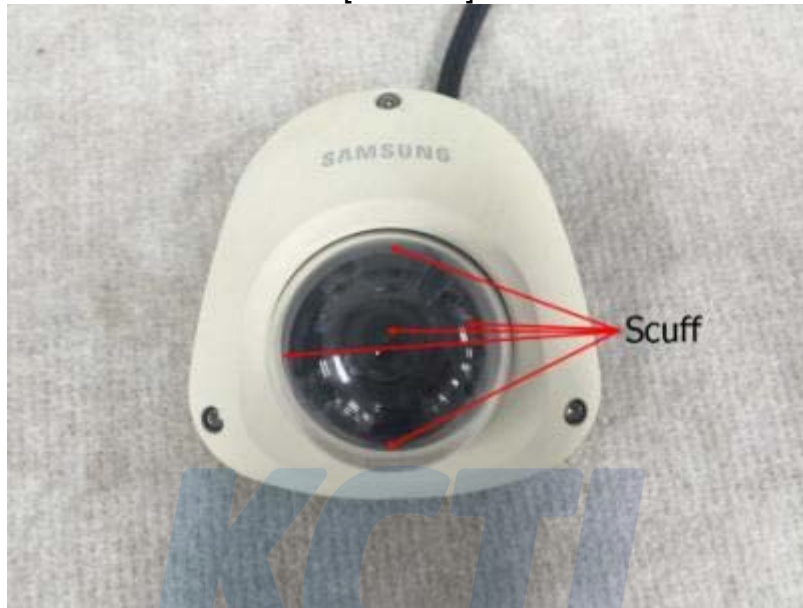
[Window]

| Drop Zone: Window | | |
|---|---|---|
| Drop 1 | Vertical drop onto center of Window. Scuff | Pass |
| Drop 2 | Normal to surface of side Window. Scuff | Pass |
| Drop 3 | Normal to surface of side Window, about 90° circumferentially from previous drop. Scuff | Pass |
| Drop 4 | Normal to surface of side Window, about 90° circumferentially from previous drop. Scuff | Pass |
| Drop 5 | Normal to surface of side Window, about 90° circumferentially from previous drop. Scuff | Pass |

8) Images (After test):

After testing according to the procedure set forth by IEC 62262, model SNV-L6013R\*(N:NTSC/ P:PAL) was found to meet the criteria required for an IK10 specification

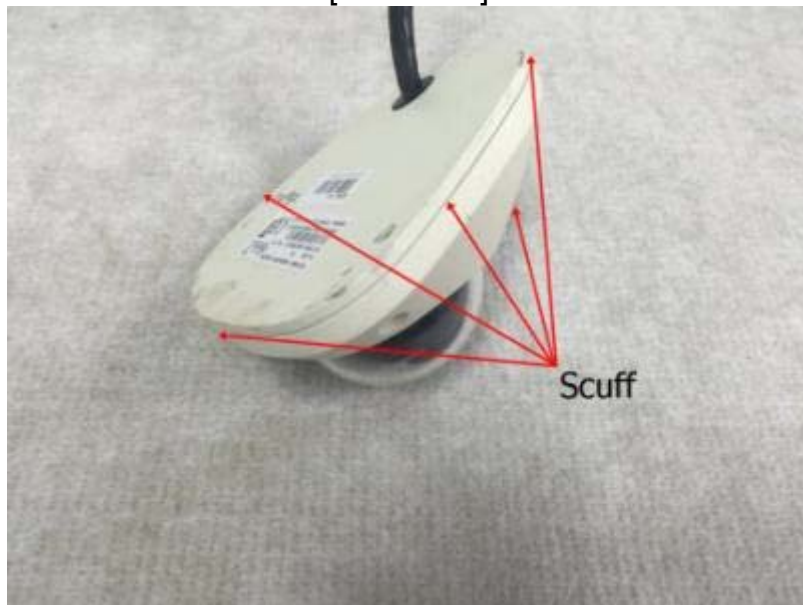
[Enclosure]

| Drop Zone: Enclosure | | |
|---|---|---|
| Drop 1 | Normal to surface of enclosure. Scuff | Pass |
| Drop 2 | Normal to surface of enclosure, about 90° circumferentially from previous drop. Scuff | Pass |
| Drop 3 | Normal to surface of enclosure, about 90° circumferentially from previous drop. Scuff | Pass |
| Drop 4 | Normal to surface of enclosure, about 90° circumferentially from previous drop. Scuff | Pass |
| Drop 5 | Normal to surface of enclosure, about 90° circumferentially from previous drop. Scuff | Pass |

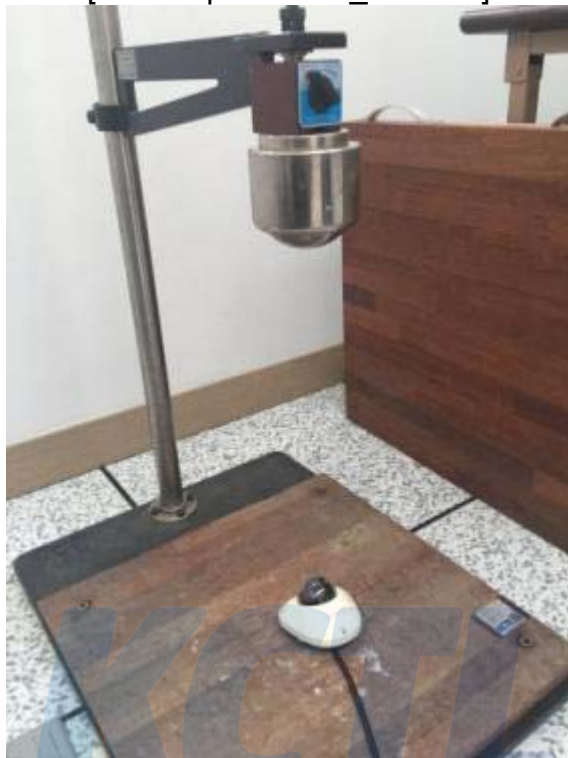
[IK10 Impacts Test\_Window]

For the test used Pendulum Hammer

IK10 (Characteristics of impact test):

Energy: 20 Joule

Mass: 5 kg

High  $\Delta h$ : 400 mm

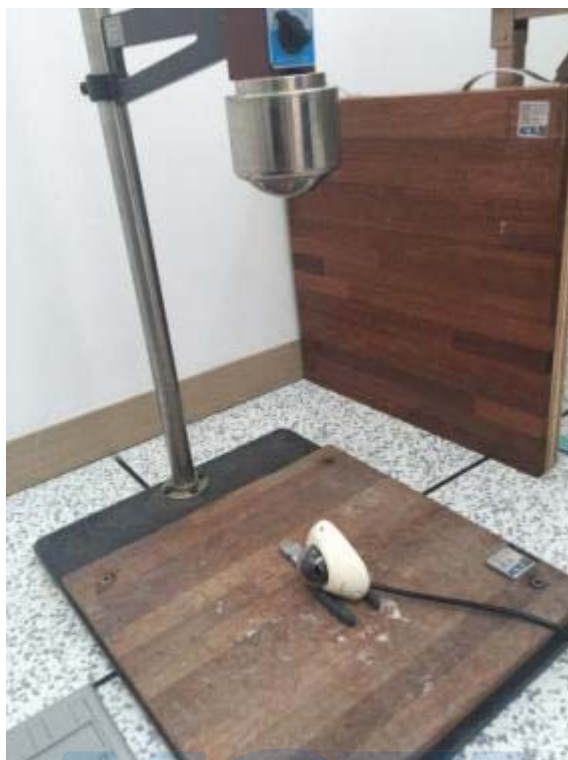
[IK10 Impacts Test\_Enclosure]

The verification of IK10 has been done positioning the enclosure on a rigid support.

5 impacts have been applied on each surface in sight with the enclosure.
