# TEST REPORT

REPORT No.:  
CTK-2024-01320  
Page (1) / (19) pages

NETWORK CAMERA / PNM-C32084RQZ  
PoE Injector / PT-PSE109GBRO-AH-S

Specifications presented by the sponsor  
(reference NEMA TS 2.2.7 ~ 9)

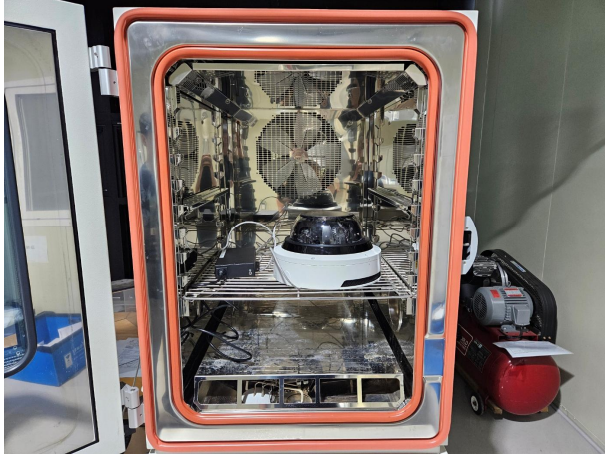
Transient Tests
