# TEST REPORT

REPORT No.:  
CTK-2025-01949  
Page (1) / (13) pages

LENS MODULE / SLA-F1080FA

IEC 60529:1989 +A1:1999+A2:2013

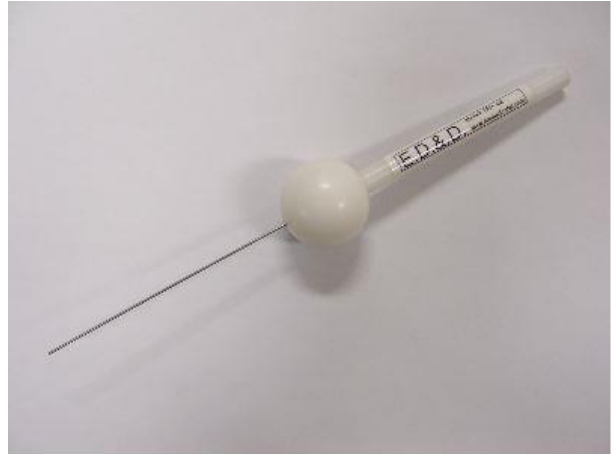
Test Rod Probe Ø1.0

| First characteristic numeral | Degree of protection | Application |
|---|---|---|
| 6 | Protected against access to hazardous parts with a wire.<br>The access probe of 1.0 mmØ, shall not penetrate.<br>Test force: 1 N ± 10 % | <input checked="" type="checkbox"/> |

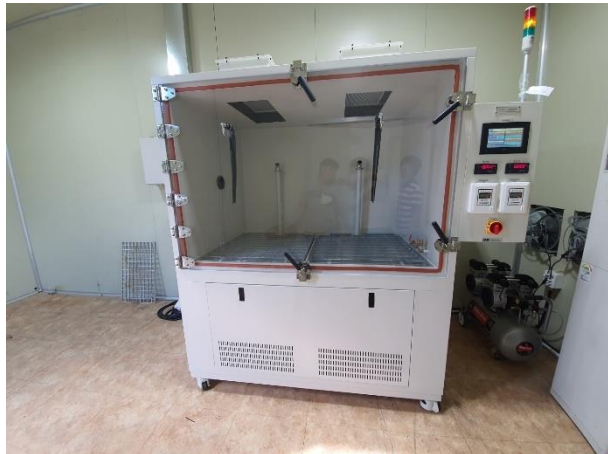
Dust Chamber

| First characteristic numeral | Degree of protection | Application |
|---|---|---|
| 6 | <p>In Dust Testing Equipment, the test sample must have no ingress of dust after testing atmospheric pressure present condition for 8 h.</p> <p>(The talcum powder must pass through a calibrated sieve with a 50 µm wire mesh, spaced at 75 µm intervals in a square pattern. Additionally, the bulk density of the talcum powder should be 2 kg/m<sup>3</sup>)</p> <p>Products in volume .....: <b>84.40 cm<sup>3</sup> → 0.08 L</b></p> <p>Target intake volume (Products in volume 80) : <b>6.75 L</b></p> <p>Suction volume (Max product in volume 60) ..: <b>5.06 LPH → 0.08 LPM</b></p> <p>Actual Suction volume .....: <b>0.08 L</b></p> <p>Suction pressure (Up to 2 kPa) .....: <b>1.90 kPa</b></p> <p>Test time (Up to 8 time) .....: <b>8 hr</b></p> | <input checked="" type="checkbox"/> |

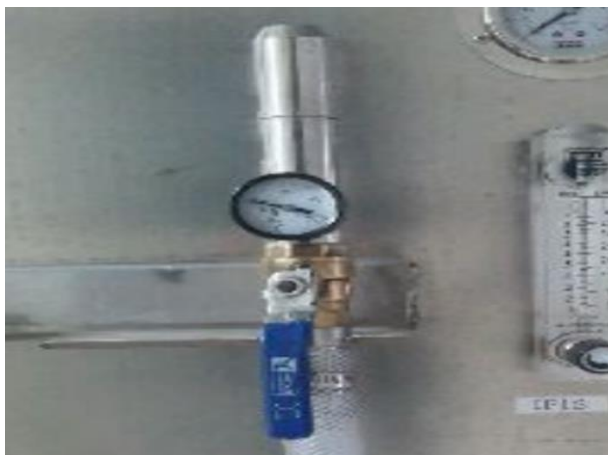
Hose Nozzle (12.5 mm)

| Second characteristic numeral | Degrees of protection | Application |
|---|---|---|
| 6 | <p>The product must not be harmed in any direction even strong jet water.</p> <p>Water jet hose nozzle Fig.6, Nozzle 12.5 mm diameter</p> <p>Water flow rate: 100 l/min ± 5 % : <b>100 LPM</b></p> <p>Distance: 2.5 m to 3 m: <b>3 m</b></p> <p>Duration of test: 1 min/m<sup>2</sup> at least 3 min: <b>3 min</b></p> | <input checked="" type="checkbox"/> |

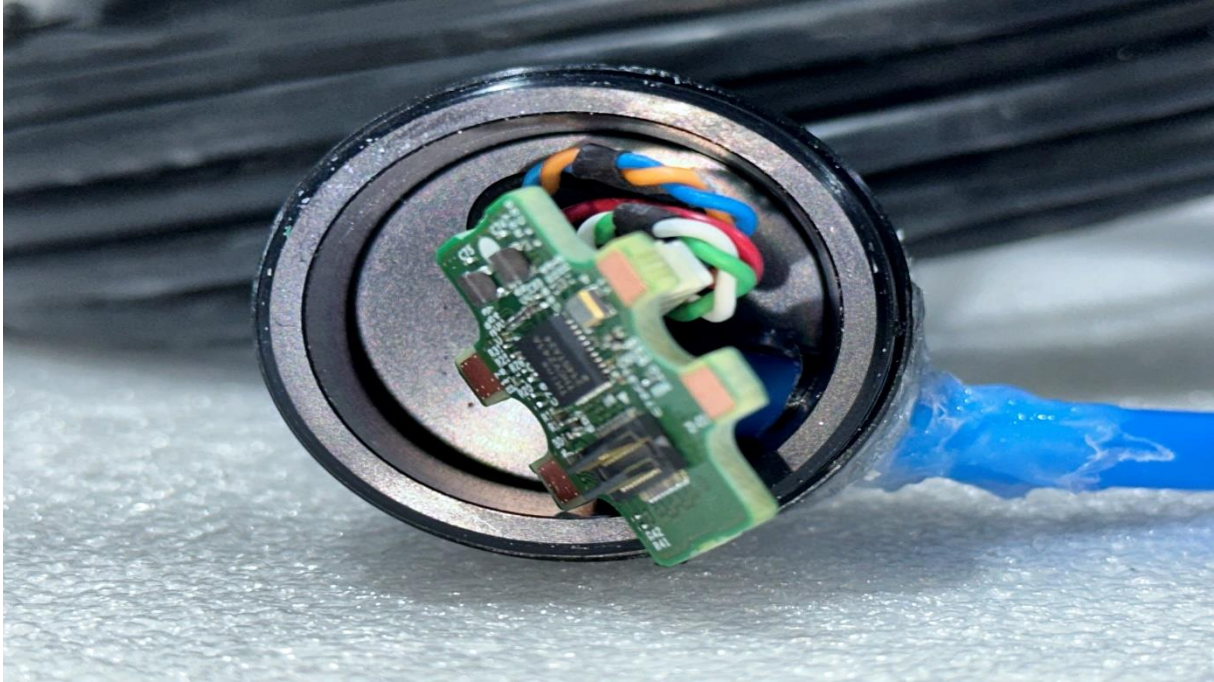
※ Refer to the product photos after the completion of testing in section 3.5.

#### 3.5.1 Product internal images after test
