# TEST REPORT

REPORT No.:  
CTK-2026-00017  
Page (1) / (13) pages

LENS MODULE / SLA-T16080WA

IEC 60529:1989 +A1:1999+A2:2013

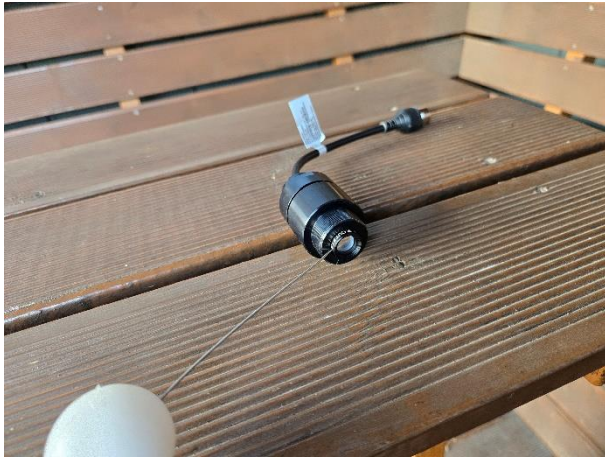
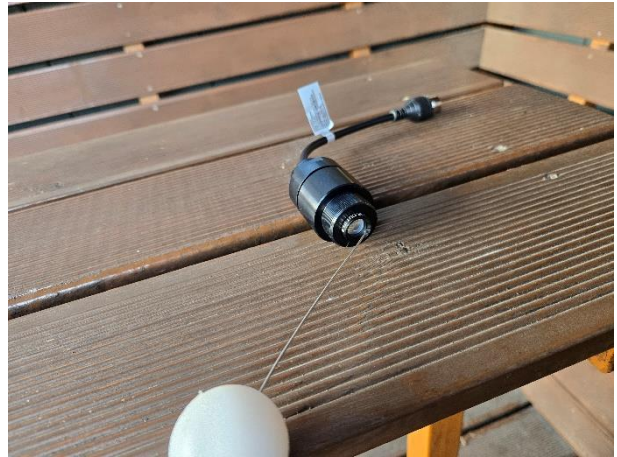
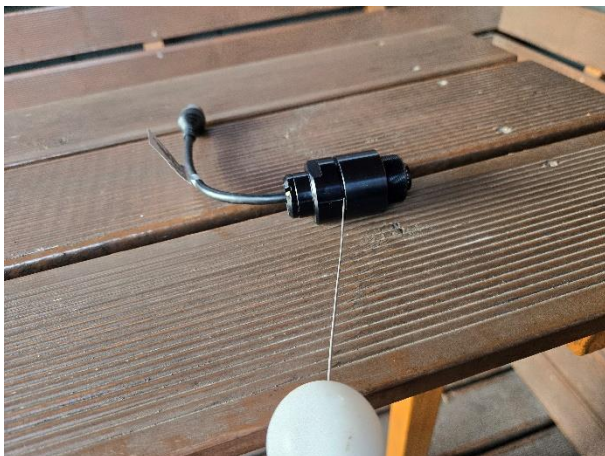
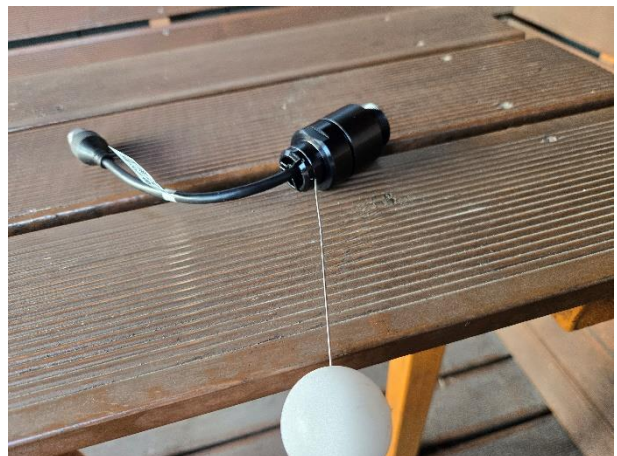
| First characteristic numeral | Degree of protection | Application |
|---|---|---|
| 6 | Protected against access to hazardous parts with a wire.<br>The access probe of 1.0 mmØ, shall not penetrate.<br>Test force: 1 N ± 10 % | <input checked="" type="checkbox"/> |

Probe test

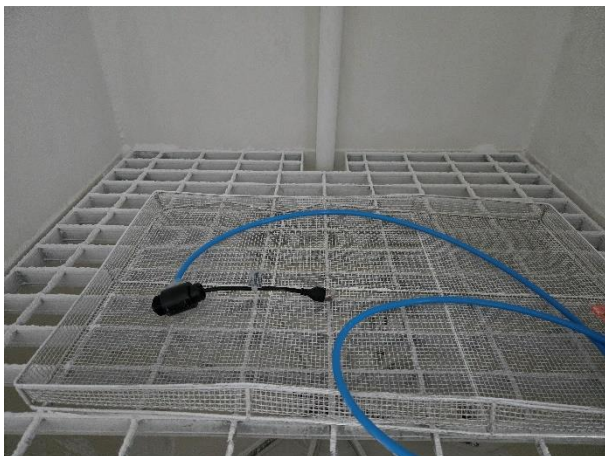
| First characteristic numeral | Degree of protection | Application |
|---|---|---|
| 6 | <p>In Dust Testing Equipment, the test sample must have no ingress of dust after testing atmospheric pressure present condition for 8 h.</p> <p>(The talcum powder must pass through a calibrated sieve with a 50 µm wire mesh, spaced at 75 µm intervals in a square pattern. Additionally, the bulk density of the talcum powder should be 2 kg/m<sup>3</sup>)</p> <p>Products in volume .....: <b>634.192 cm<sup>3</sup> → 0.634 L</b></p> <p>Target intake volume (Products in volume 80) : <b>50.735 L</b></p> <p>Suction volume (Max product in volume 60) ...: <b>38.051 LPH → 0.634 LPM</b></p> <p>Actual Suction volume .....: <b>0.631 L</b></p> <p>Suction pressure (Up to 2 kPa) .....: <b>2 kPa</b></p> <p>Test time (Up to 8 time) .....: <b>8 hr</b></p> | <input checked="" type="checkbox"/> |

Dust test

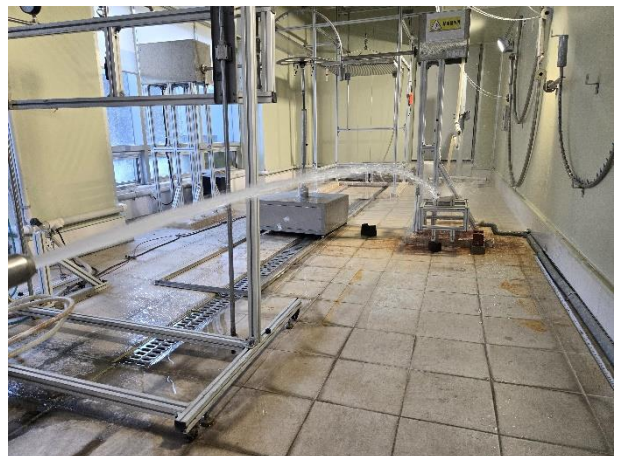
| Second characteristic numeral | Degrees of protection | Application |
|---|---|---|
| 6 | <p>The product must not be harmed in any direction even strong jet water.</p> <p>Water jet hose nozzle Fig.6, Nozzle 12.5 mm diameter</p> <p>Water flow rate: 100 l/min ± 5 % : <b>100 LPM</b></p> <p>Distance: 2.5 m to 3 m: <b>3 m</b></p> <p>Duration of test: 1 min/m<sup>2</sup> at least 3 min: <b>3 min</b></p> | <input checked="" type="checkbox"/> |

Water test

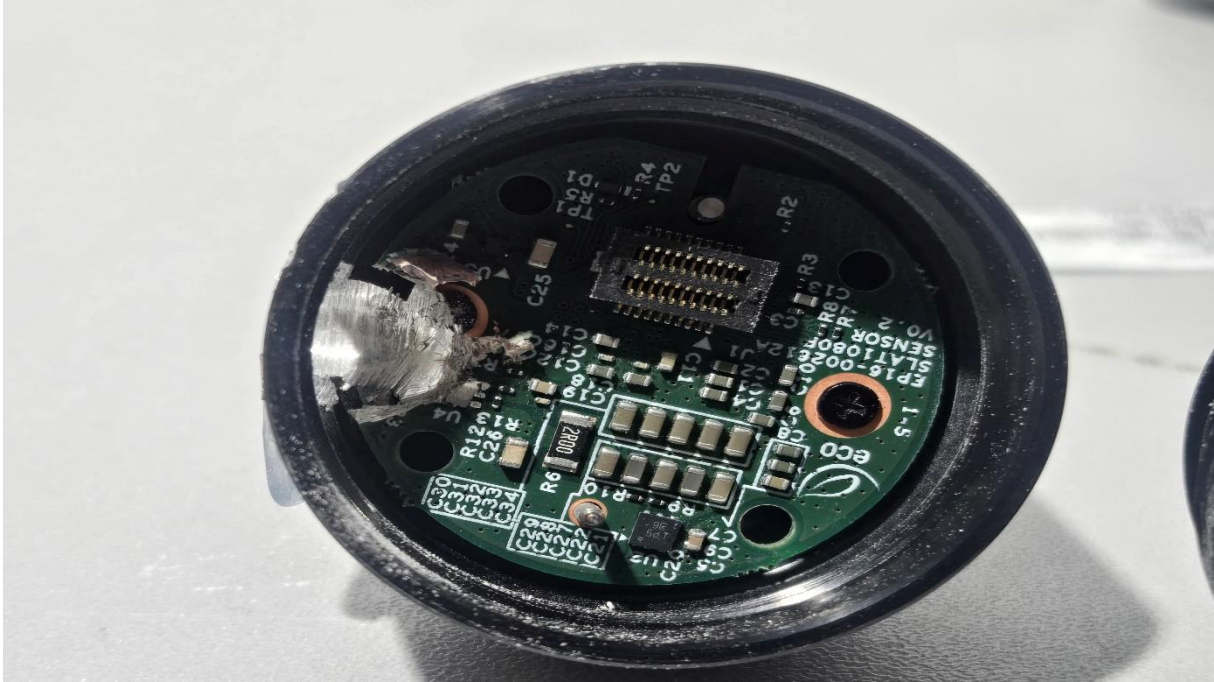
#### 3.5.1 Product internal images after test [The first characteristic numeral test]

| IP code | Evaluation Criteria | Test Results | Remark |
|---|---|---|---|
| IP 6X | No ingress of Probe | Normal | - |
| | No ingress of dust | Normal | |

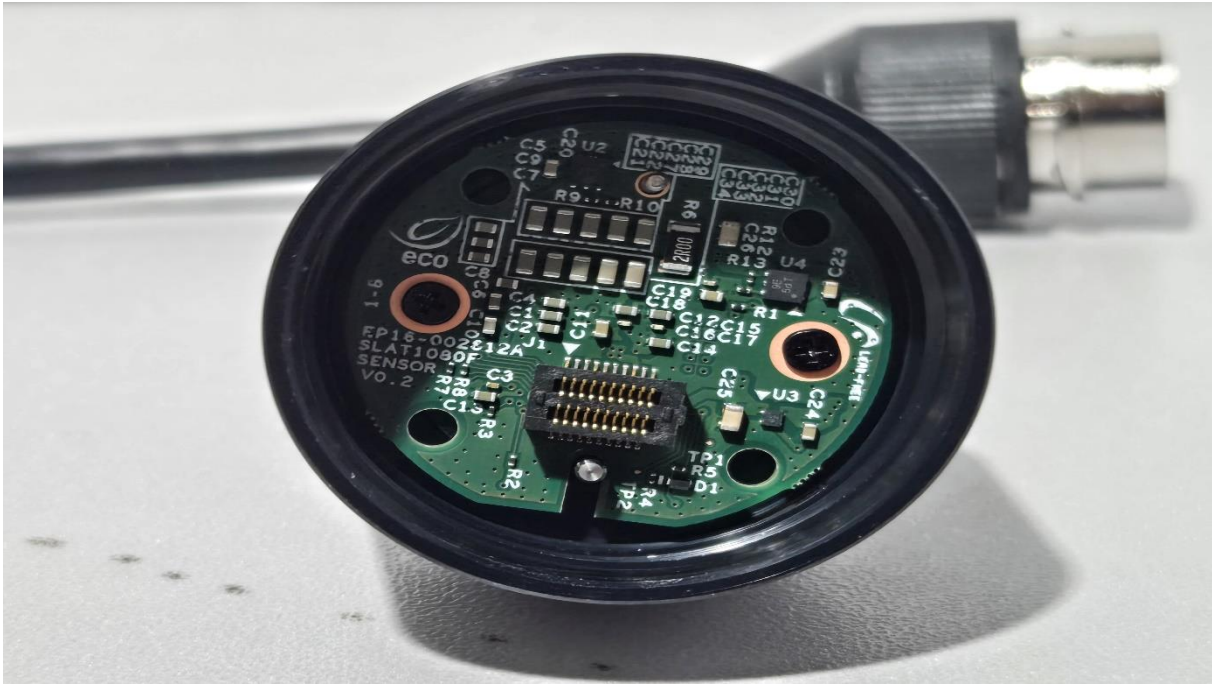
### 3.5.2 Product internal images after test [The second characteristic numeral test]

| IP code | Evaluation Criteria | Test Results | Remark |
|---|---|---|---|
| IP X6 | No ingress of water | Normal | |
