## TEST REPORT

| <b>Report Ref. No.</b> | 13EMC-RT-0689 |
| ○ Product | Network Camera |
| ○ Model | SNO-6084RN, SNO-6084RP |

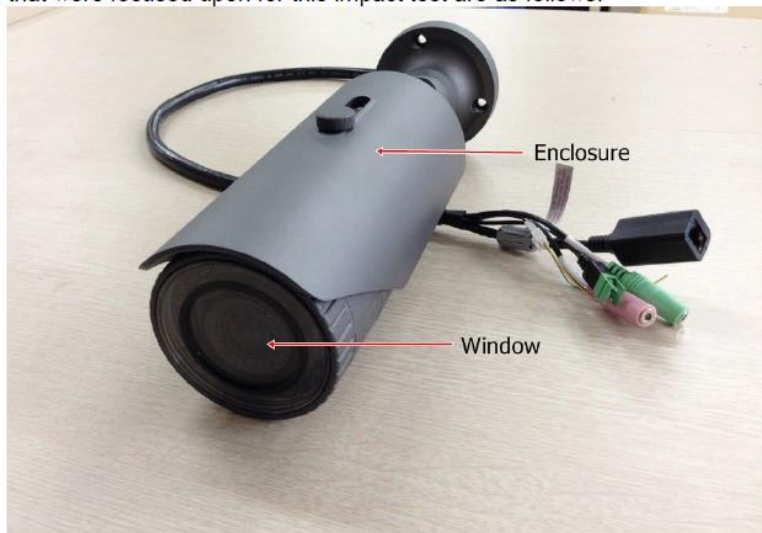
## 5. Drop Zones:

The areas that were focused upon for this impact test are as follows:

| Drop Zone: Enclosure | | |

| Drop Zone: Window | | |
