# TEST REPORT

REPORT No.:  
CTK-2025-03139  
Page (1) / (14) pages

Network Thermal Camera / TNM-C4940TD

IEC 60529:1989 +A1:1999+A2:2013

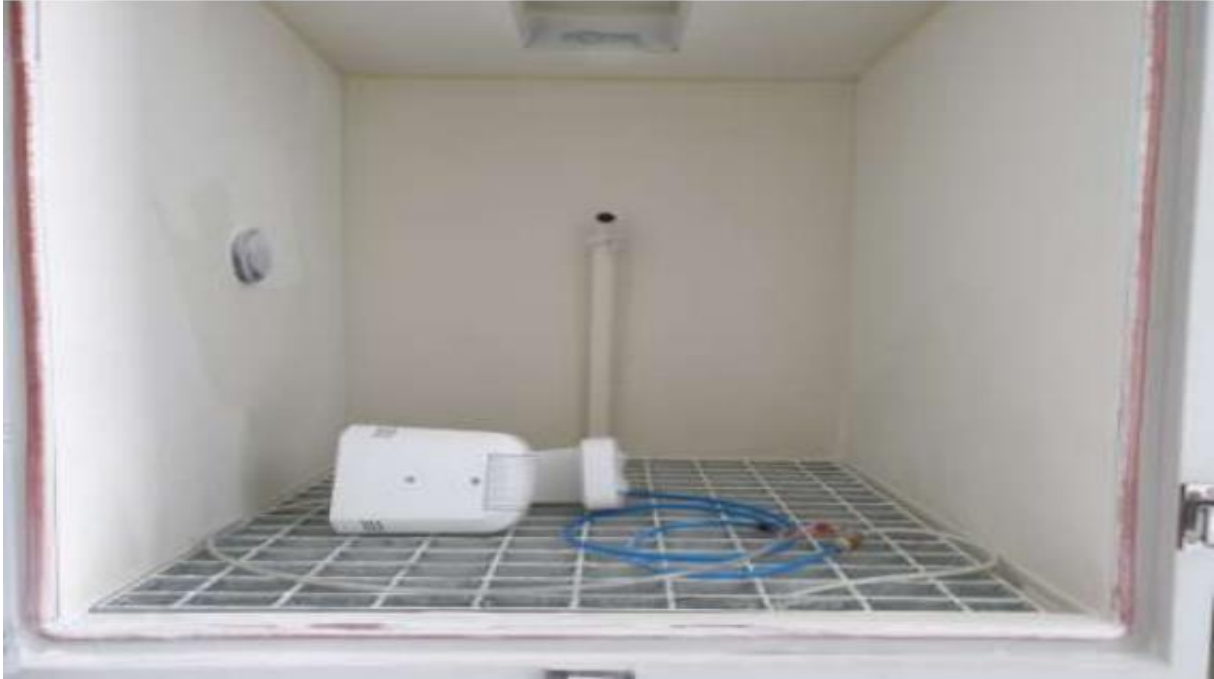
| First characteristic numeral | Degree of protection | Application |
|---|---|---|
| 6 | <p>In Dust Testing Equipment, the test sample must have no ingress of dust after testing atmospheric pressure present condition for 8 h.</p> <p>(The talcum powder must pass through a calibrated sieve with a 50 µm wire mesh, spaced at 75 µm intervals in a square pattern. Additionally, the bulk density of the talcum powder should be 2 kg/m<sup>3</sup>)</p> <p>Products in volume .....: 10 884.75 cm<sup>3</sup> → 10.884 L</p> <p>Target intake volume (Products in volume 80) : 870.780 L</p> <p>Suction volume (Max product in volume 60) ...: 653.085 LPH → 10.884 LPM</p> <p>Actual Suction volume .....: 10.884 L</p> <p>Suction pressure (Up to 2 kPa) .....: 2 kPa</p> <p>Test time (Up to 8 time) .....: 8 hr</p> | <input checked="" type="checkbox"/> |

Dust test

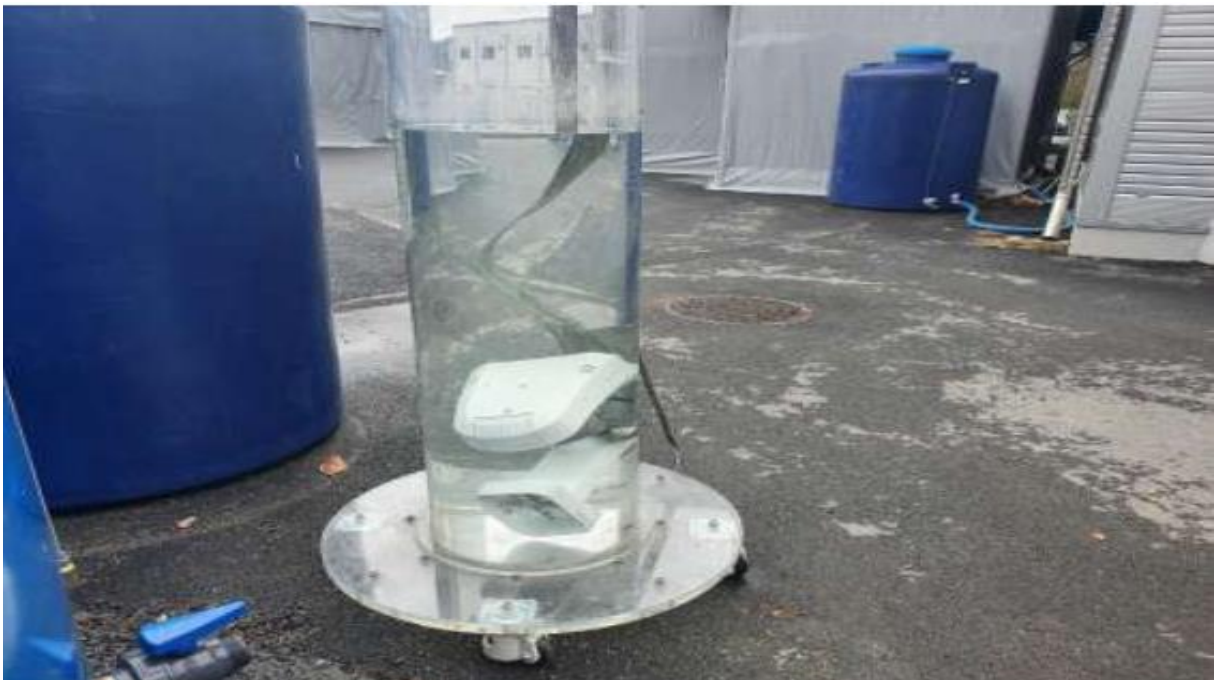
| Second characteristic numeral | Degrees of protection | Application |
|---|---|---|
| 7 | <p>Sink the product in the water by the Pressure and Time according to regulation and the product must not be harmed.</p> <p>Immersion tank water-level on enclosure with:</p> <p><input type="checkbox"/> height equal to or greater than 850 mm: the highest point of enclosures located 0.15 m below the surface of the water</p> <p><input checked="" type="checkbox"/> height less than 850 mm: the lowest point of enclosures located 1 m below the surface of the water</p> <p>Duration of test: 30 min</p> | <input checked="" type="checkbox"/> |

Water test

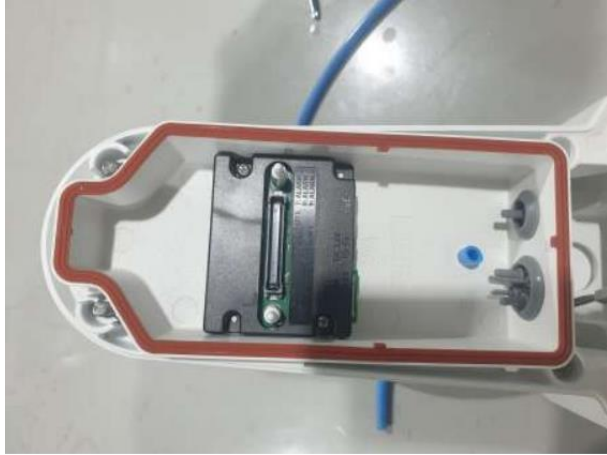
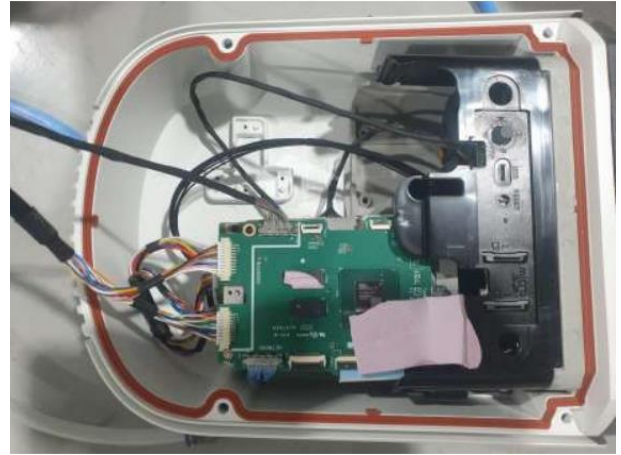
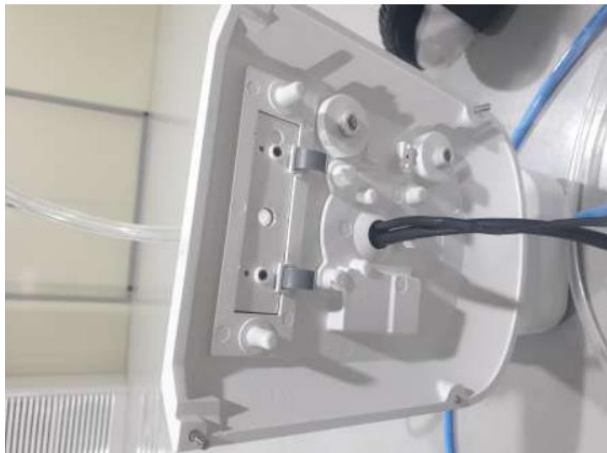
#### 3.5.1 Product internal images after test [The first characteristic numeral test]

| IP code | Evaluation Criteria | Test Results | Remark |
|---|---|---|---|
| IP 6X | No ingress of Probe | Normal | - |
| | No ingress of dust | Normal | - |

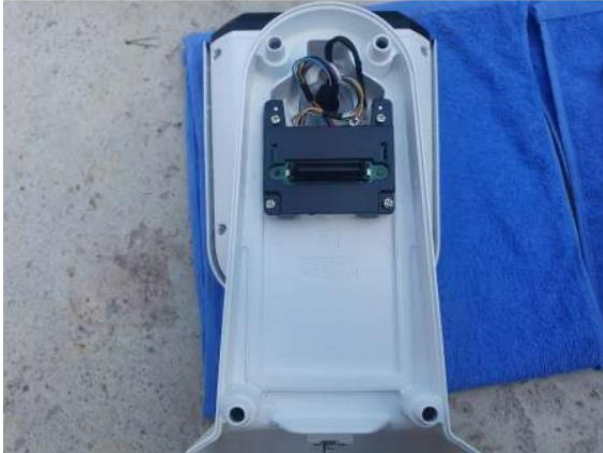
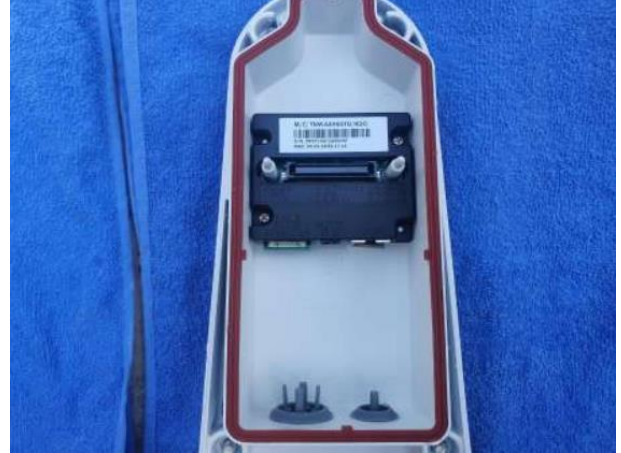
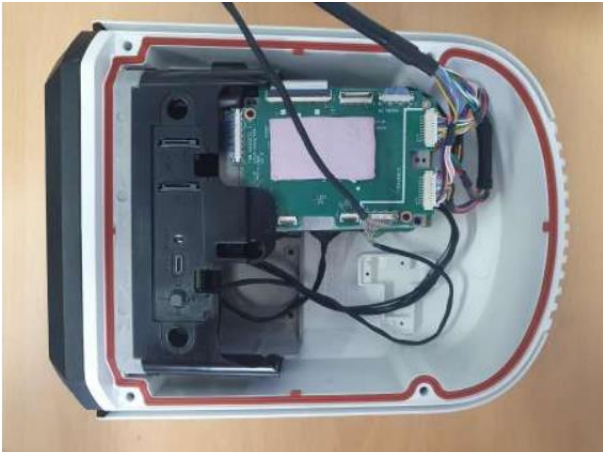
### 3.5.2 Product internal images after test [The second characteristic numeral test]

| IP code | Evaluation Criteria | Test Results | Remark |
|---|---|---|---|
| IP X7 | No ingress of water | Normal | - |
