# TEST REPORT

REPORT No.:  
CTK-2025-01523  
Page (1) / (14) pages

Network Thermal Camera / TNO-C3080T

IEC 60529:1989 +A1:1999+A2:2013

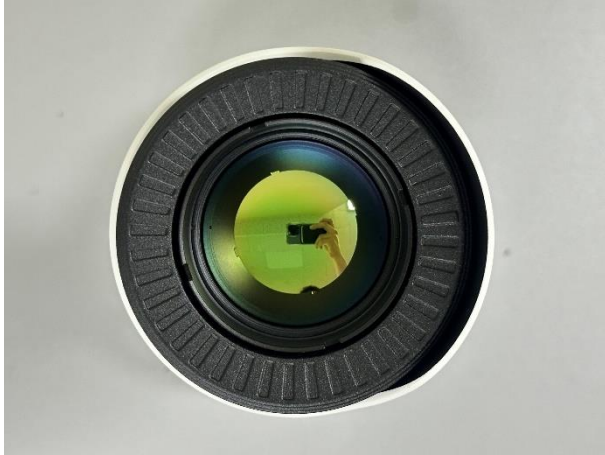
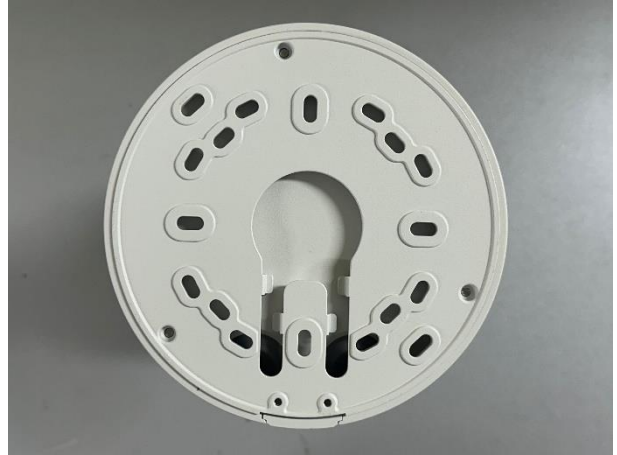
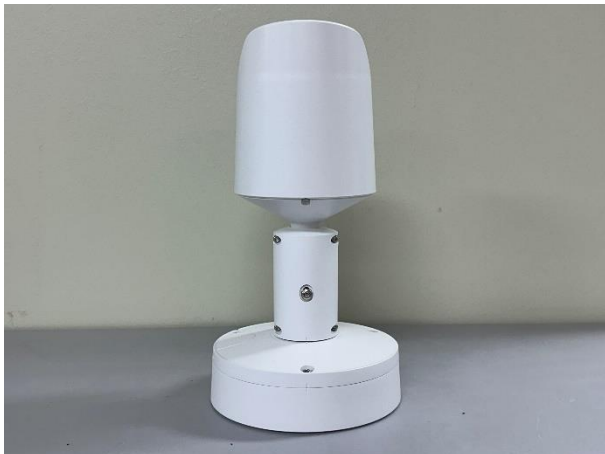
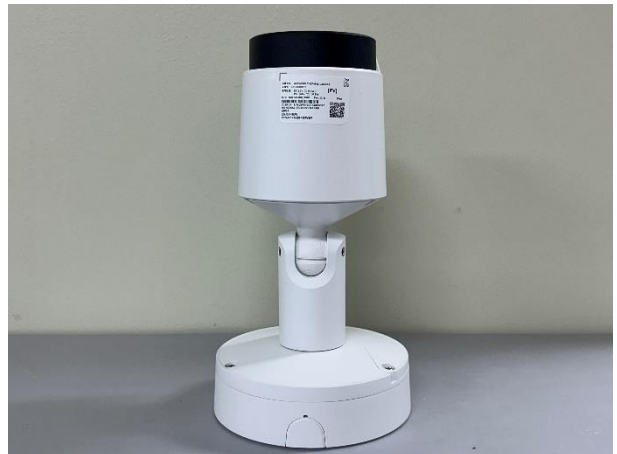
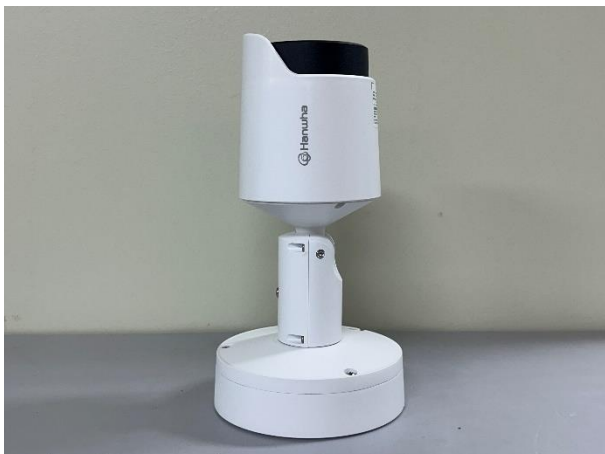
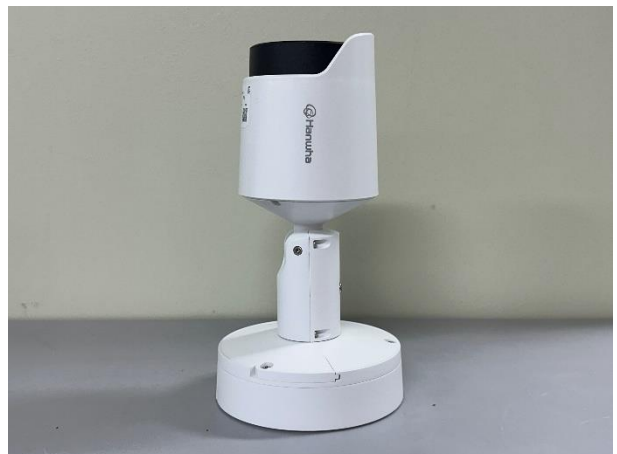
### 2.3 Pre-test product images

#### 2.3.1 Test sample #1

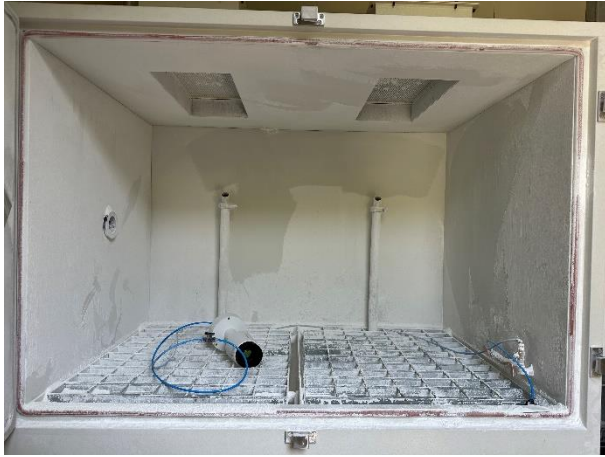
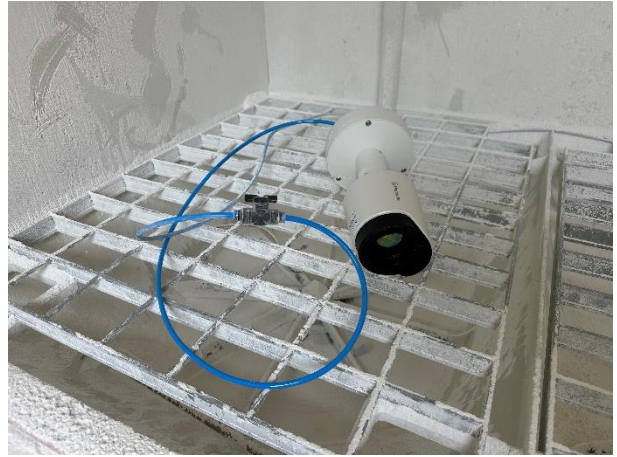
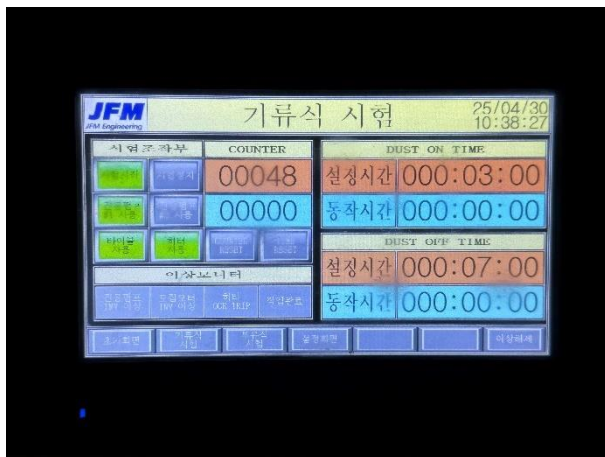
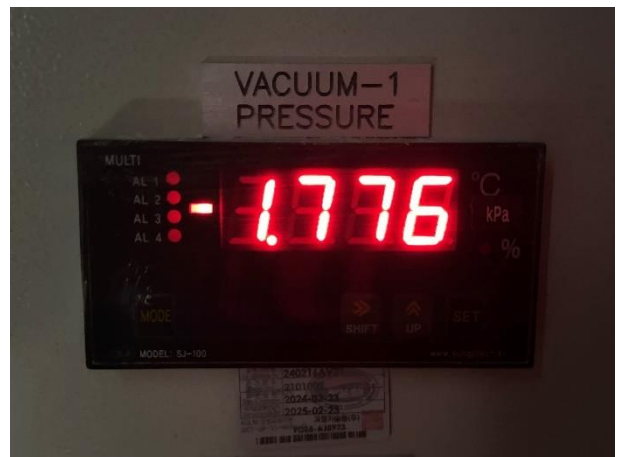
### 3.3.2 Evidence of test setting (2)

| First characteristic numeral | Degree of protection | Application |
|---|---|---|
| 6 | <p>In Dust Testing Equipment, the test sample must have no ingress of dust after testing atmospheric pressure present condition for 8 h.</p> <p>(The talcum powder must pass through a calibrated sieve with a 50 µm wire mesh, spaced at 75 µm intervals in a square pattern. Additionally, the bulk density of the talcum powder should be 2 kg/m<sup>3</sup>)</p> <p>Products in volume .....: <b>2 499.03 cm<sup>3</sup> → 2.49 L</b></p> <p>Target intake volume (Products in volume 80) : <b>199.92 L</b></p> <p>Suction volume (Max product in volume 60) ..: <b>149.94 LPH → 2.49 LPM</b></p> <p>Actual Suction volume .....: <b>2.48 L</b></p> <p>Suction pressure (Up to 2 kPa) .....: <b>1.776 kPa</b></p> <p>Test time (Up to 8 time) .....: <b>8 시간</b></p> | <input checked="" type="checkbox"/> |

Dust test

Dust test Monitor

Digital Vacuum Pressure

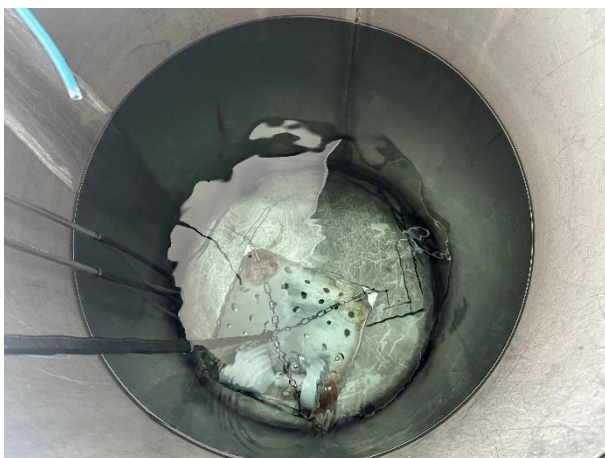
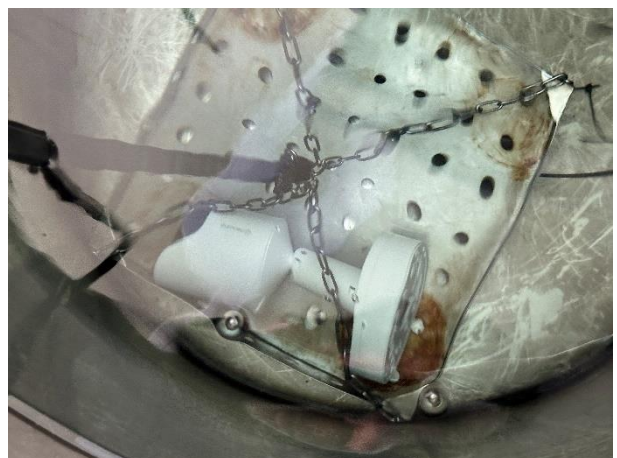
| Second characteristic numeral | Degrees of protection | Application |
|---|---|---|
| 7 | <p>Sink the product in the water by the Pressure and Time according to regulation and the product must not be harmed.</p> <p>Immersion tank water-level on enclosure with:</p> <p><input type="checkbox"/> height equal to or greater than 850 mm: the highest point of enclosures located 0.15 m below the surface of the water</p> <p><input checked="" type="checkbox"/> height less than 850 mm: the lowest point of enclosures located 1 m below the surface of the water</p> <p>Duration of test: 30 min</p> | <input checked="" type="checkbox"/> |

Water test

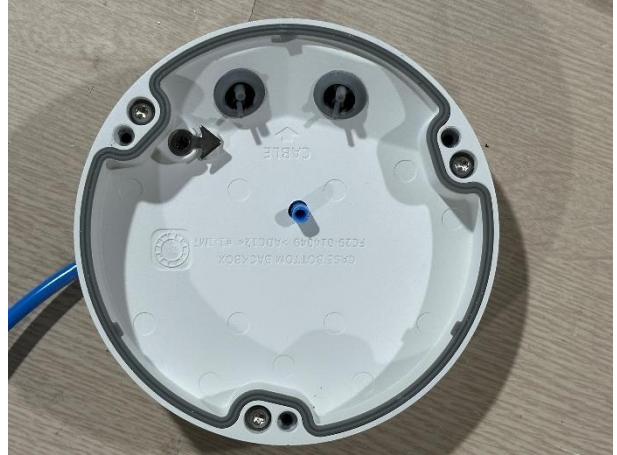
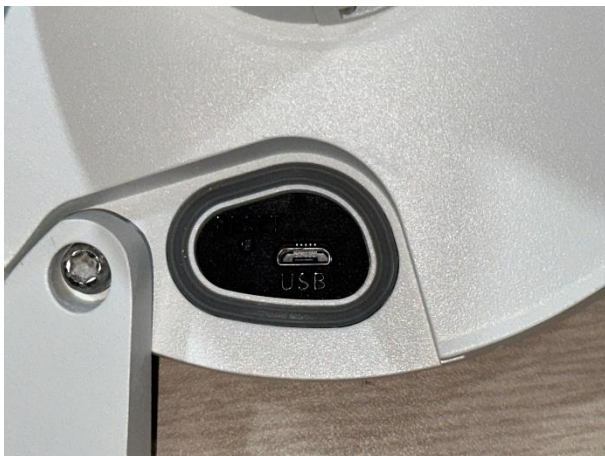
#### 3.5.1 Product internal images after test [The first characteristic numeral test]

| IP code | Evaluation Criteria | Test Results | Remark |
|---|---|---|---|
| IP 6X | No ingress of Probe | Normal | - |
| | No ingress of dust | Normal | |

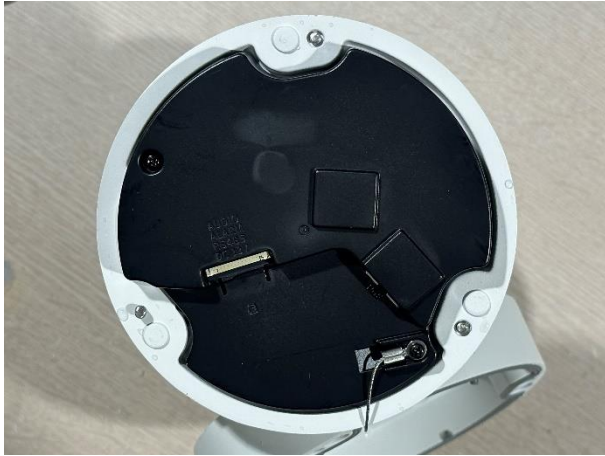
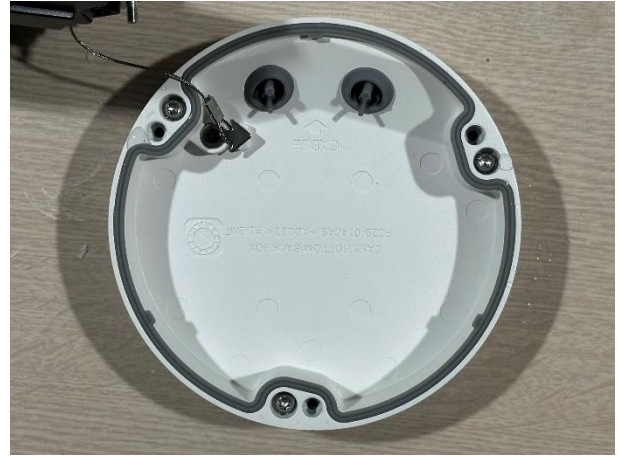
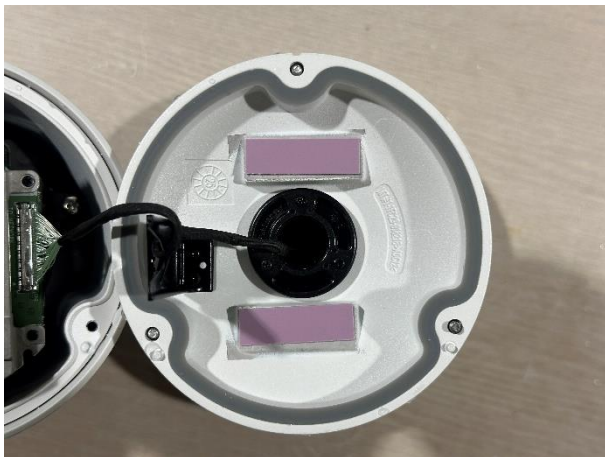
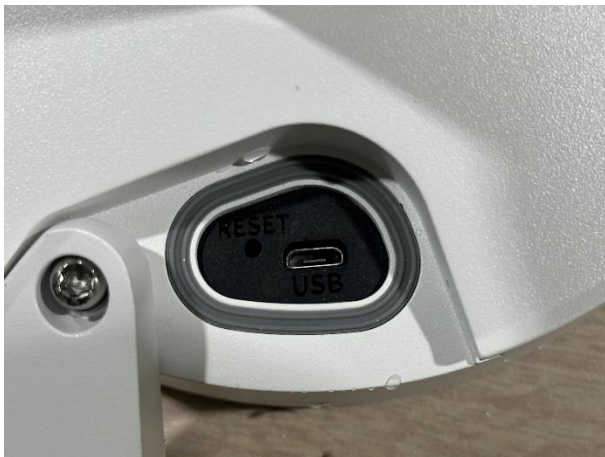
### 3.5.2 Product internal images after test [The second characteristic numeral test]

| IP code | Evaluation Criteria | Test Results | Remark |
|---|---|---|---|
| IP X7 | No ingress of water | Normal | |
