# TEST REPORT

REPORT No.:  
CTK-2026-00327  
Page (1) / (14) pages

NETWORK THERMAL CAMERA / TNO-C4060T

IEC 60529:1989 +A1:1999+A2:2013

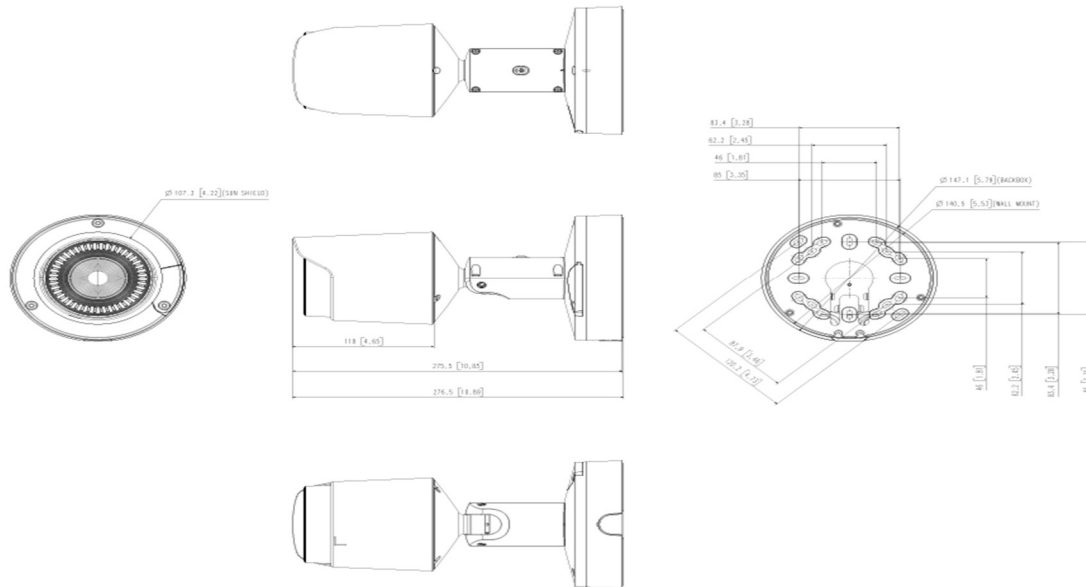
Enclosure dimensions [unit : mm]

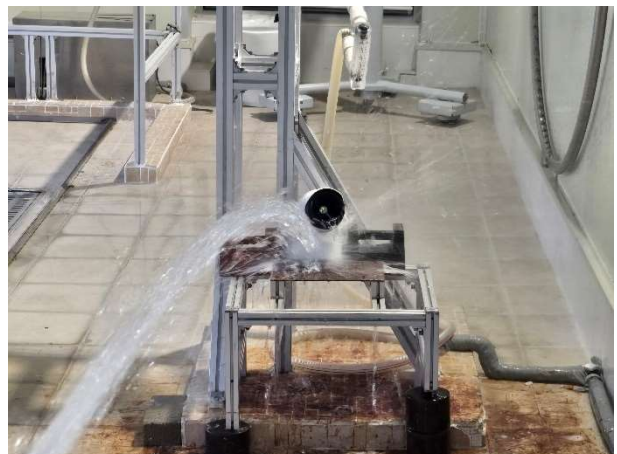
| Second characteristic numeral | Degrees of protection | Application |
|---|---|---|
| 6 | <p>The product must not be harmed in any direction even strong jet water.</p> <p>Water jet hose nozzle Fig.6, Nozzle 12.5 mm diameter</p> <p>Water flow rate: 100 l/min ± 5 % : <b>100 LPM</b></p> <p>Distance: 2.5 m to 3 m: <b>3 m</b></p> <p>Duration of test: 1 min/m² at least 3 min: <b>3 min</b></p> | <input checked="" type="checkbox"/> |

Water test

| IP code | Evaluation Criteria | Test Results | Remark |
|---|---|---|---|
| IP X6 | No ingress of water | Normal | |
