# TEST REPORT

REPORT No.:  
CTK-2026-00329  
Page (1) / (14) pages

NETWORK THERMAL CAMERA / TNO-C4060T

IEC 60529:1989 +A1:1999+A2:2013

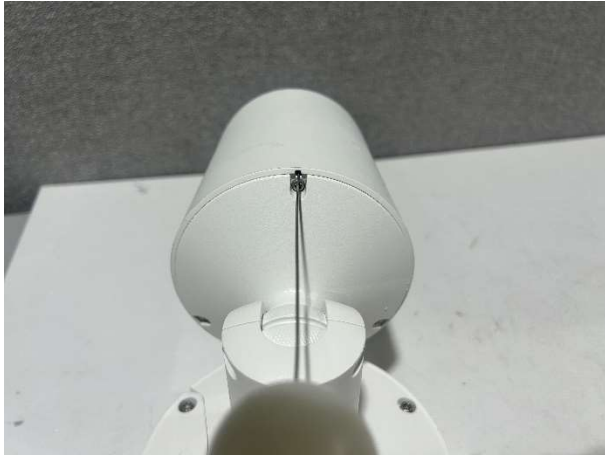
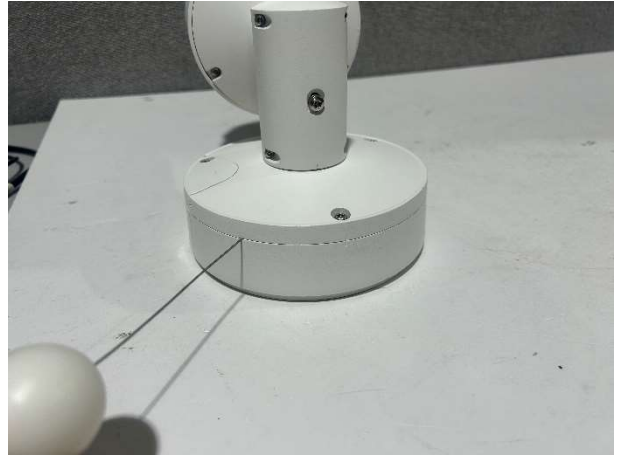
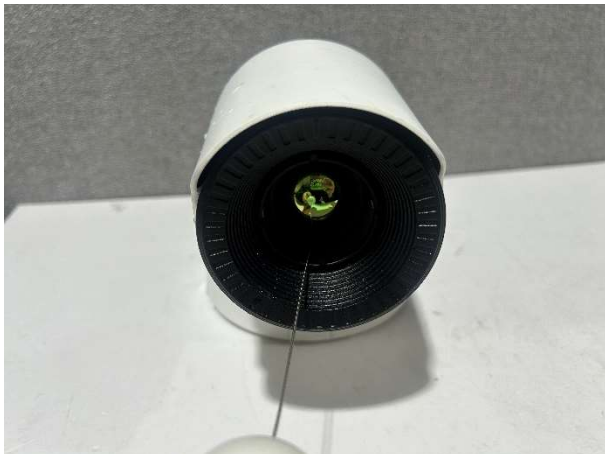
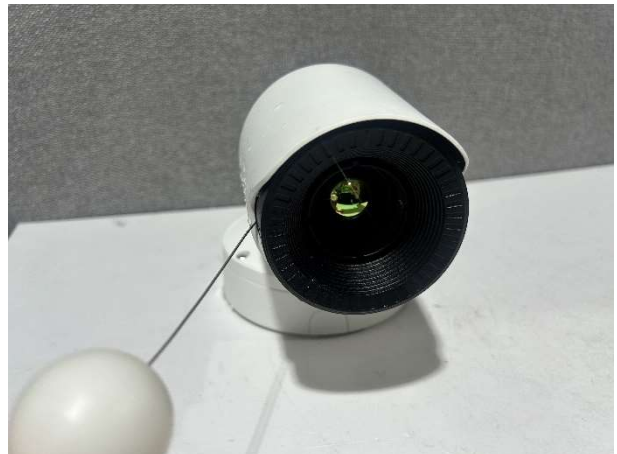
| First characteristic numeral | Degree of protection | Application |
|---|---|---|
| 6 | Protected against access to hazardous parts with a wire.<br>The access probe of 1.0 mmØ, shall not penetrate.<br>Test force: 1 N ± 10 % | <input checked="" type="checkbox"/> |

Probe test

| IP code | Evaluation Criteria | Test Results | Remark |
|---|---|---|---|
| IP 6X | No ingress of Probe | Normal | - |

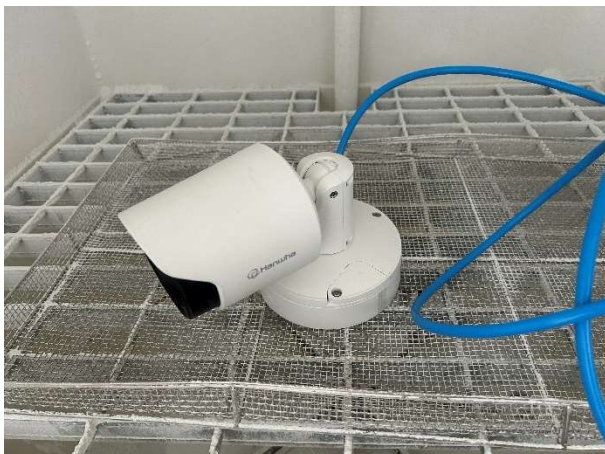
| First characteristic numeral | Degree of protection | Application |
|---|---|---|
| 6 | <p>In Dust Testing Equipment, the test sample must have no ingress of dust after testing atmospheric pressure present condition for 8 h.</p> <p>(The talcum powder must pass through a calibrated sieve with a 50 µm wire mesh, spaced at 75 µm intervals in a square pattern. Additionally, the bulk density of the talcum powder should be 2 kg/m³)</p> <p>Products in volume .....: <b>4 284.671 cm³ → 4.284 L</b></p> <p>Target intake volume (Products in volume 80) : <b>342.773 L</b></p> <p>Suction volume (Max product in volume 60) ...: <b>257.080 LPH → 4.284 LPM</b></p> <p>Actual Suction volume .....: <b>2.856 L</b></p> <p>Suction pressure (Up to 2 kPa) .....: <b>2 kPa</b></p> <p>Test time (Up to 8 time) .....: <b>8 hr</b></p> | <input checked="" type="checkbox"/> |

Dust test

| IP code | Evaluation Criteria | Test Results | Remark |
|---|---|---|---|
| | No ingress of dust | Normal | - |

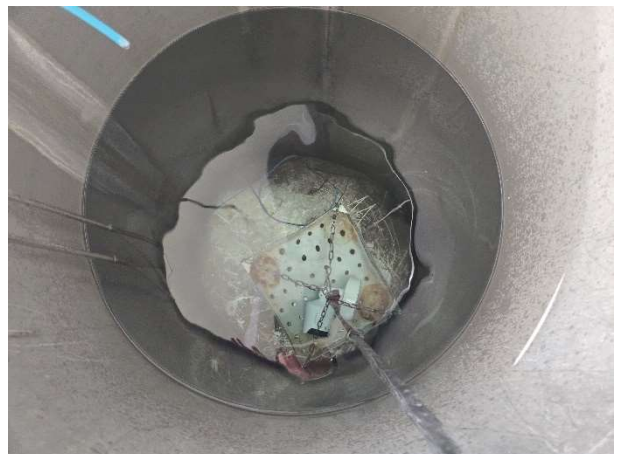
| Second characteristic numeral | Degrees of protection | Application |
|---|---|---|
| 7 | <p>Sink the product in the water by the Pressure and Time according to regulation and the product must not be harmed.</p> <p>Immersion tank water-level on enclosure with:</p> <p><input type="checkbox"/> height equal to or greater than 850 mm: the highest point of enclosures located 0.15 m below the surface of the water</p> <p><input checked="" type="checkbox"/> height less than 850 mm: the lowest point of enclosures located 1 m below the surface of the water</p> <p>Duration of test: 30 min</p> | <input checked="" type="checkbox"/> |

Water test

| IP code | Evaluation Criteria | Test Results | Remark |
|---|---|---|---|
| IP X7 | No ingress of water | Normal | - |

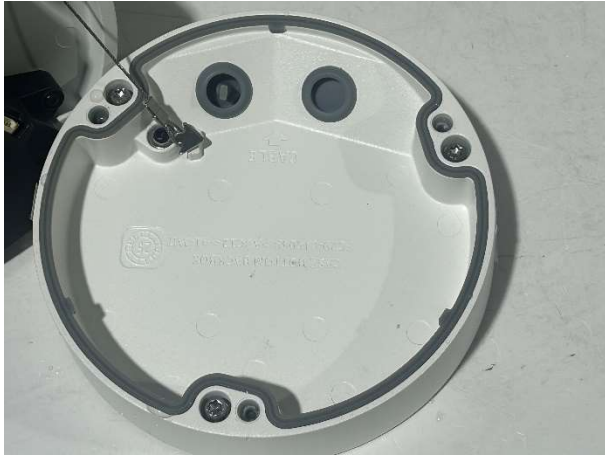
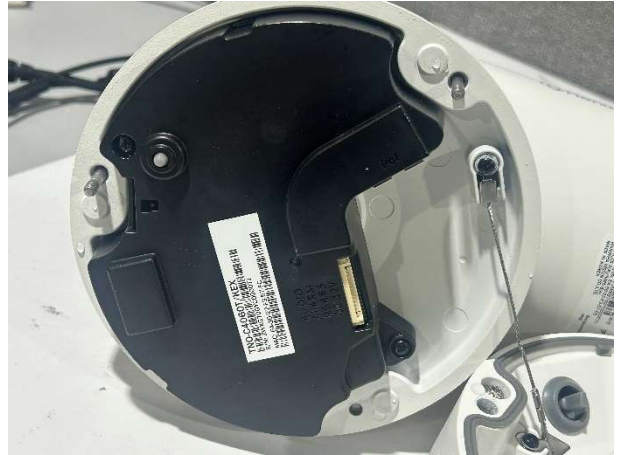
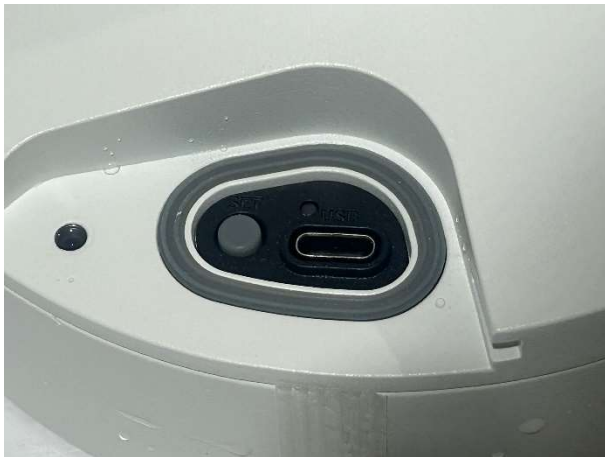
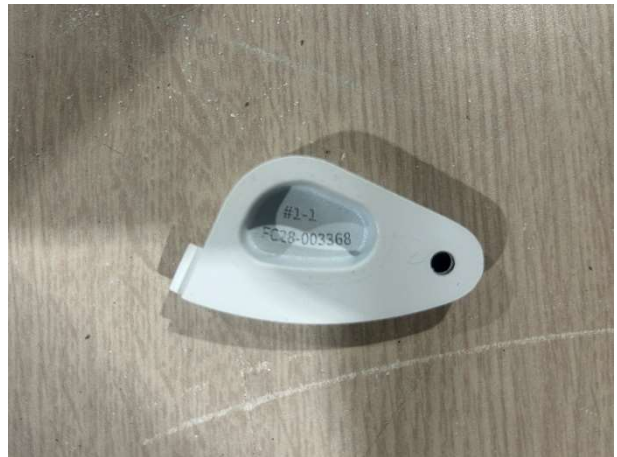
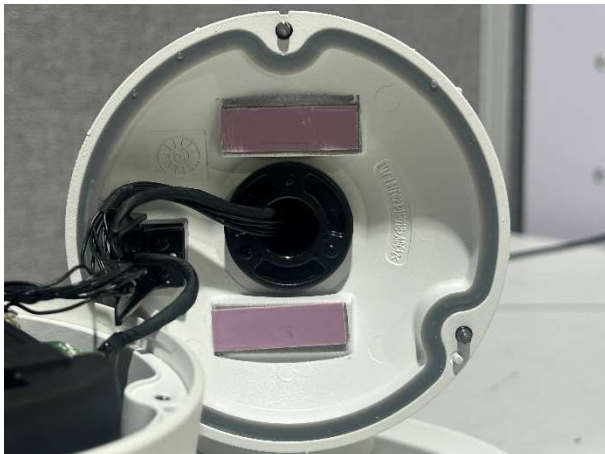
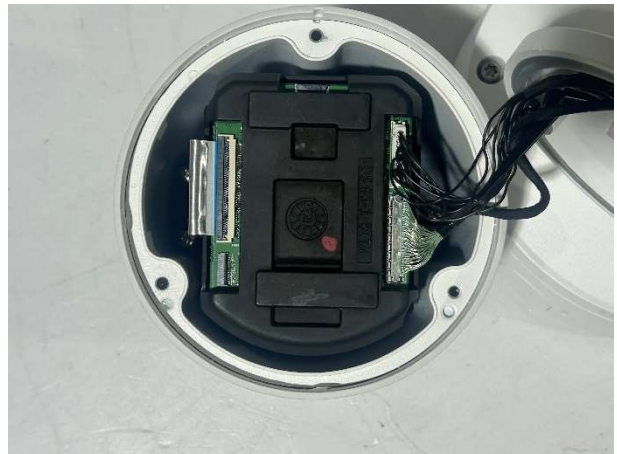
#### 3.5.1 Product internal images after test [The first characteristic numeral test]

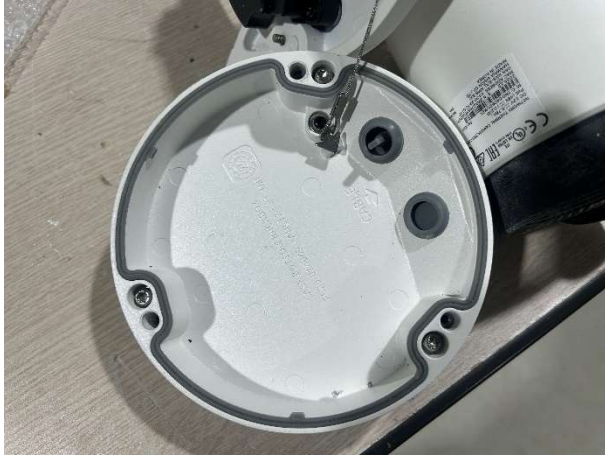
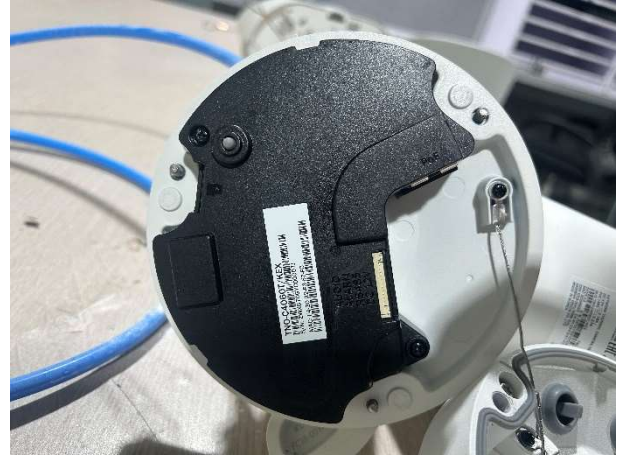
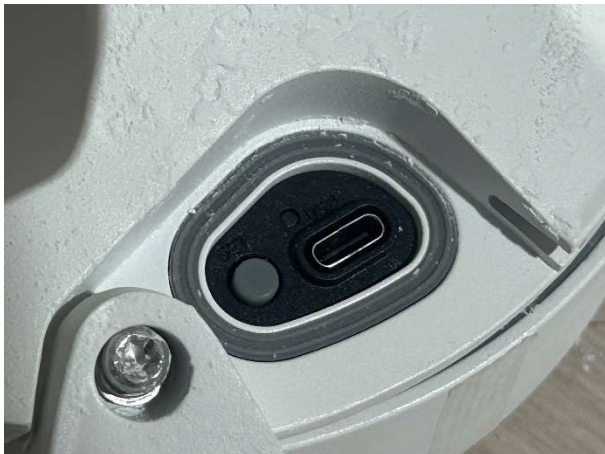
### 3.5.2 Product internal images after test [The second characteristic numeral test]
