# TEST REPORT

REPORT No.:  
CTK-2026-01027  
Page (1) / (43) pages

NETWORK THERMAL CAMERA / TNO-C4060T

EN 60068-2-1, EN 60068-2-2, EN 60068-2-14, EN 60068-2-6, EN 60068-2-27, EN 60068-2-78, IEC 60068-2-1, IEC 60068-2-2, IEC 60068-2-14, IEC 60068-2-6, IEC 60068-2-27, IEC 60068-2-78

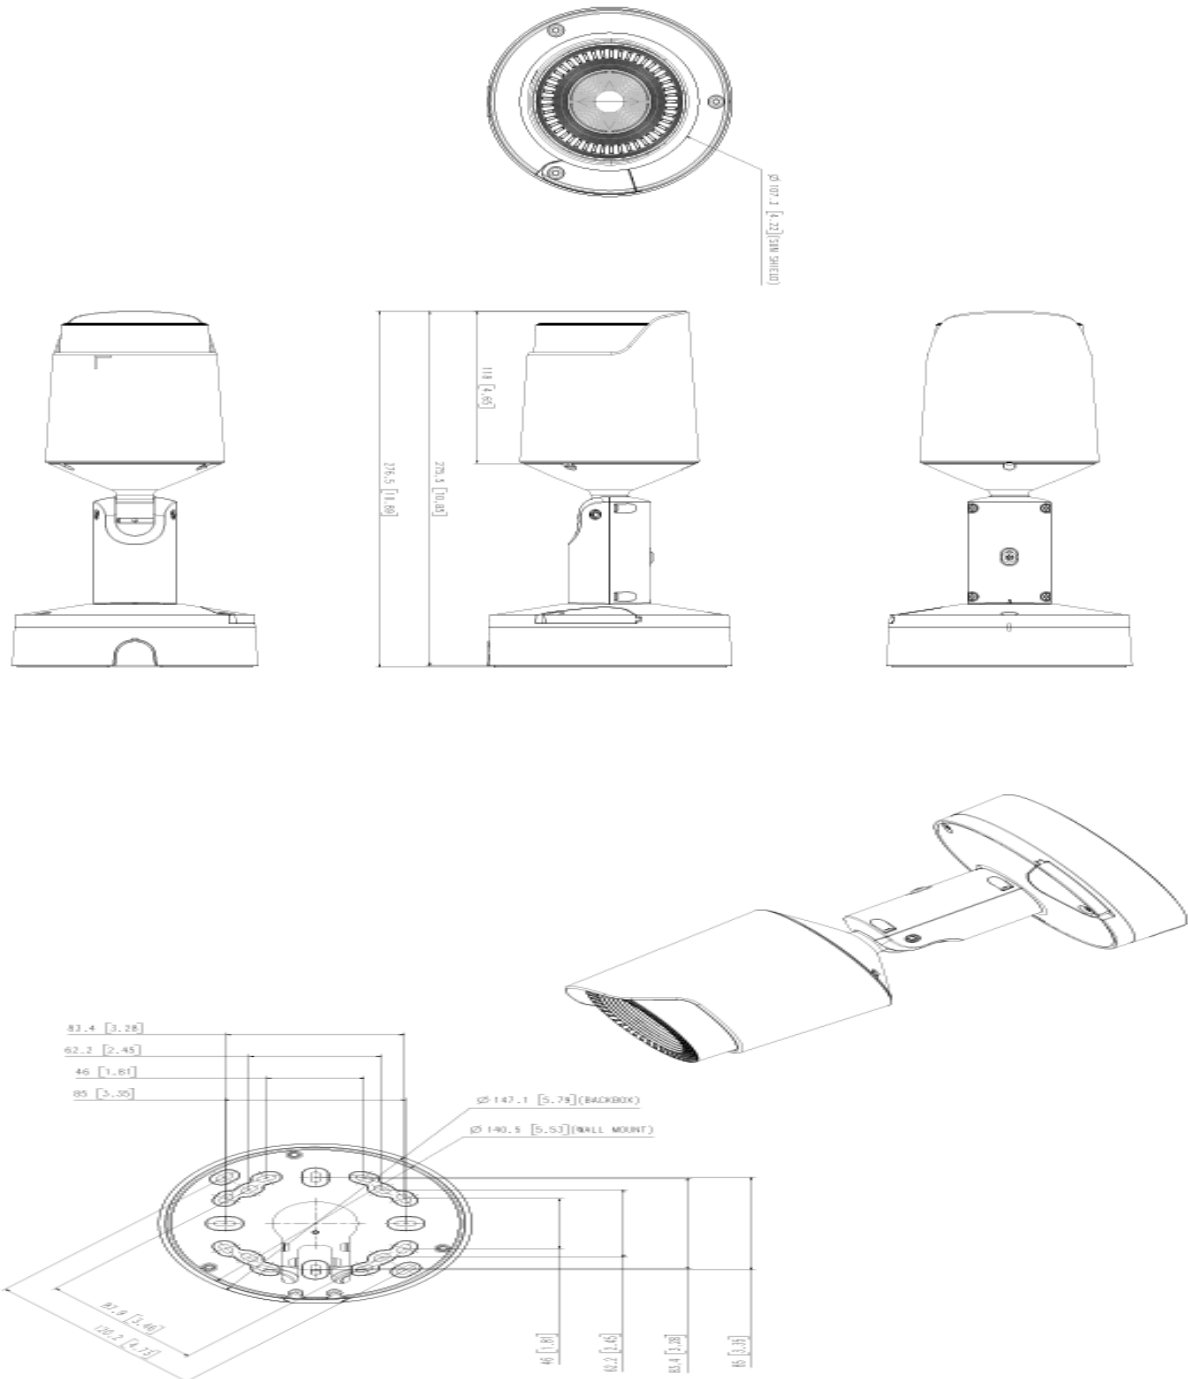
Enclosure dimensions [unit: mm]

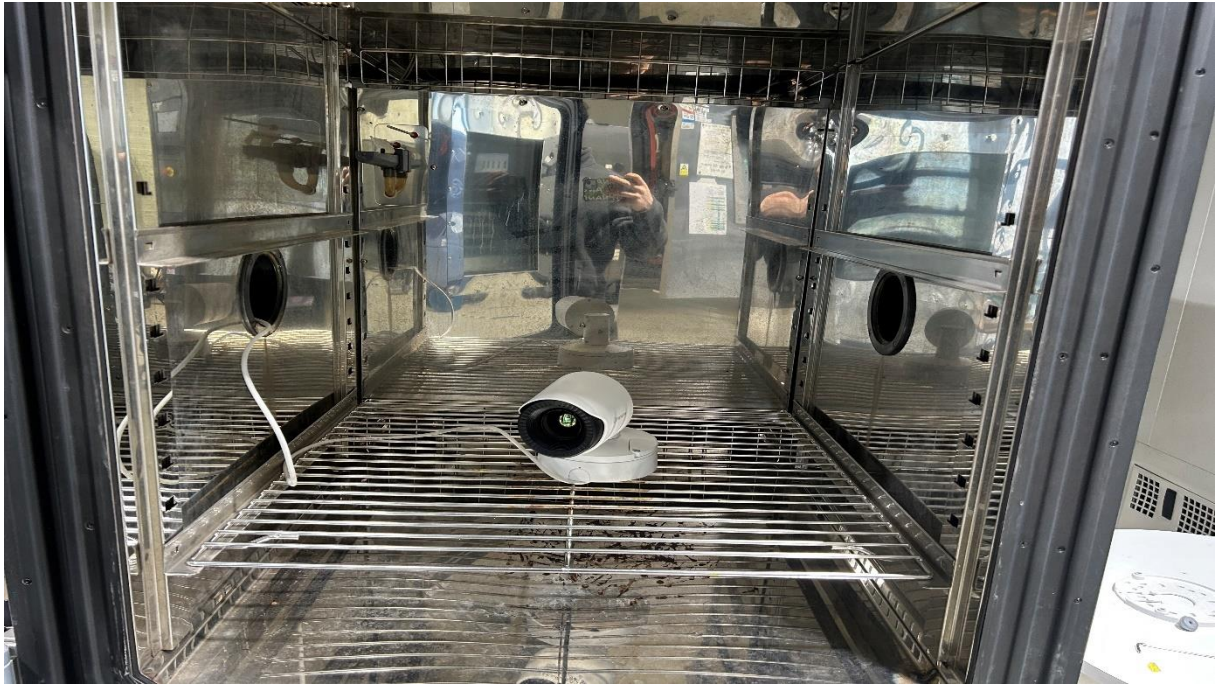
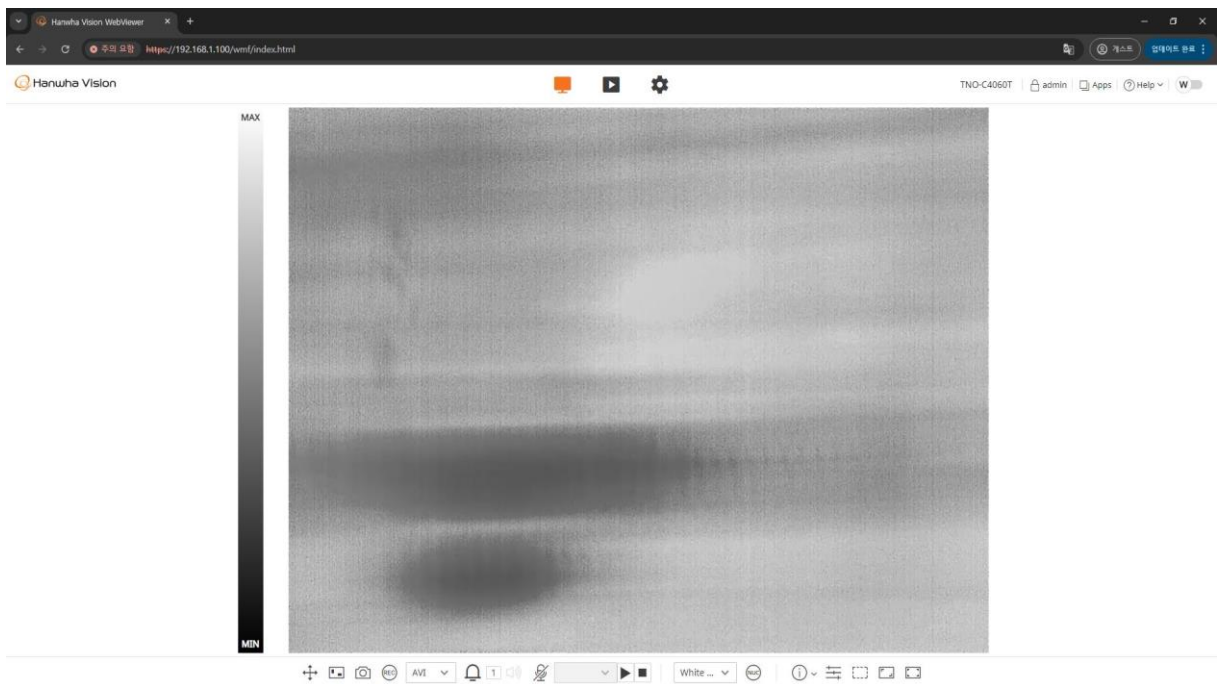
#### 3.3.1 Evidence of test setting

3.2.1 Preconditioning temperature: 25 °C

3.2.2 Sample status: Operation

3.2.3 Test temperature: -33 °C

3.2.4 Test time: 16 h

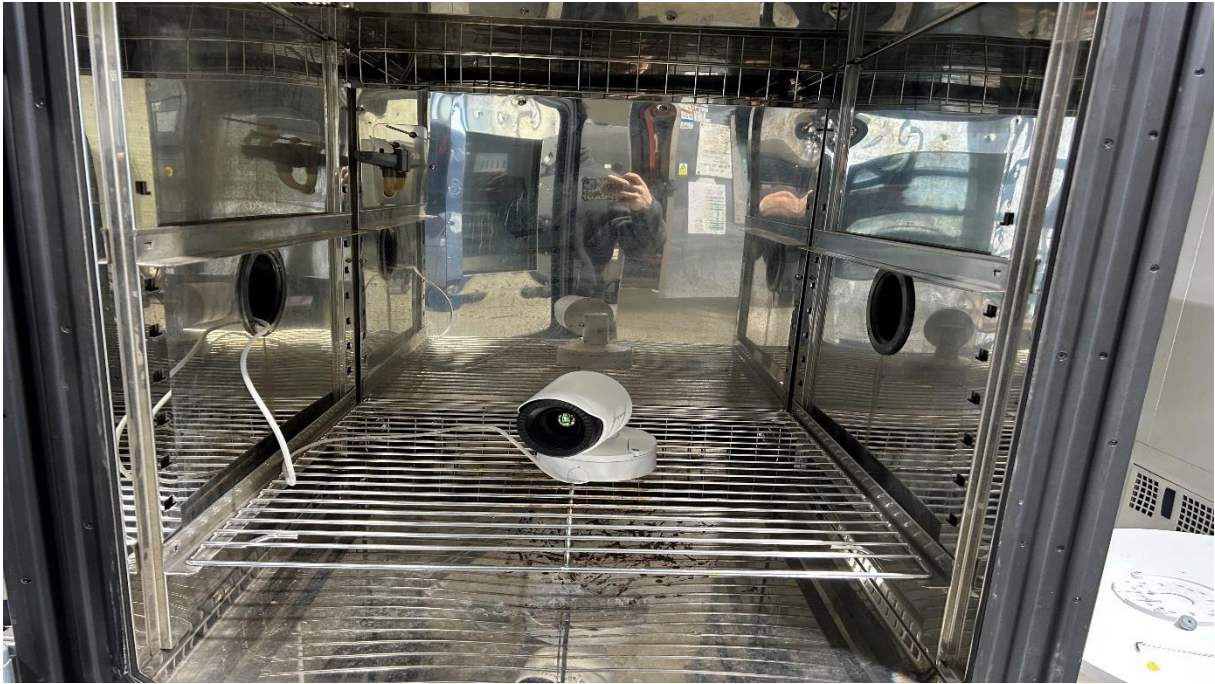
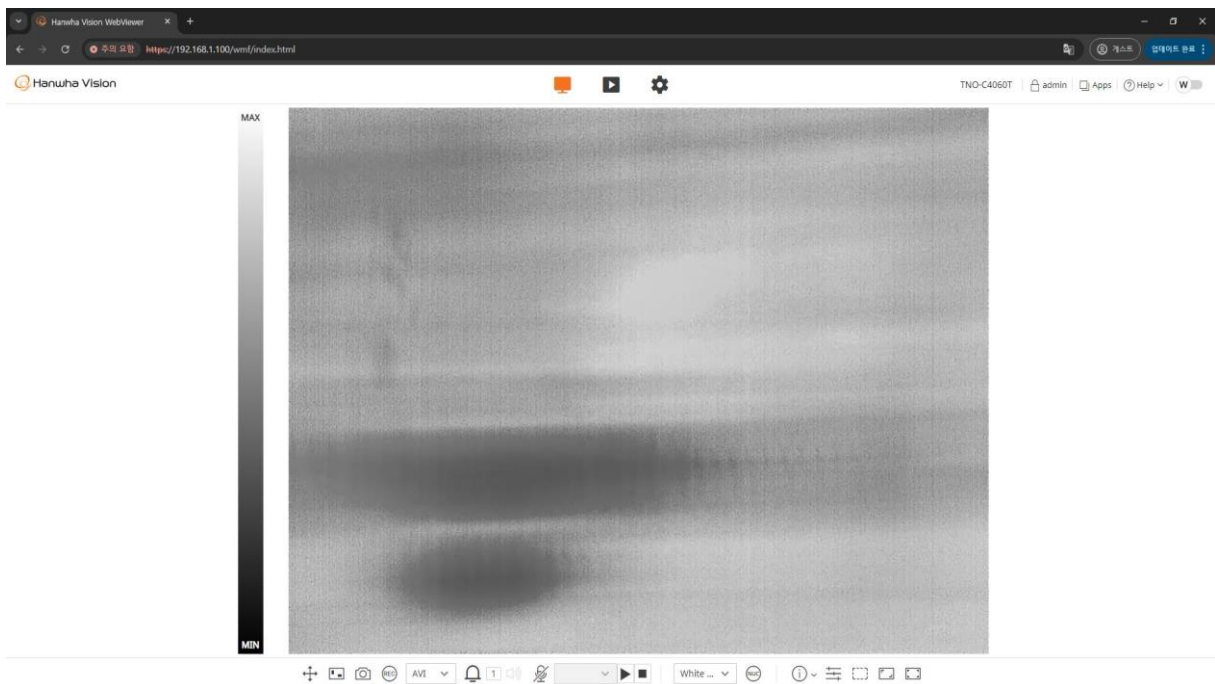
#### 4.3.1 Evidence of test setting

4.2.1 Preconditioning temperature: 25 °C

4.2.2 Sample status: Operation

4.2.3 Test temperature: 60 °C

4.2.4 Test time: 96 h

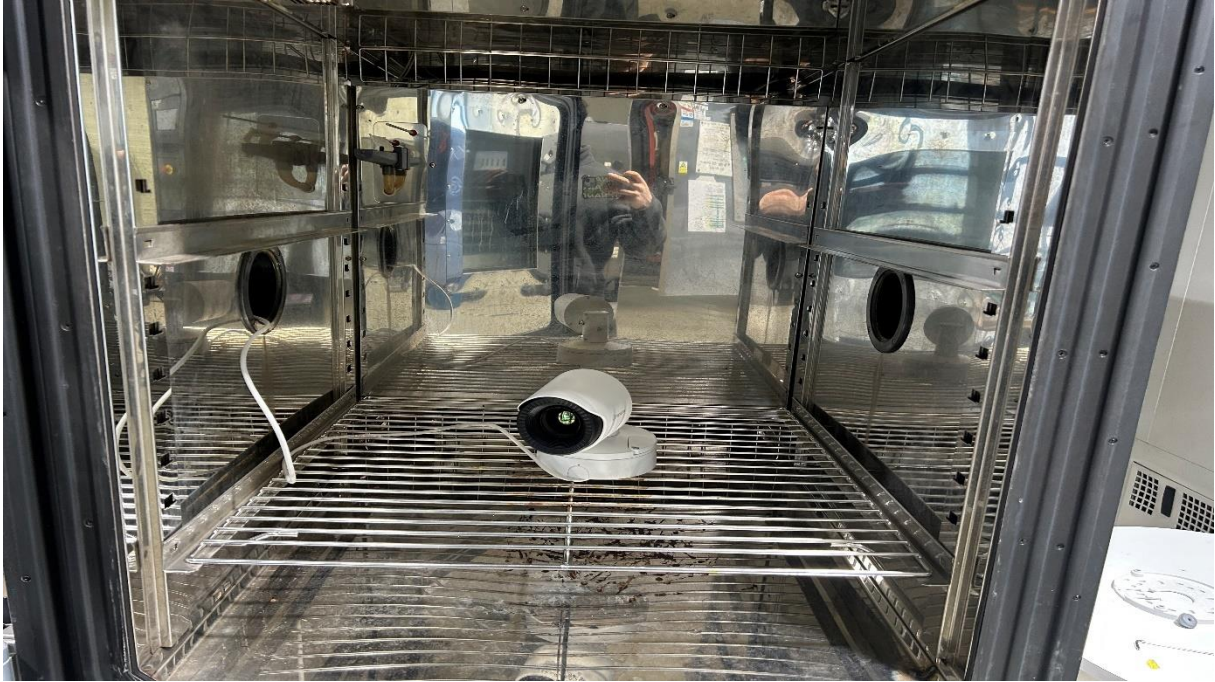
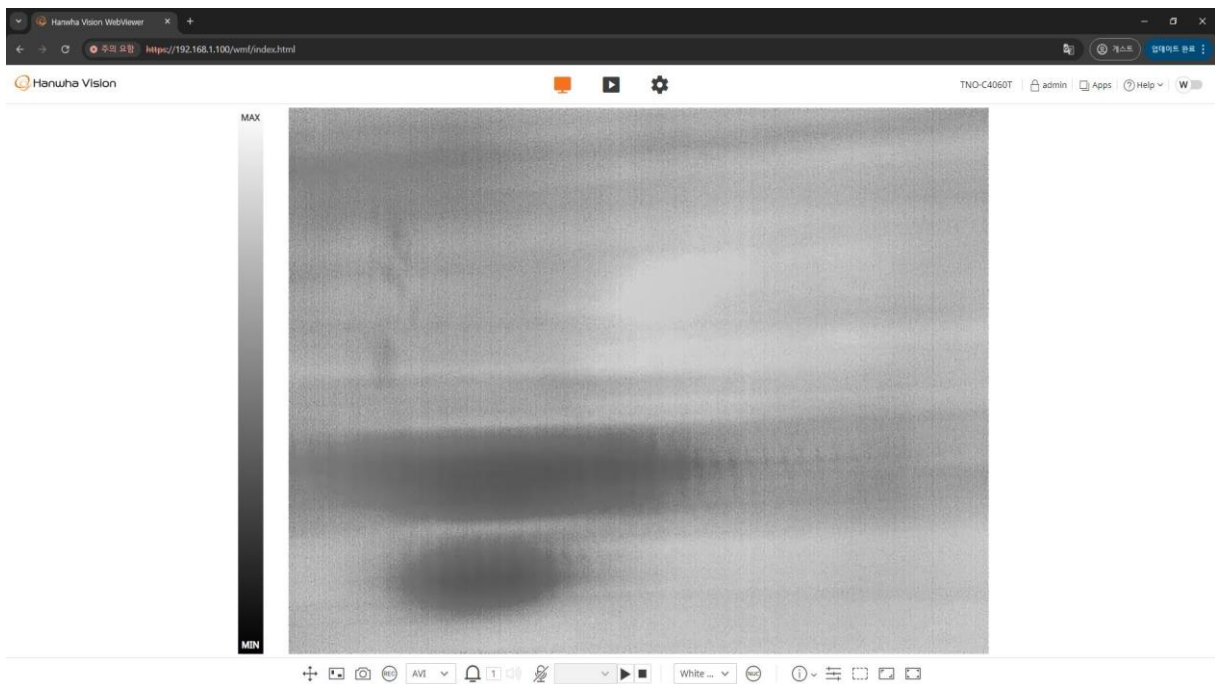
#### 5.3.1 Evidence of test setting

5.2.2 Test temperature: - 40 °C, 60 °C

| Temp↵ | Temperature change rate(°C/min)↵ | t <sub>1</sub> (idle time)↵ | Cycles↵ |
| High↵ | 5 °C/min↵ | 3 h↵ | 3↵ |
| Low↵ | 1 °C/min↵ | 3 h↵ | 3↵ |

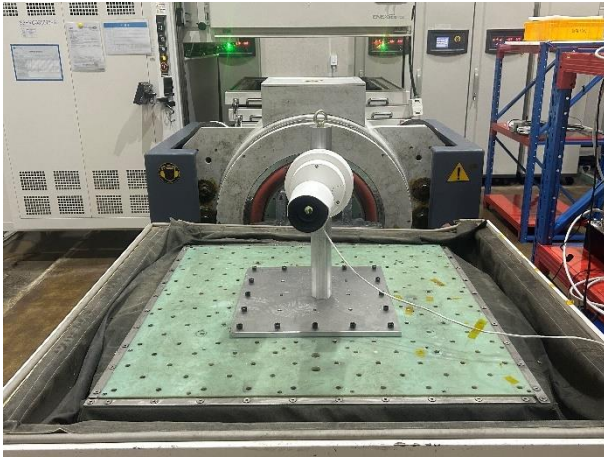
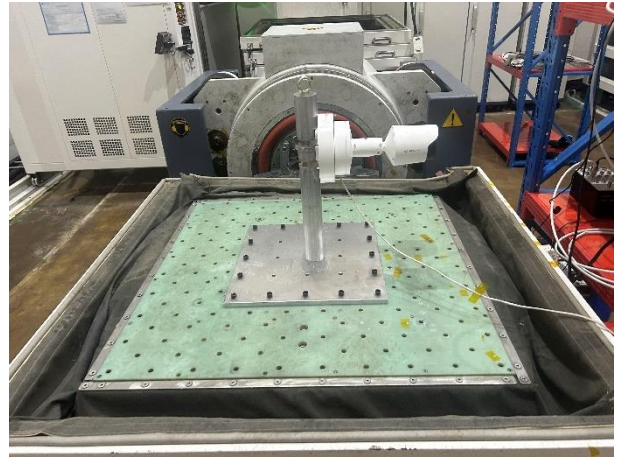
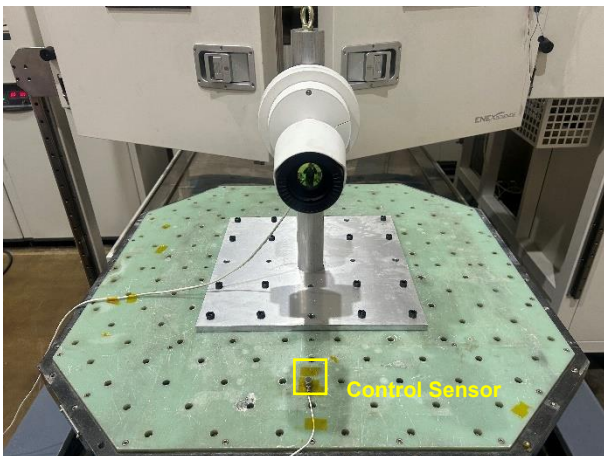
### 6.3.1 Evidence of test setting

X axis

Y axis

Z axis

※ The control sensors for the X and Y axes are mounted on the vibration plate.

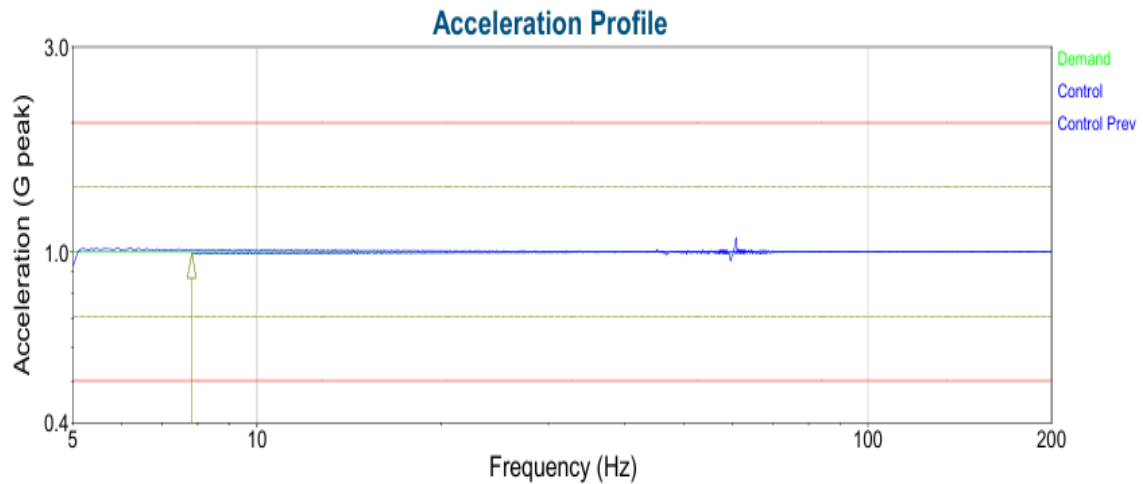
#### Vibration Test (X Axis)

Demand: 1 G

Frequency: 7.835 Hz

Control: 0.993 G

Total Time: 0:10:12

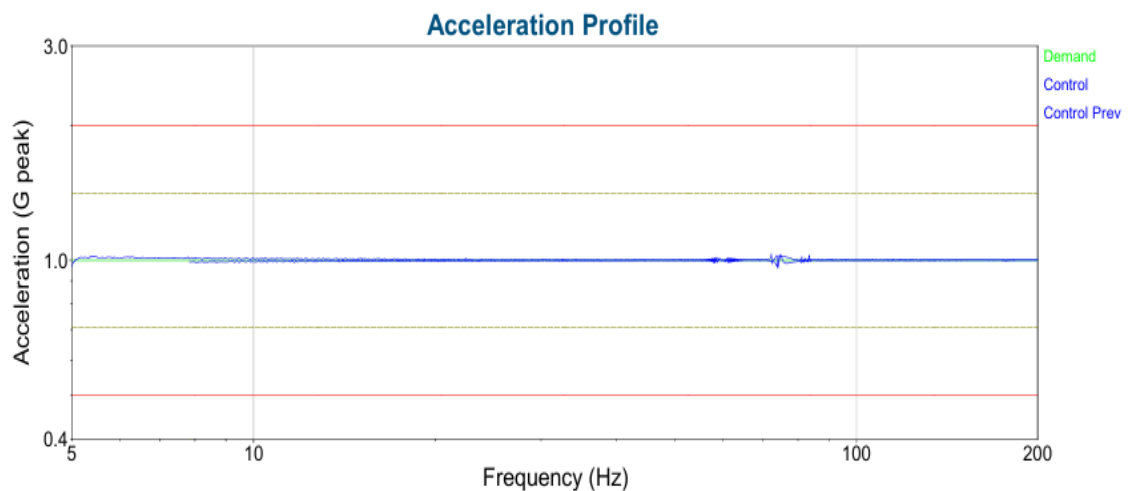
#### Vibration Test (Y Axis)

Demand: 1 G

Frequency: 7.841 Hz

Control: 0.002031 G

Total Time: 0:10:13

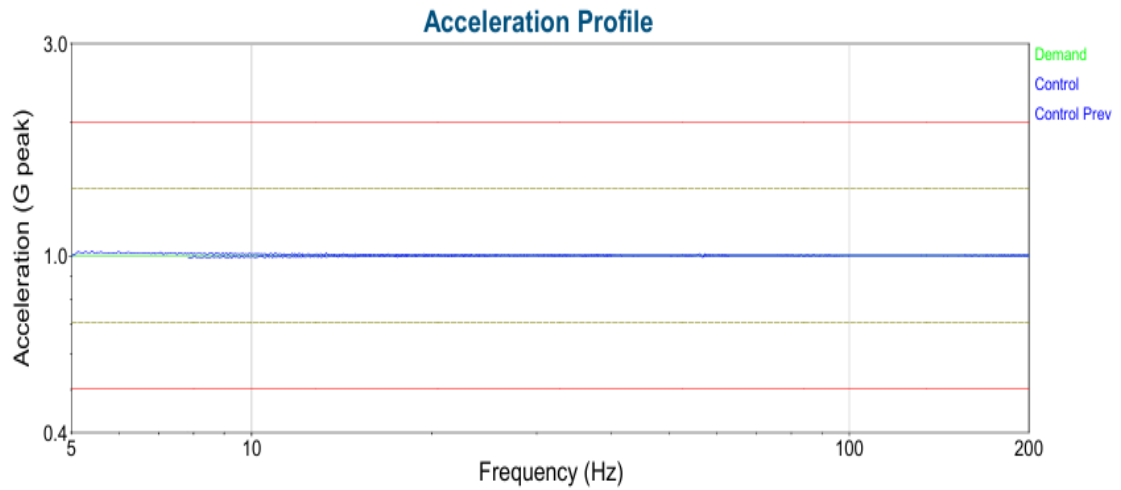
Vibration Test (Z Axis)

Demand: 1 G

Frequency: 7.846 Hz

Control: 0.001228 G

Total Time: 0:10:13

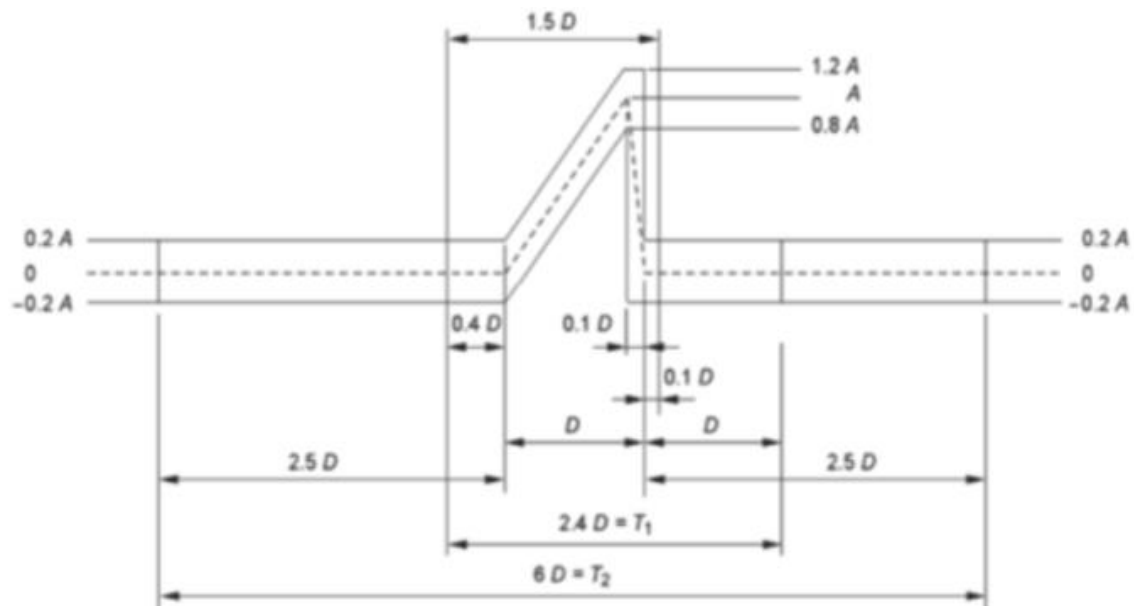
7.2.6 Profile

7.2.2 Acceleration( $\text{m/s}^2$ ):  $100 \text{ m/s}^2$

7.2.4 Number of impacts: 10 per direction (total 60)

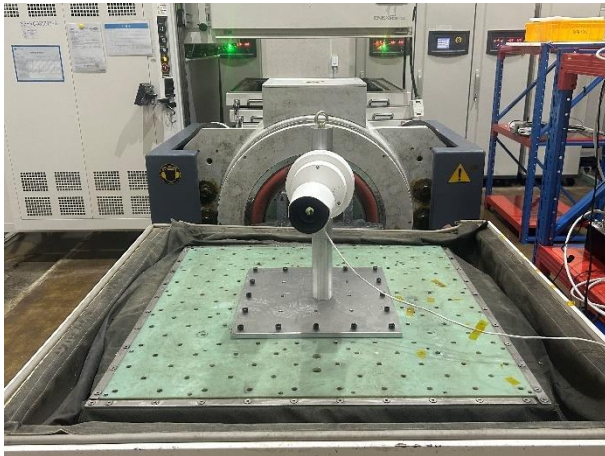
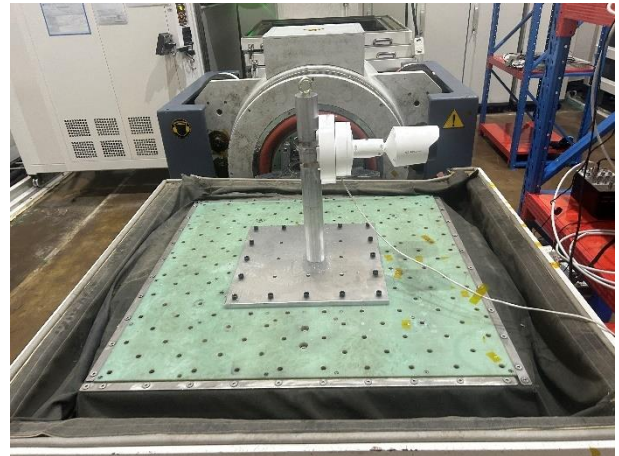
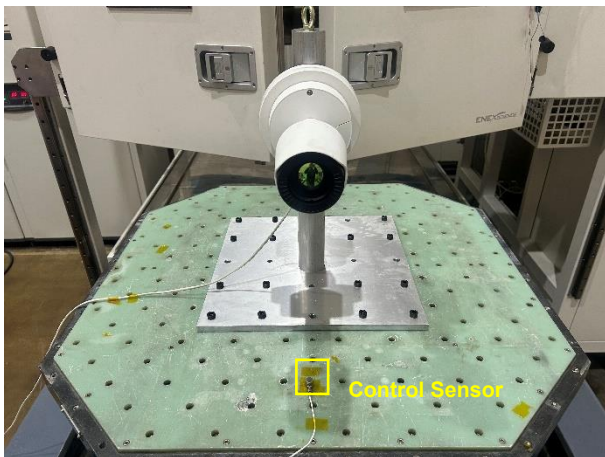
### 7.3.1 Evidence of test setting

X axis

Y axis

Z axis

※ The control sensors for the X and Y axes are mounted on the vibration plate.

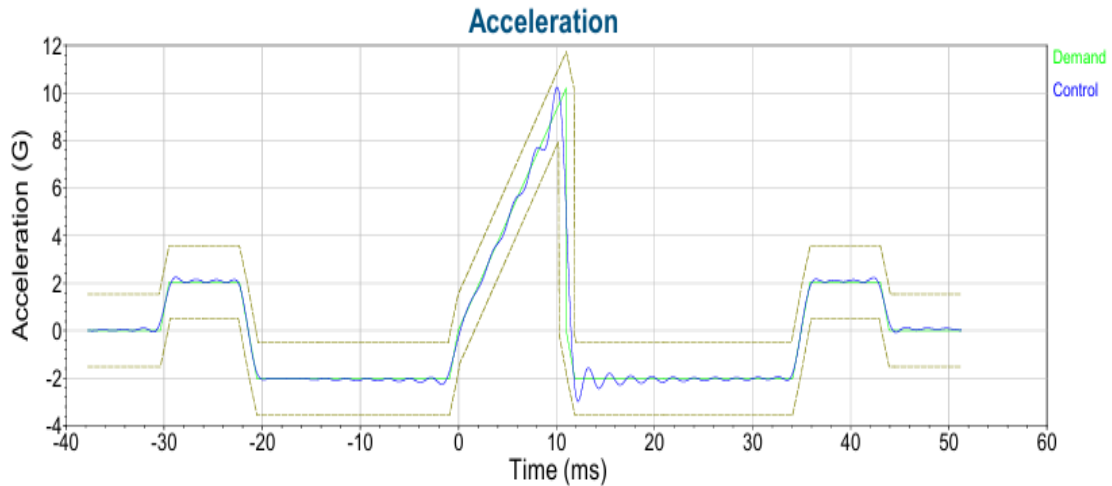
#### 7.5.1 Mechanical shock data ( $\pm X$ Axis)

4 03, 2026 18:23:29 Level 1) 100 %

Output: 0.5417 Volts peak 한화비전 60068-2-27

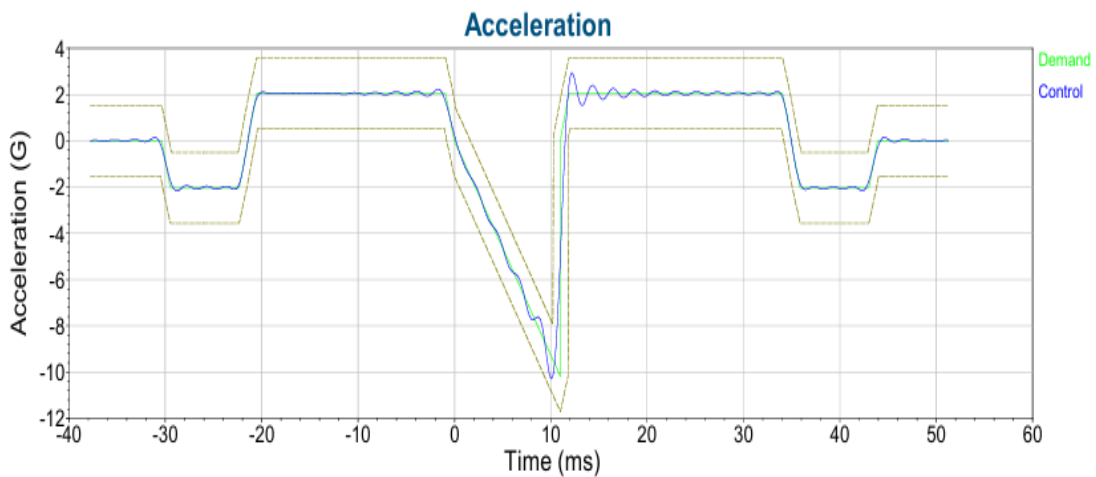
Mechanical Chock data +X Axis

4 03, 2026 18:23:39 Level 2) 100 %

Output: 0.5468 Volts peak 한화비전 60068-2-27

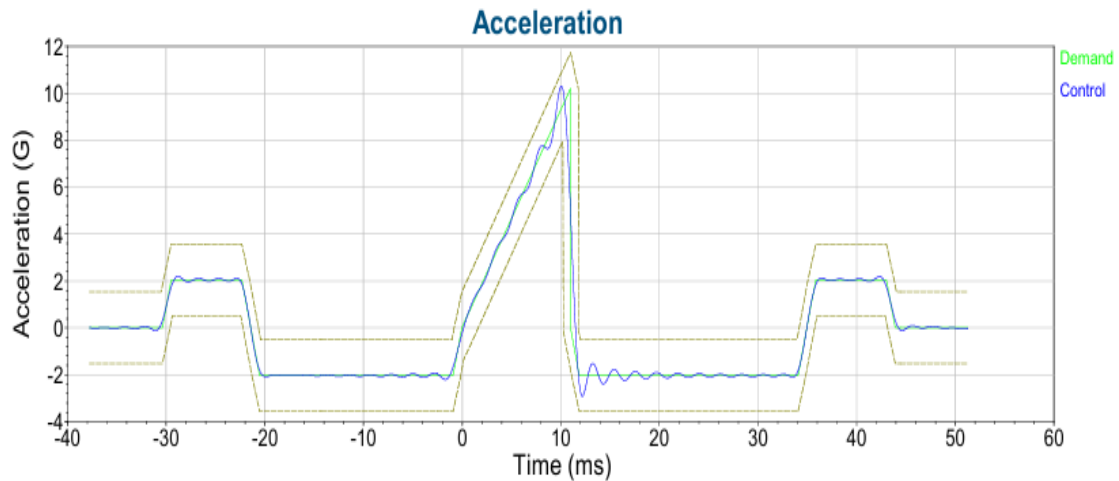
### 7.5.2 Mechanical shock data ( $\pm Y$ Axis)

4 06, 2026 11:02:10 Level 1) 100 %  
Demand: 10.2 G  
Control: 10.29 G Pulse: 10 of 10

Output: 0.5378 Volts peak 한화비전 60068-2-27  
Running

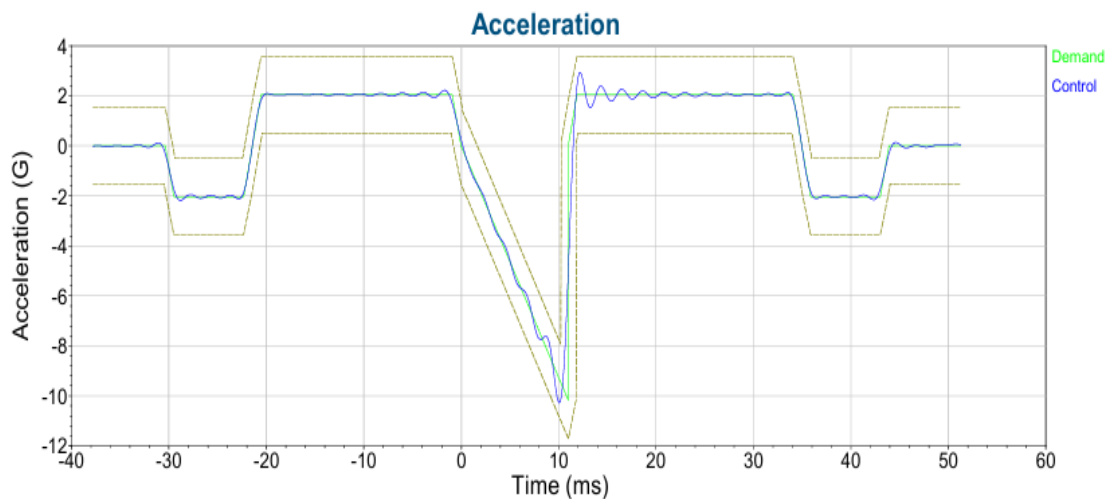
#### Mechanical Chock data +Y Axis

4 06, 2026 11:02:59 Level 2) 100 %  
Demand: 10.2 G  
Control: 10.29 G Pulse: 10 of 10

Output: 0.5384 Volts peak 한화비전 60068-2-27  
End of Test

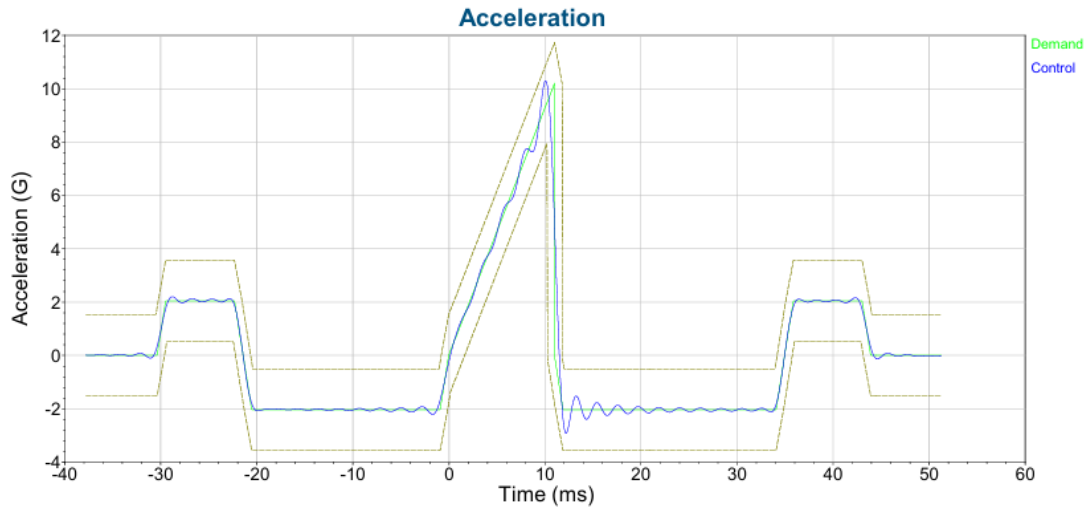
### 7.5.3 Mechanical shock data ( $\pm Z$ Axis)

4 07, 2026 11:09:21

Level 1) 100 %

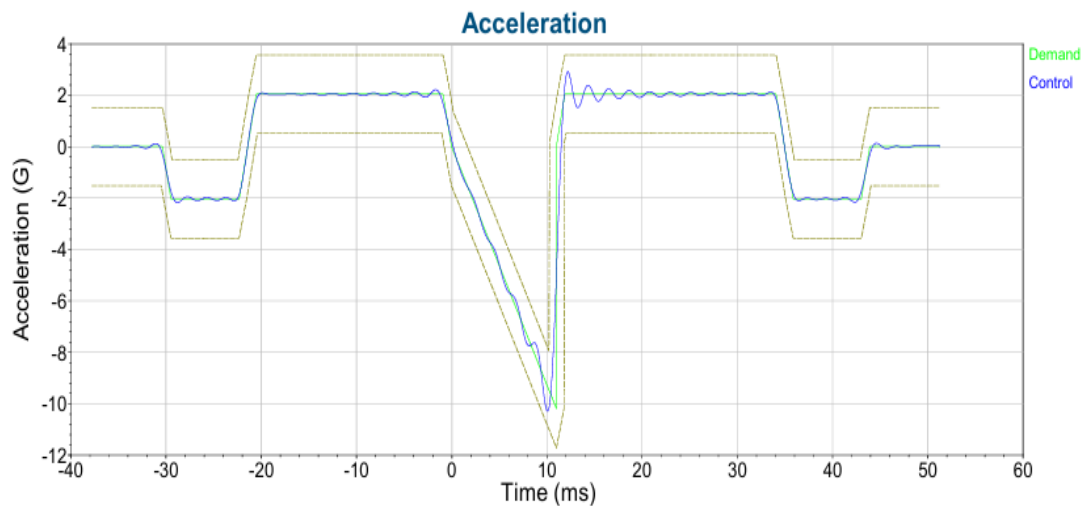
#### Mechanical Chock data +Z Axis

4 07, 2026 11:10:17

Level 2) 100 %

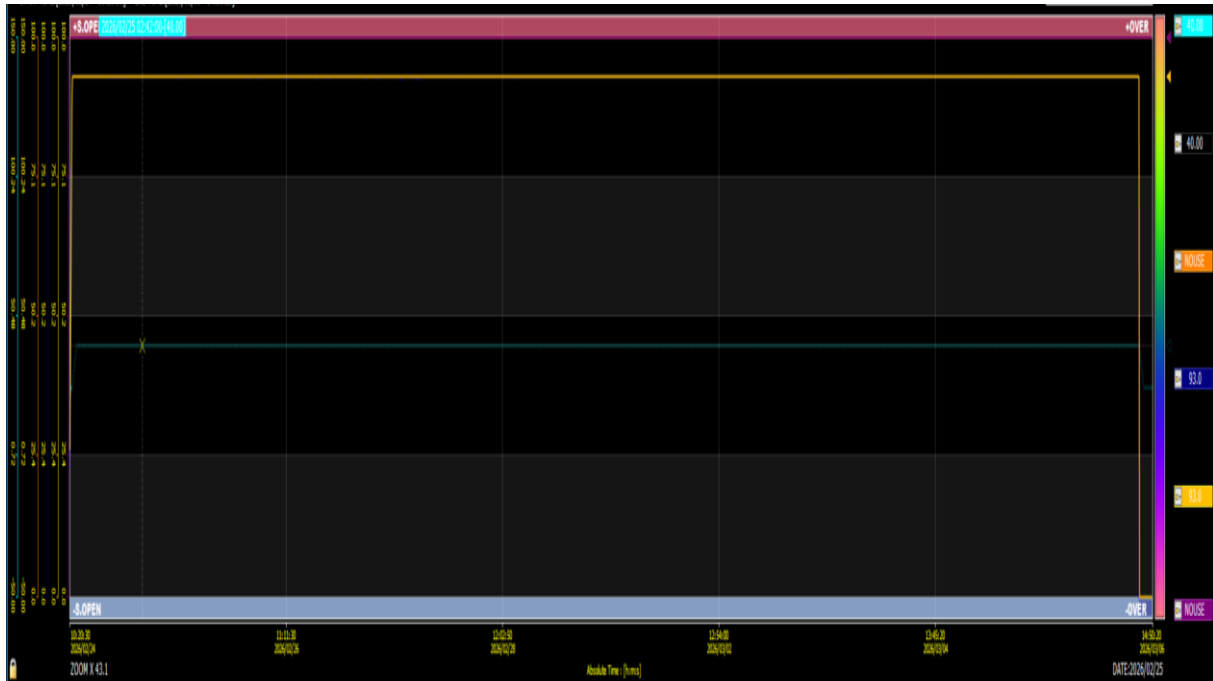
## Temperature Data

8.2.4 Test humidity: 93 % R.H.
