# TEST REPORT

REPORT No.:  
CTK-2026-01026  
Page (1) / (31) pages

NETWORK THERMAL CAMERA / TNO-C4060T

NEMA TS-2:2021 2.2.7.3 Test C ~ 2.2.7.8 Test H,  
NEMA TS-2:2021 2.2.8, NEMA TS-2:2021 2.2.9  
Temperature: (25 ± 10) °C, Humidity: (50 ± 25) % R.H.

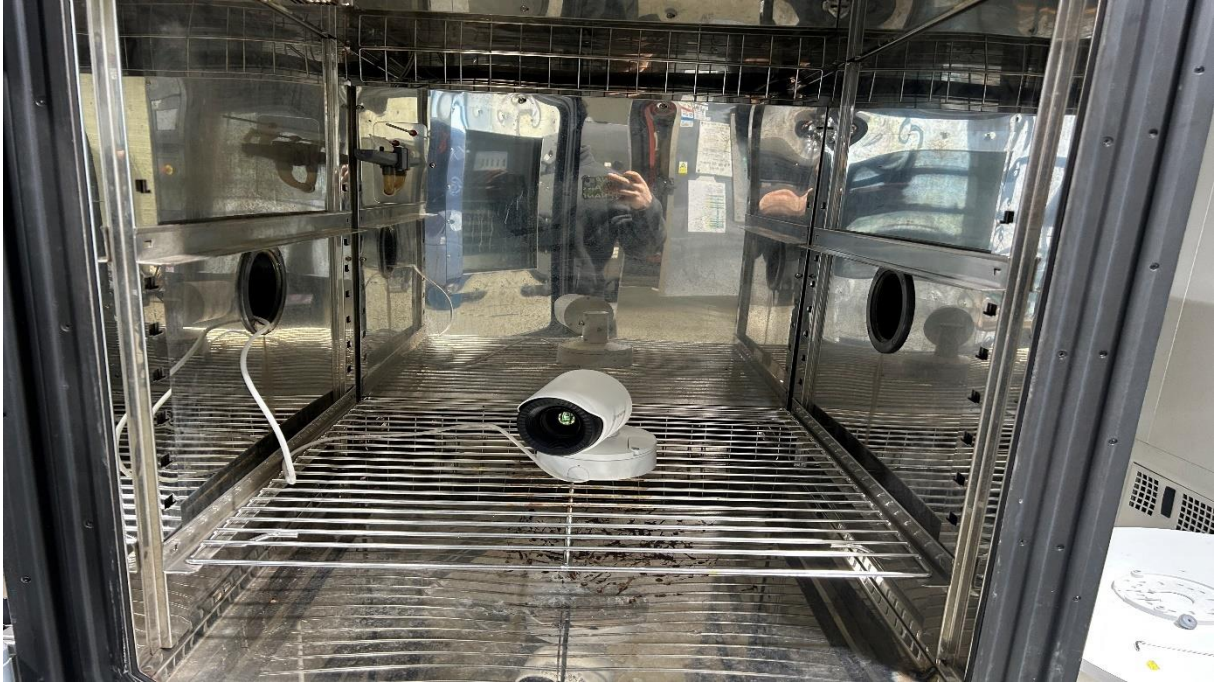
#### 3.9.1 Evidence of test setting
