# TEST REPORT

REPORT No.:  
CTK-2026-00323  
Page (1) / (13) pages

NETWORK THERMAL CAMERA / TNO-C4080T

IEC 60529:1989 +A1:1999+A2:2013

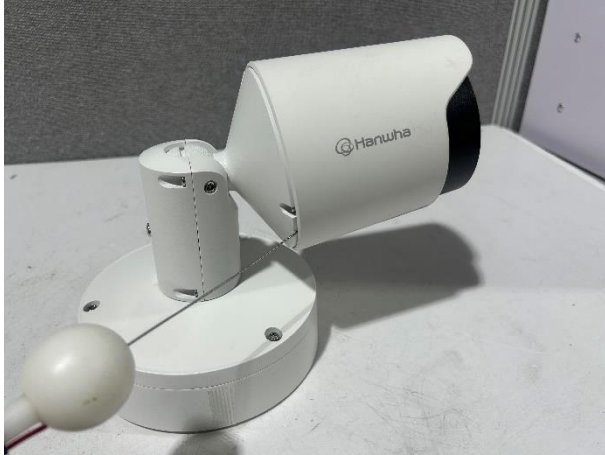
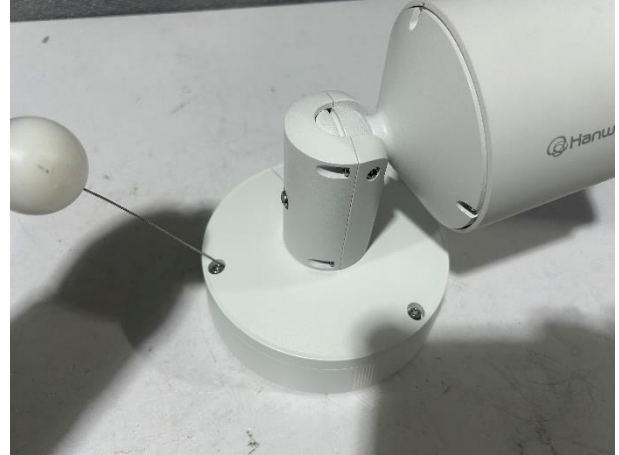
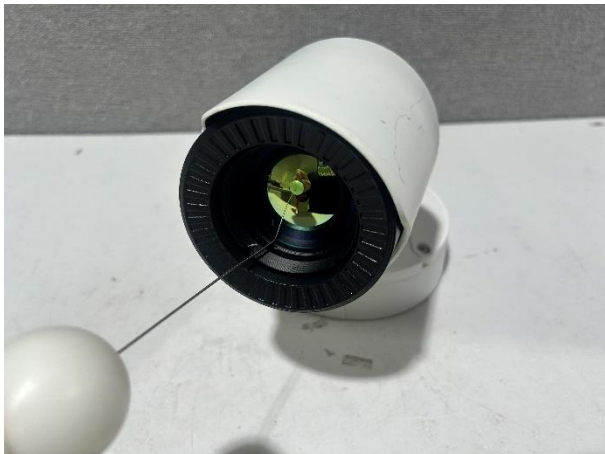
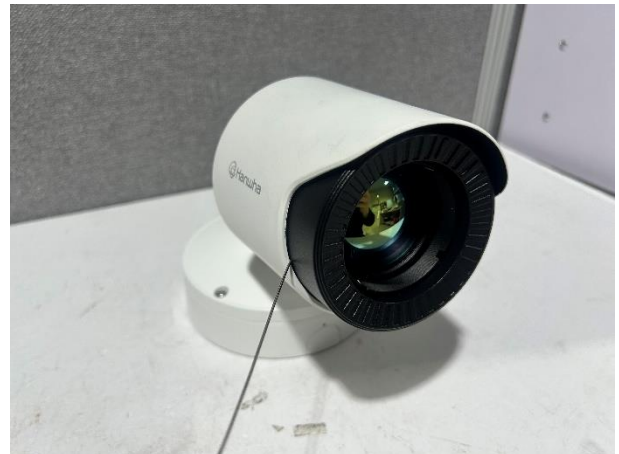
Probe test

| First characteristic numeral | Degree of protection | Application |
|---|---|---|
| 6 | Protected against access to hazardous parts with a wire.<br>The access probe of 1.0 mmØ, shall not penetrate.<br>Test force: 1 N ± 10 % | <input checked="" type="checkbox"/> |

| IP code | Evaluation Criteria | Test Results | Remark |
|---|---|---|---|
| IP 6X | No ingress of Probe | Normal | - |

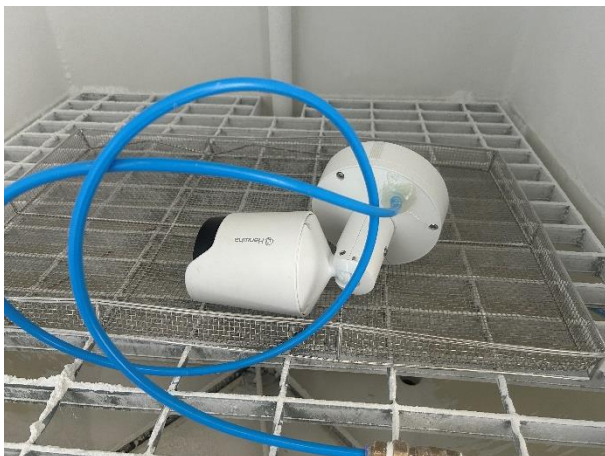
Dust test

| First characteristic numeral | Degree of protection | Application |
|---|---|---|
| 6 | <p>In Dust Testing Equipment, the test sample must have no ingress of dust after testing atmospheric pressure present condition for 8 h.</p> <p>(The talcum powder must pass through a calibrated sieve with a 50 µm wire mesh, spaced at 75 µm intervals in a square pattern. Additionally, the bulk density of the talcum powder should be 2 kg/m<sup>3</sup>)</p> <p>Products in volume .....: <b>4 696.670 cm<sup>3</sup> → 4.696 L</b></p> <p>Target intake volume (Products in volume 80) : <b>375.733 L</b></p> <p>Suction volume (Max product in volume 60) ...: <b>281.800 LPH → 4.696 LPM</b></p> <p>Actual Suction volume .....: <b>4.662 L</b></p> <p>Suction pressure (Up to 2 kPa) .....: <b>1.79 kPa</b></p> <p>Test time (Up to 8 time) .....: <b>8 hr</b></p> | <input checked="" type="checkbox"/> |

| IP code | Evaluation Criteria | Test Results | Remark |
|---|---|---|---|
| | No ingress of dust | Normal | - |

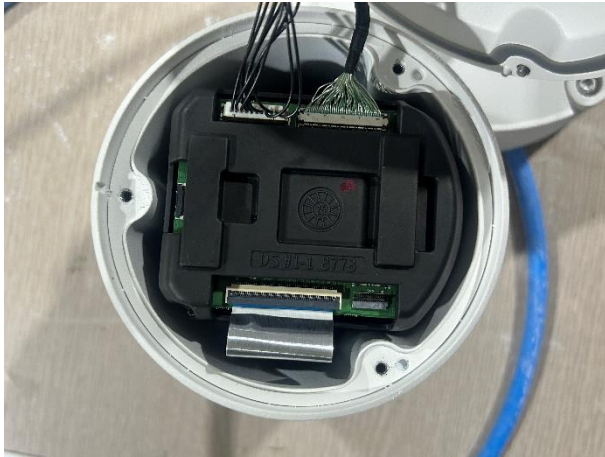
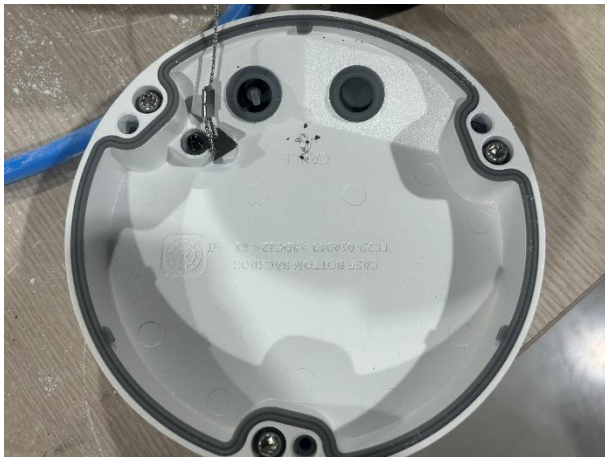
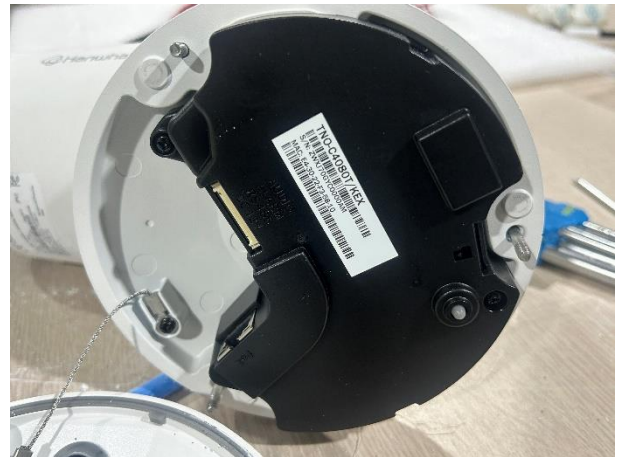
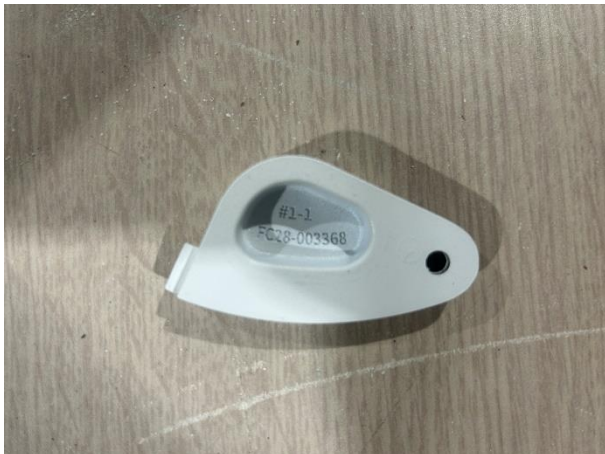
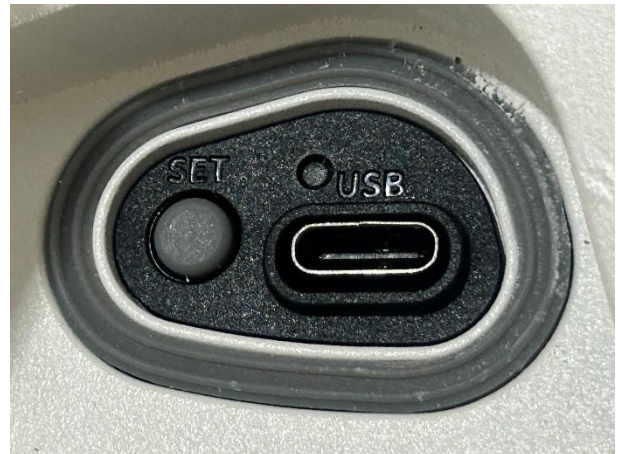
#### 3.5.1 Product internal images after test [The first characteristic numeral test]

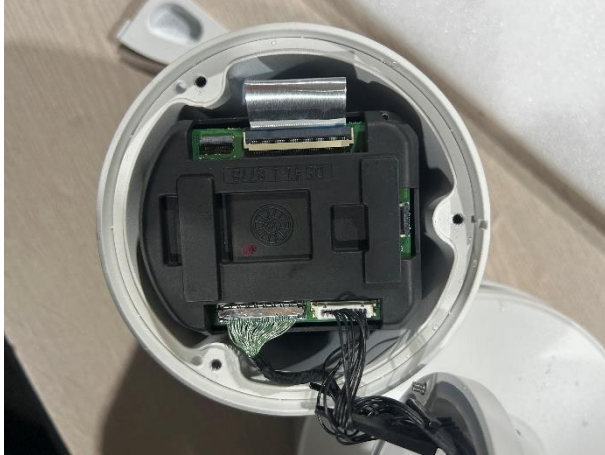
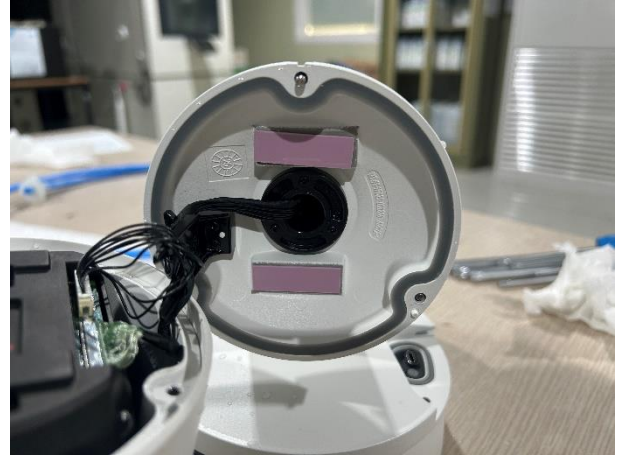
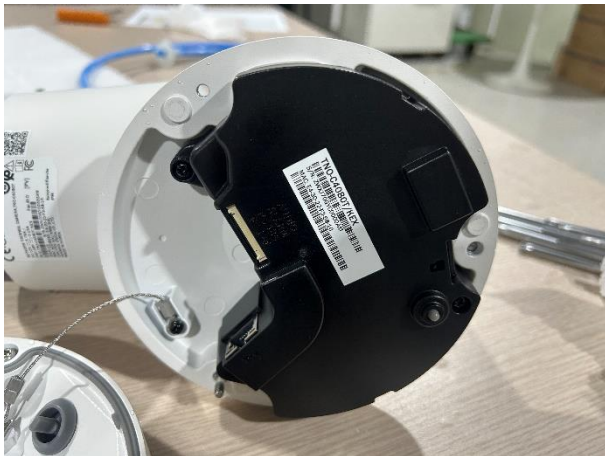
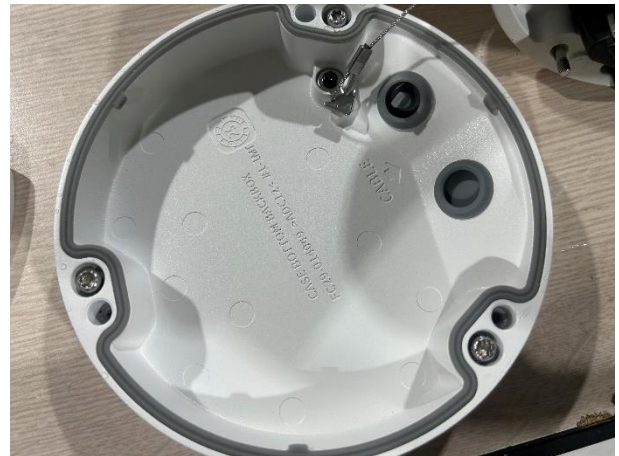
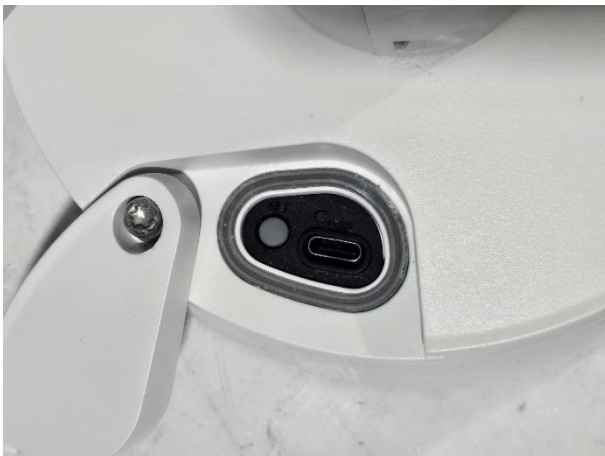
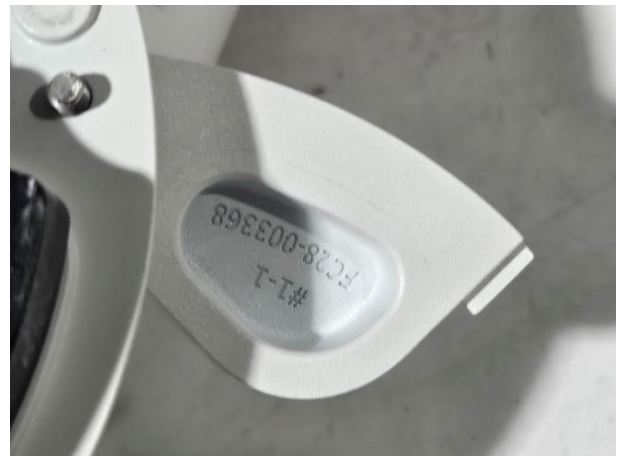
### 3.5.2 Product internal images after test [The second characteristic numeral test]

| IP code | Evaluation Criteria | Test Results | Remark |
|---|---|---|---|
| IP X6 | No ingress of water | Normal | - |
