# TEST REPORT

REPORT No.:  
CTK-2026-01032  
Page (1) / (42) pages

NETWORK THERMAL CAMERA / TNO-C4080T

EN 60068-2-1, EN 60068-2-2, EN 60068-2-14, EN 60068-2-6, EN 60068-2-27, EN 60068-2-78, IEC 60068-2-1, IEC 60068-2-2, IEC 60068-2-14, IEC 60068-2-6, IEC 60068-2-27, IEC 60068-2-78

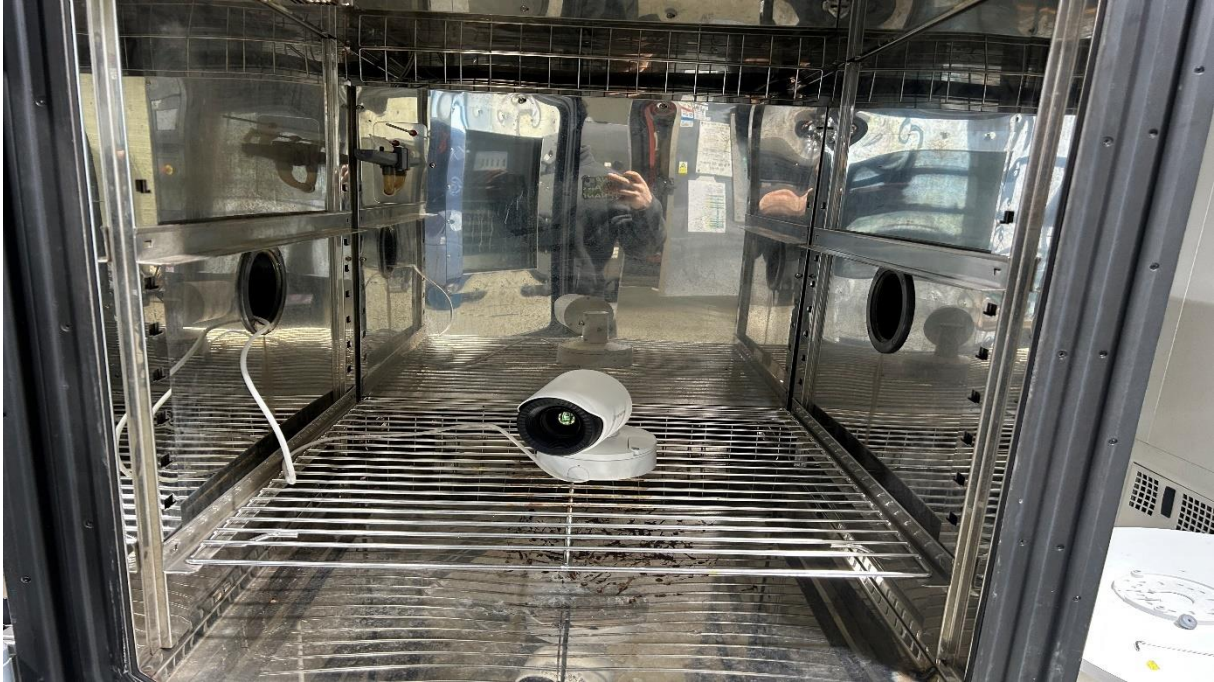
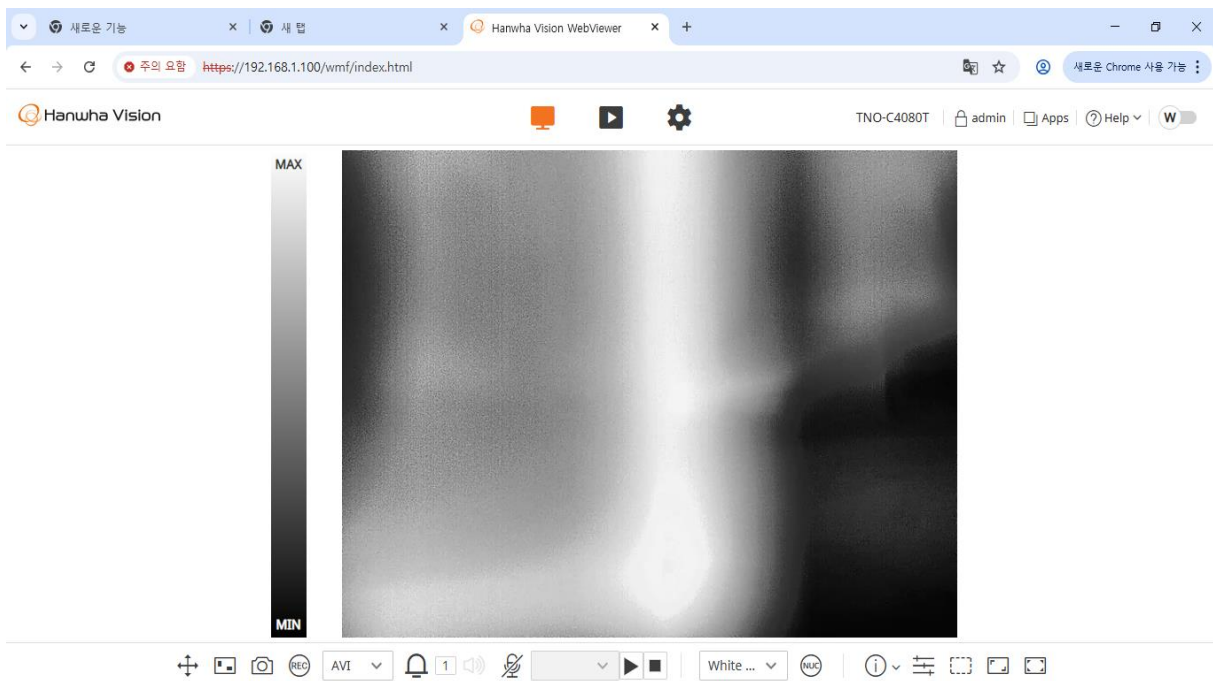
#### 3.3.1 Evidence of test setting

3.2.3 Test temperature: -33 °C

3.2.4 Test time: 16 h

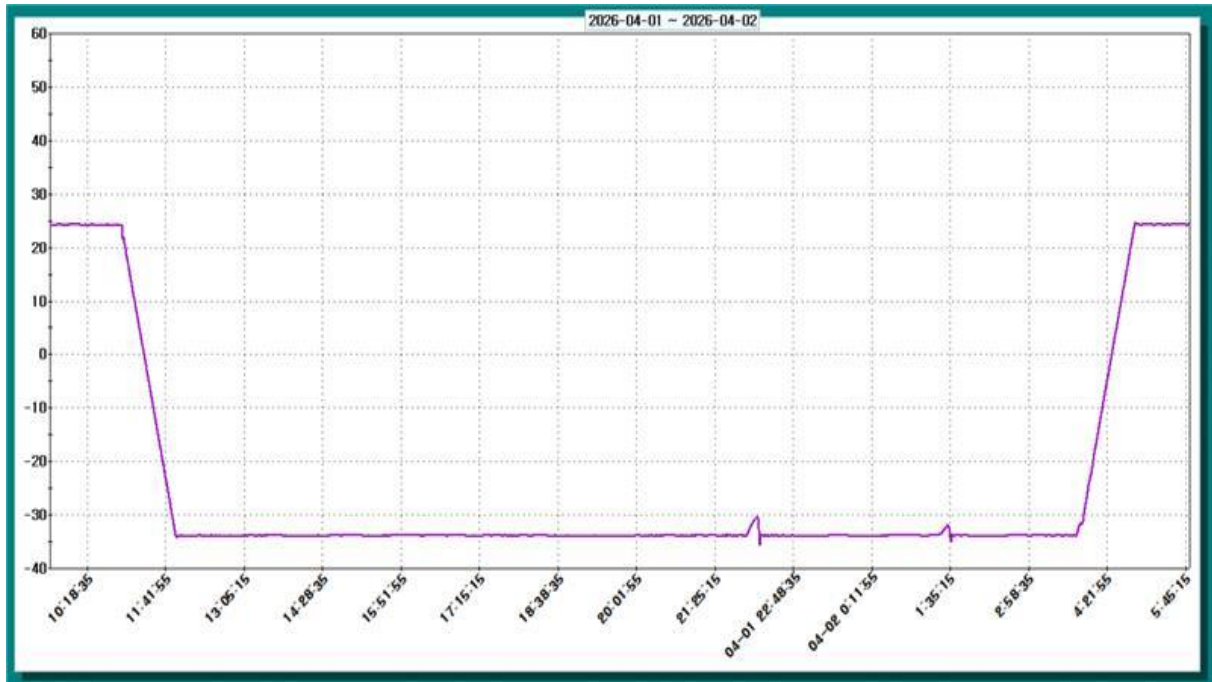
Temperature Data

#### 3.5.1 Test data and graph

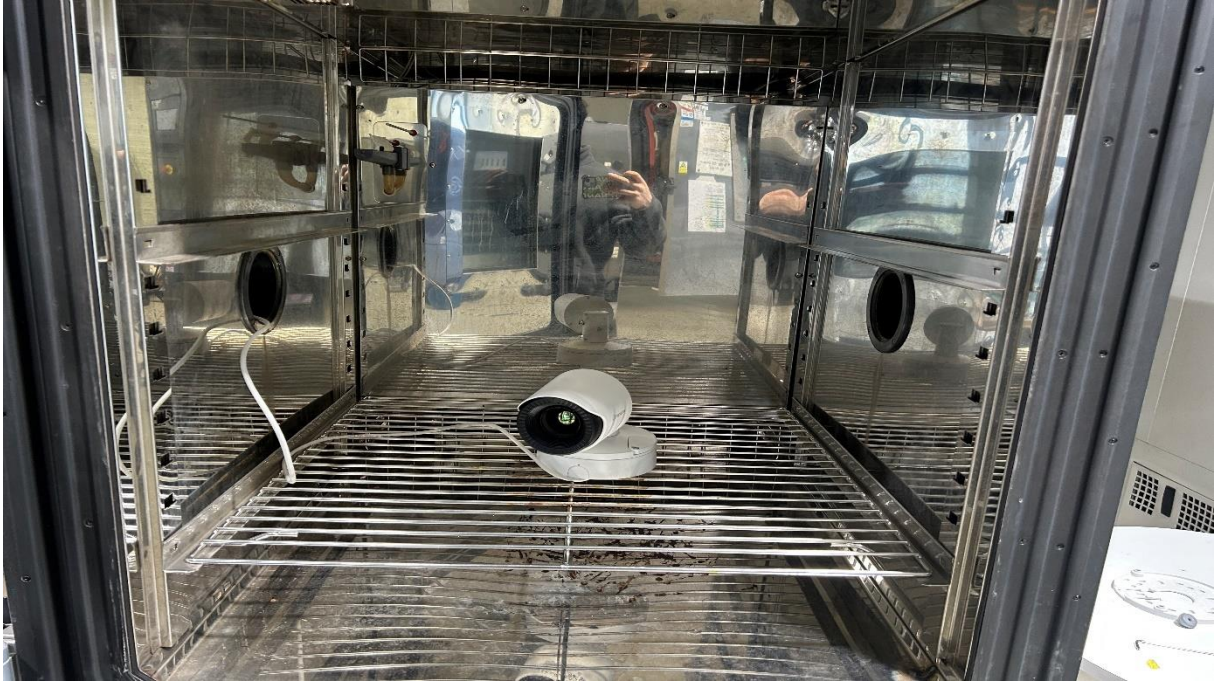
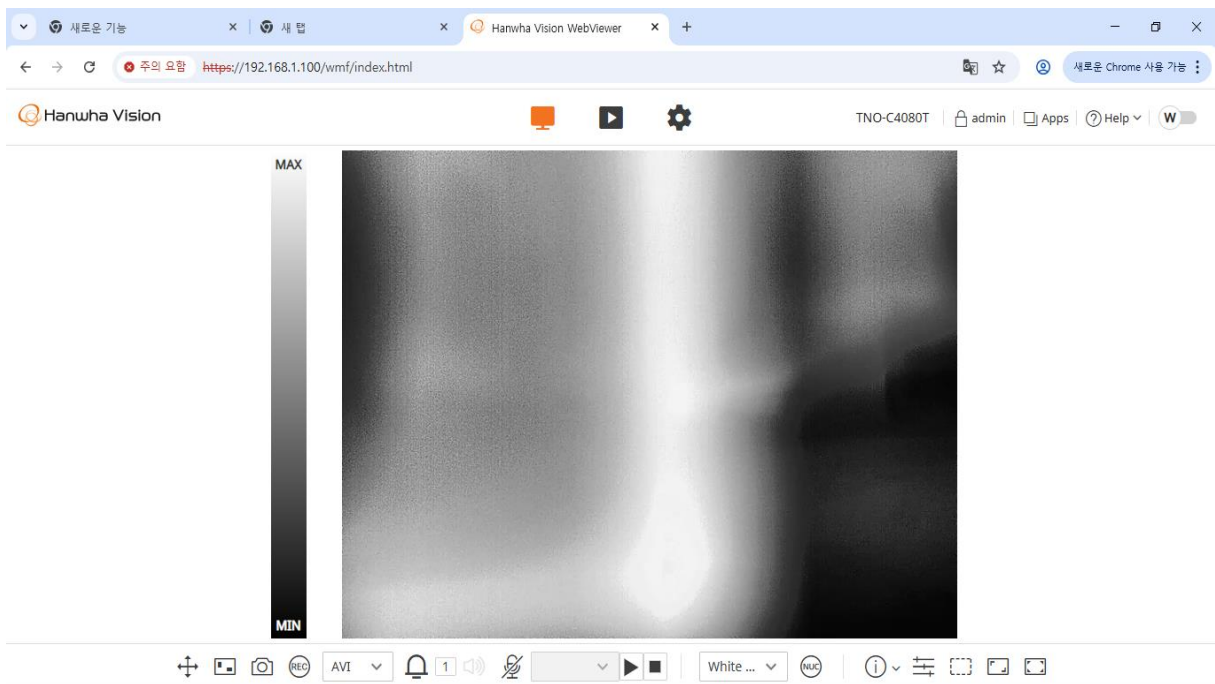
#### 4.3.1 Evidence of test setting

4.2.3 Test temperature: 60 °C

4.2.4 Test time: 96 h

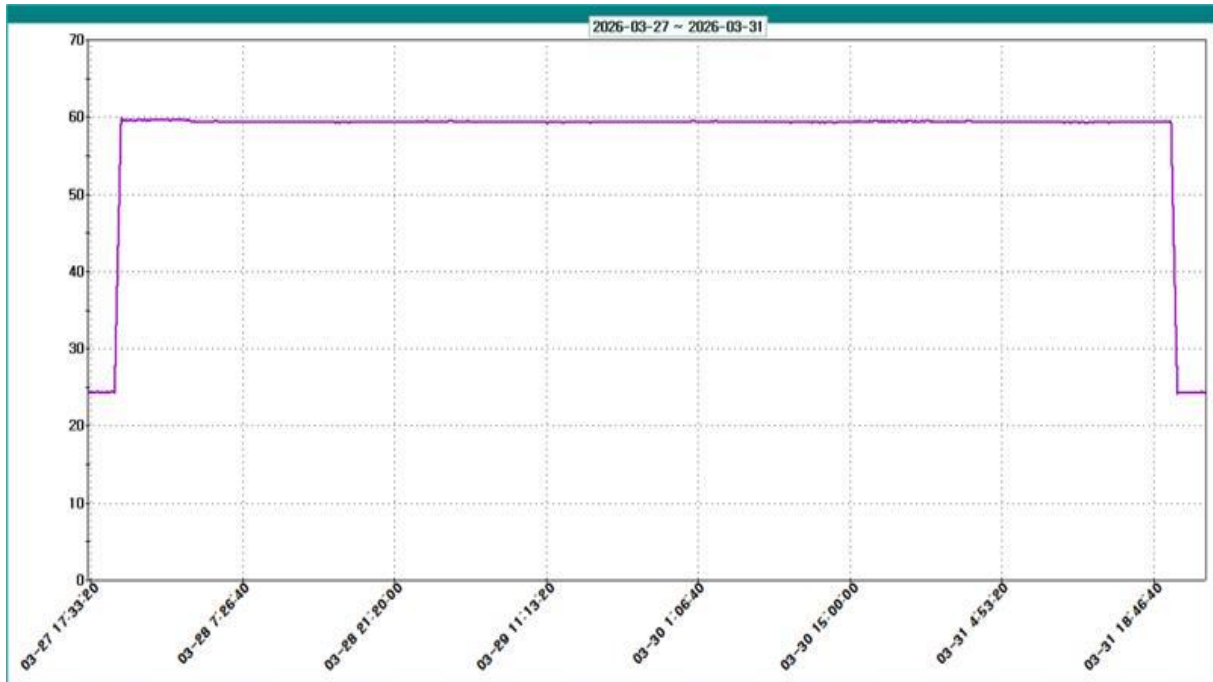
Temperature Data

#### 4.5.1 Test data and graph

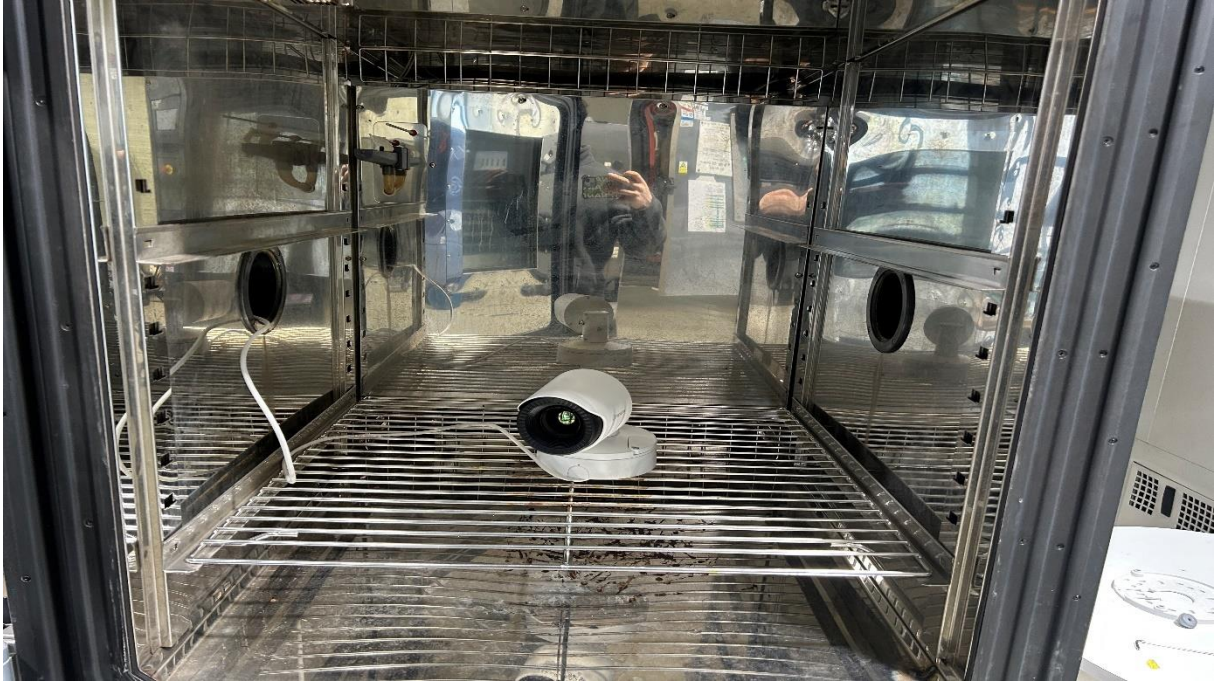
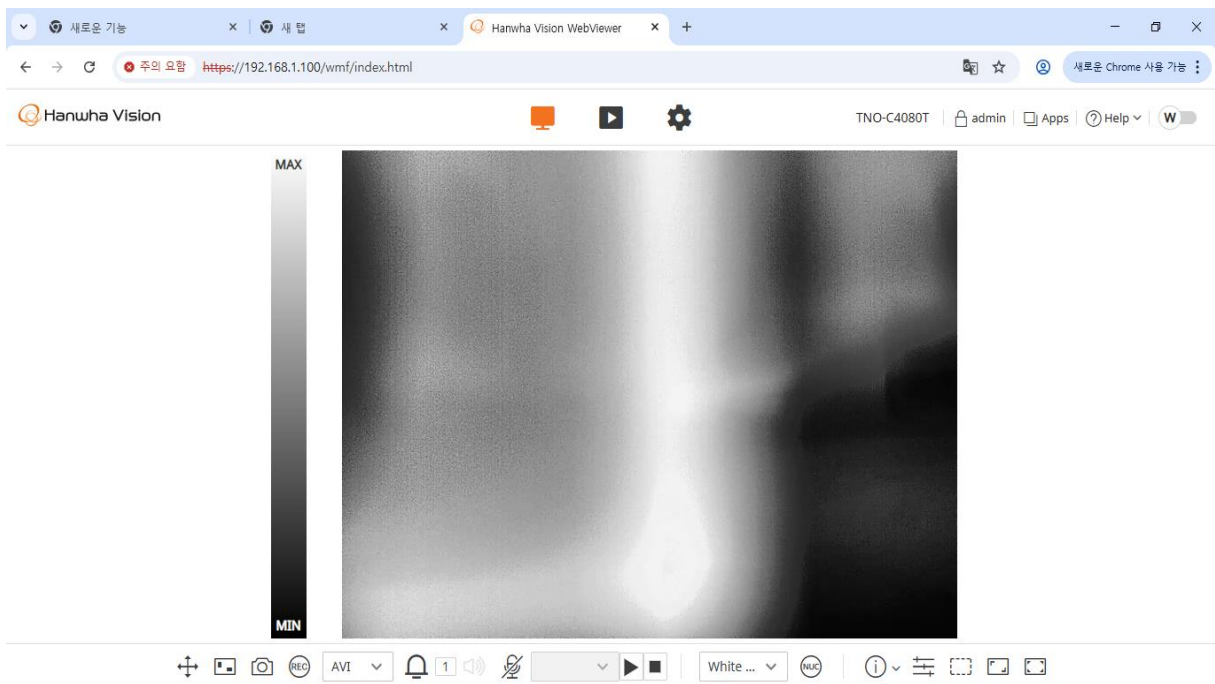
#### 5.3.1 Evidence of test setting

5.2.2 Test temperature: - 40 °C, 60 °C

| Temp↵ | Temperature change rate(°C/min)↵ | t <sub>1</sub> (idle time)↵ | Cycles↵ |
| High↵ | 5 °C/min↵ | 3 h↵ | 3↵ |
| Low↵ | 1 °C/min↵ | 3 h↵ | 3↵ |

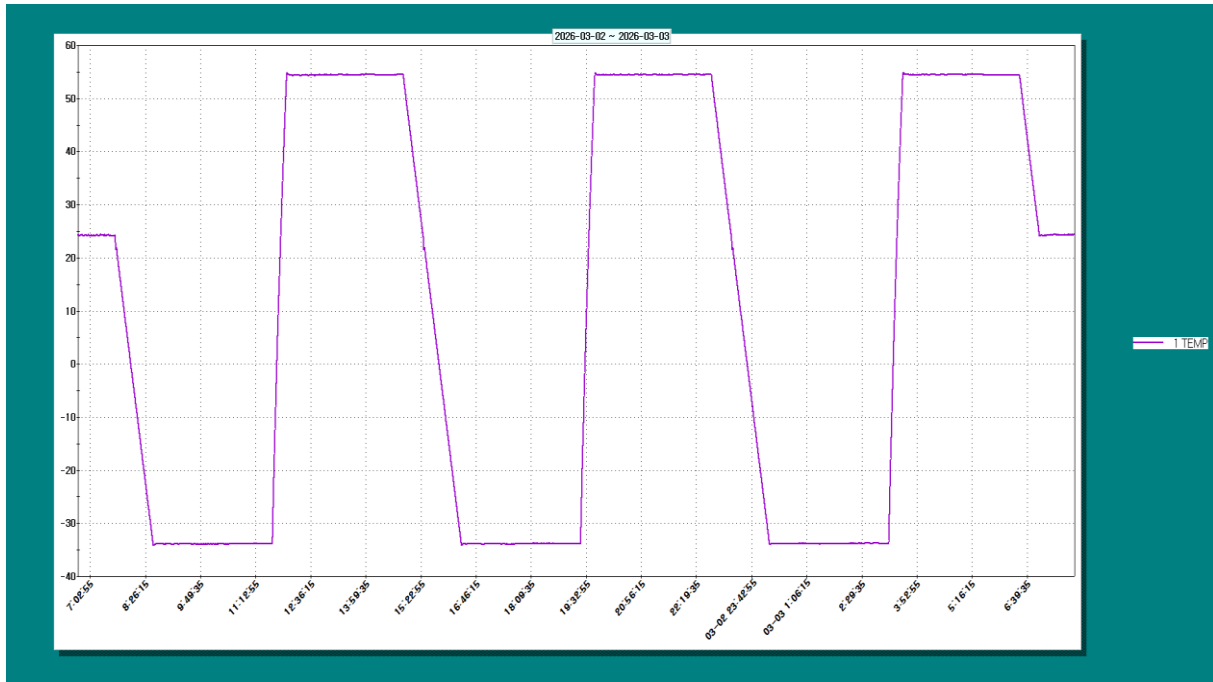
Temperature Data

#### 5.5.1 Test data and graph

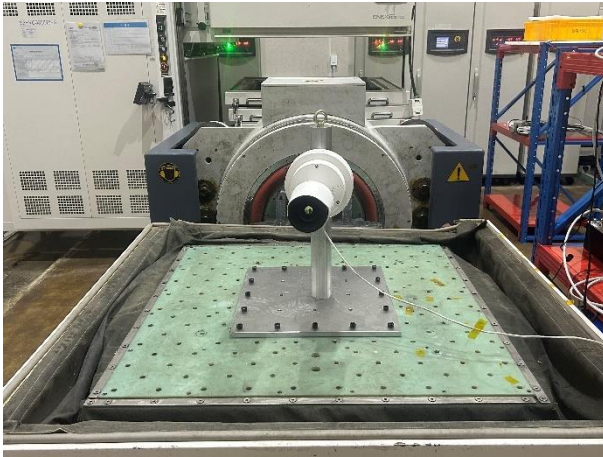
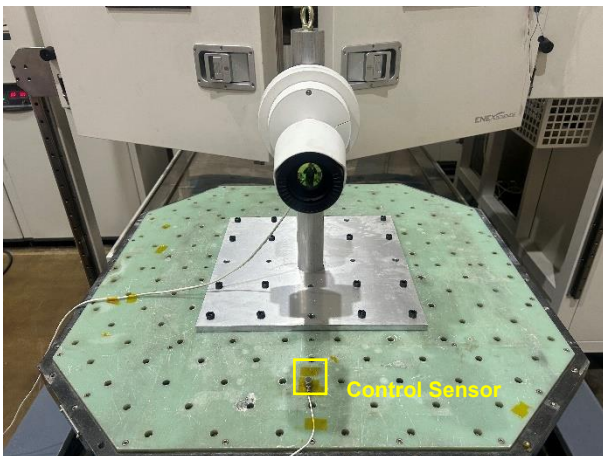
### 6.3.1 Evidence of test setting

6.2.3 Frequency (Hz): (5 ~ 200) Hz

6.2.4 Acceleration(G): 1 G

※ The control sensors for the X and Y axes are mounted on the vibration plate.

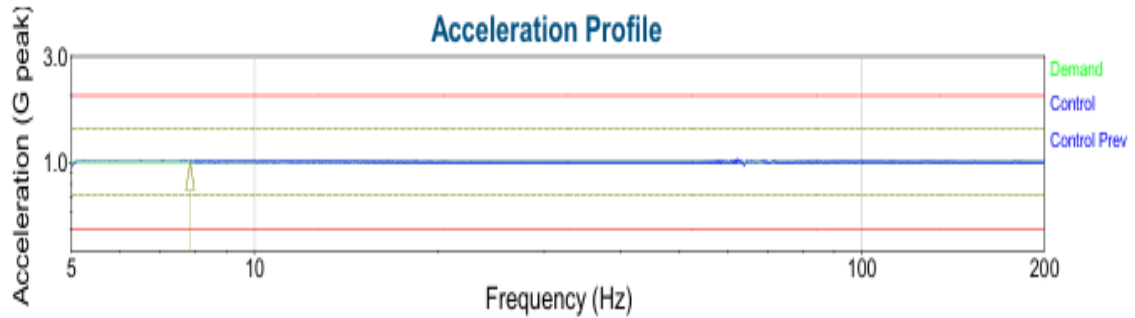
#### Vibration Test (X Axis)

4 03, 2026 11:46:42    Level 1) 100 %    Output: 0.2564 Volts peak    한화비전 60068-2-6

Demand: 1 G    Level Time: 0:10:00    Frequency: 7.841 Hz

Control: 0.9903 G    Total Time: 0:10:12    End of Timed Test

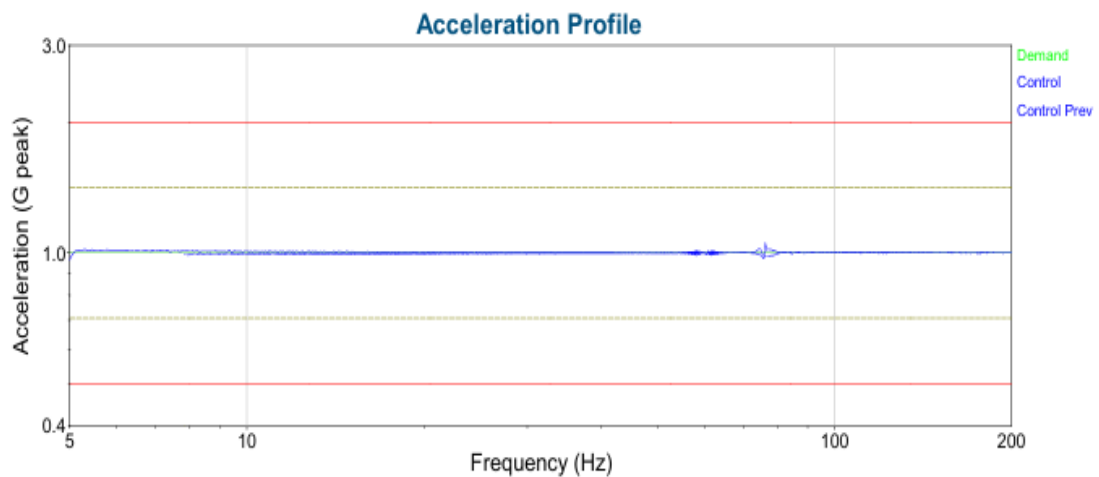
#### Vibration Test (Y Axis)

4 03, 2026 15:14:39    Level 1) 100 %    Output: 0 Volts peak    한화비전 60068-2-6  
Demand: 1 G    Level Time: 0:10:00    Frequency: 7.841 Hz  
Control: 0.003017 G    Total Time: 0:10:12    End of Timed Test

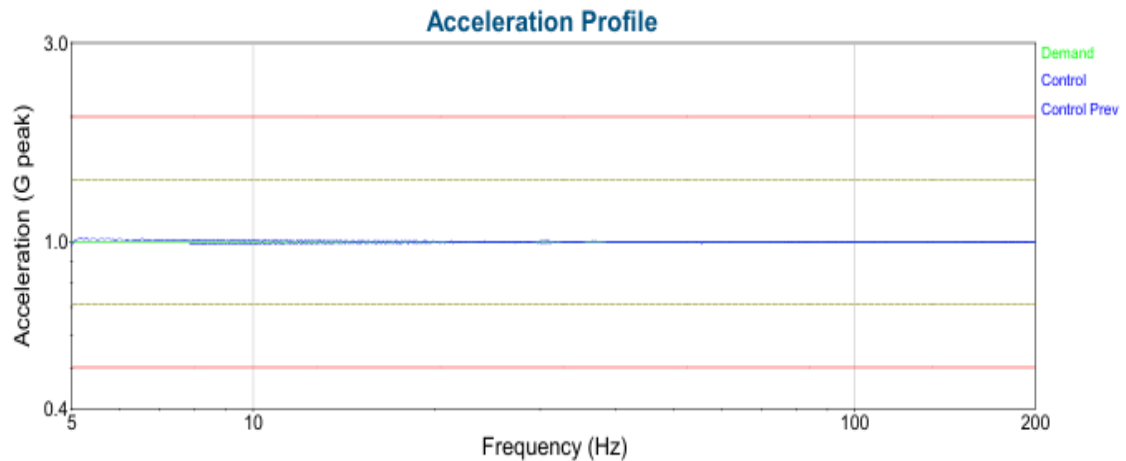
Vibration Test (Z Axis)

Frequency: 7.852 Hz

Control: 0.000801 G

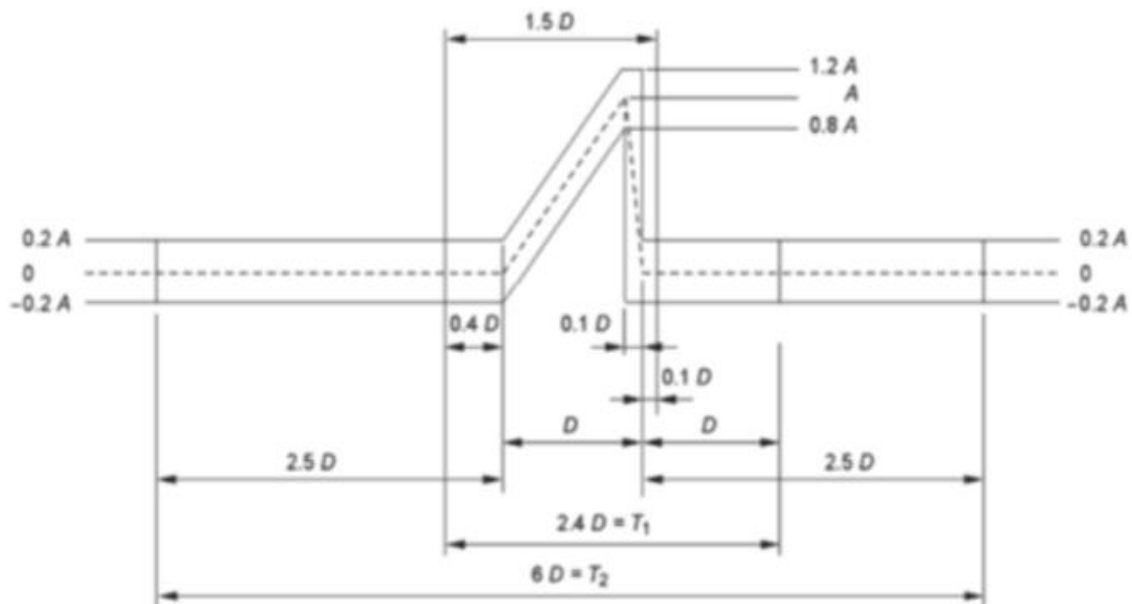
### 7.2.6 Profile

7.2.2 Acceleration( $\text{m/s}^2$ ):  $100 \text{ m/s}^2$

7.2.4 Number of impacts: 10 per direction (total 60)

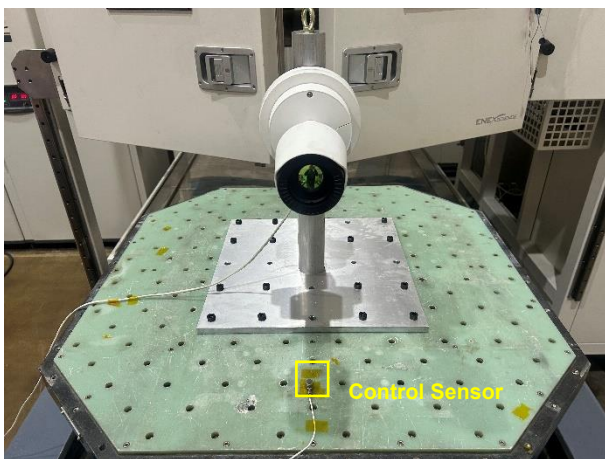
### 7.3.1 Evidence of test setting

※ The control sensors for the X and Y axes are mounted on the vibration plate.

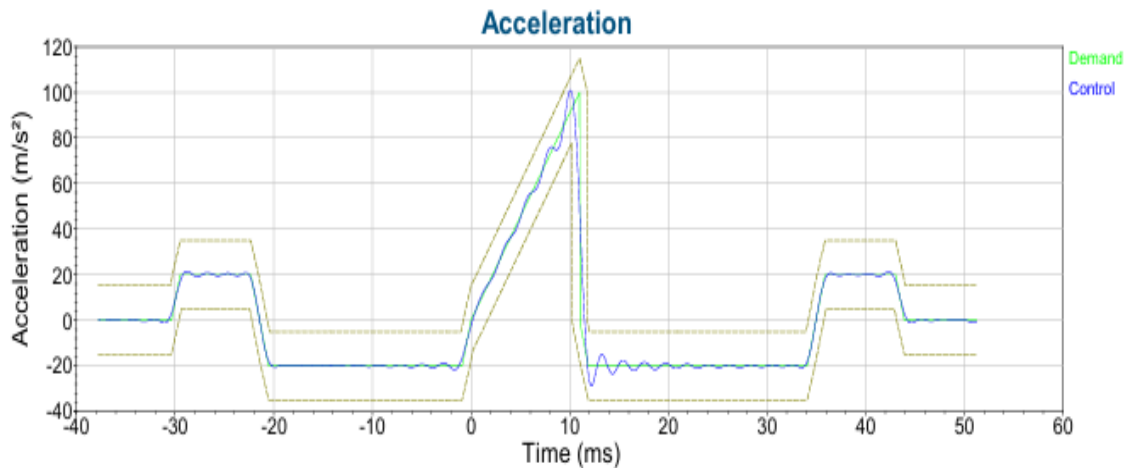
Mechanical Chock data +X Axis

Demand: 100 m/s<sup>2</sup>

Control: 100.8 m/s<sup>2</sup> Pulse: 10 of 10

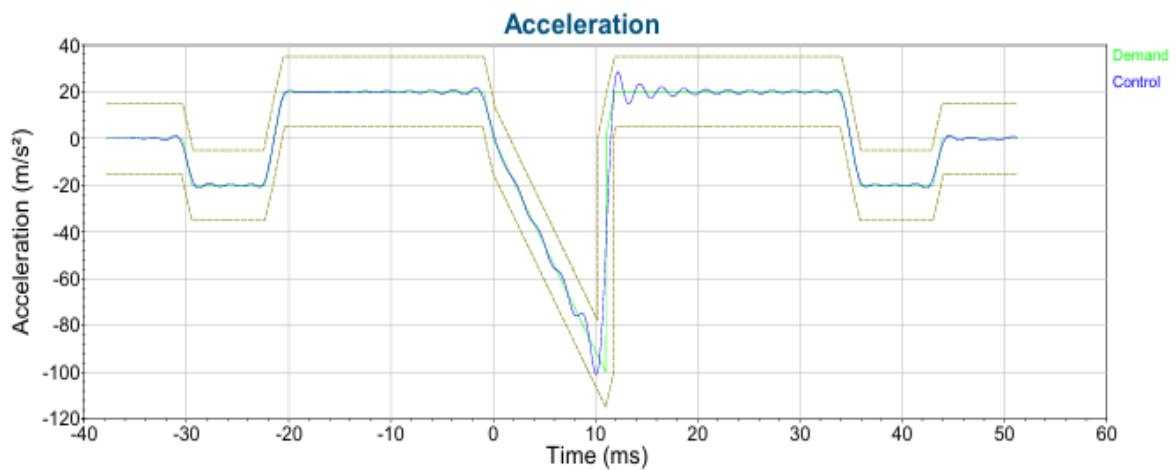
Mechanical Chock data -X Axis

Demand: 100 m/s<sup>2</sup>

Control: 101 m/s<sup>2</sup> Pulse: 10 of 10

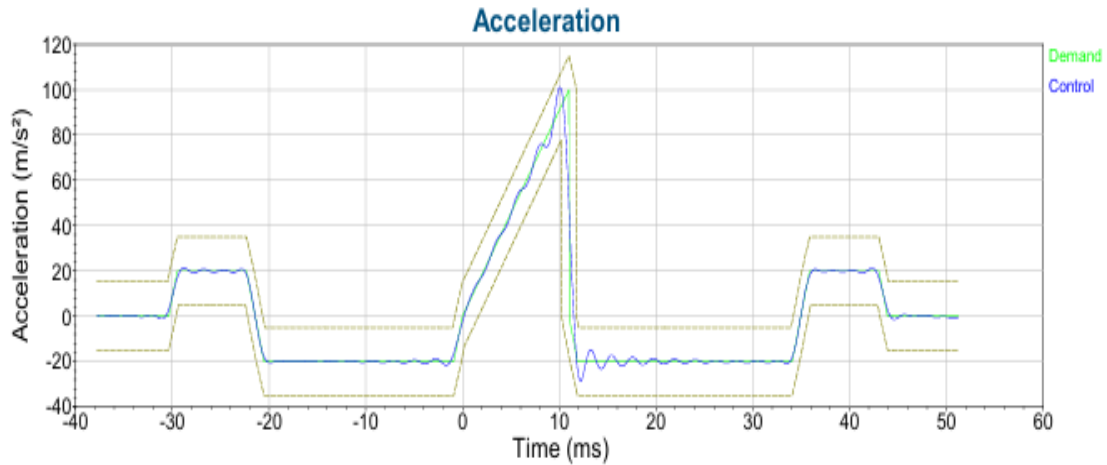
#### Mechanical Chock data +Y Axis

4 03, 2026 15:03:14 Level 1) 100 %  
Demand: 100 m/s<sup>2</sup>  
Control: 101 m/s<sup>2</sup> Pulse: 10 of 10

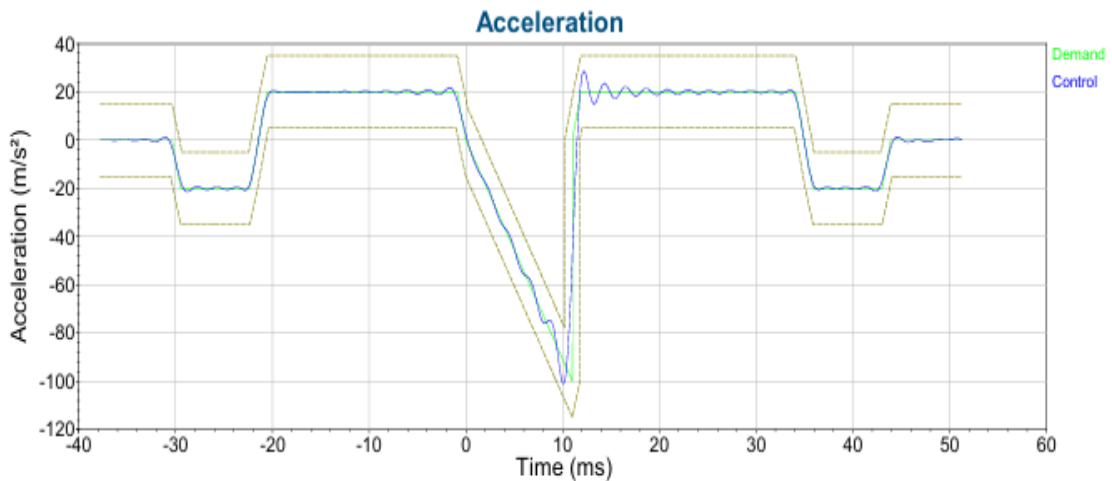
#### Mechanical Chock data -Y Axis

4 03, 2026 15:03:33 Level 2) 100 %  
Demand: 100 m/s<sup>2</sup>  
Control: 101 m/s<sup>2</sup> Pulse: 10 of 10

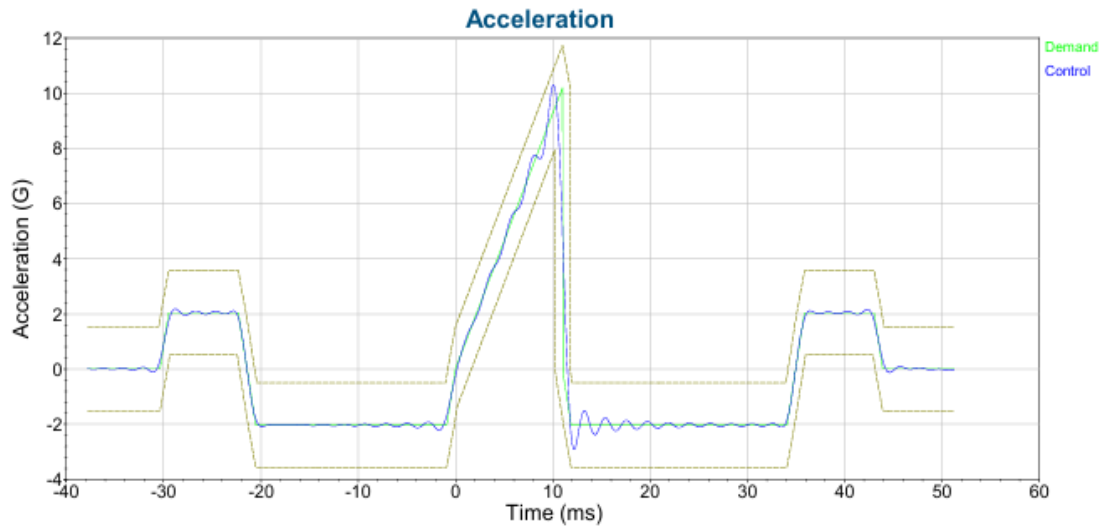
#### Mechanical Chock data +Z Axis

Demand: 10.2 G

Control: 10.29 G

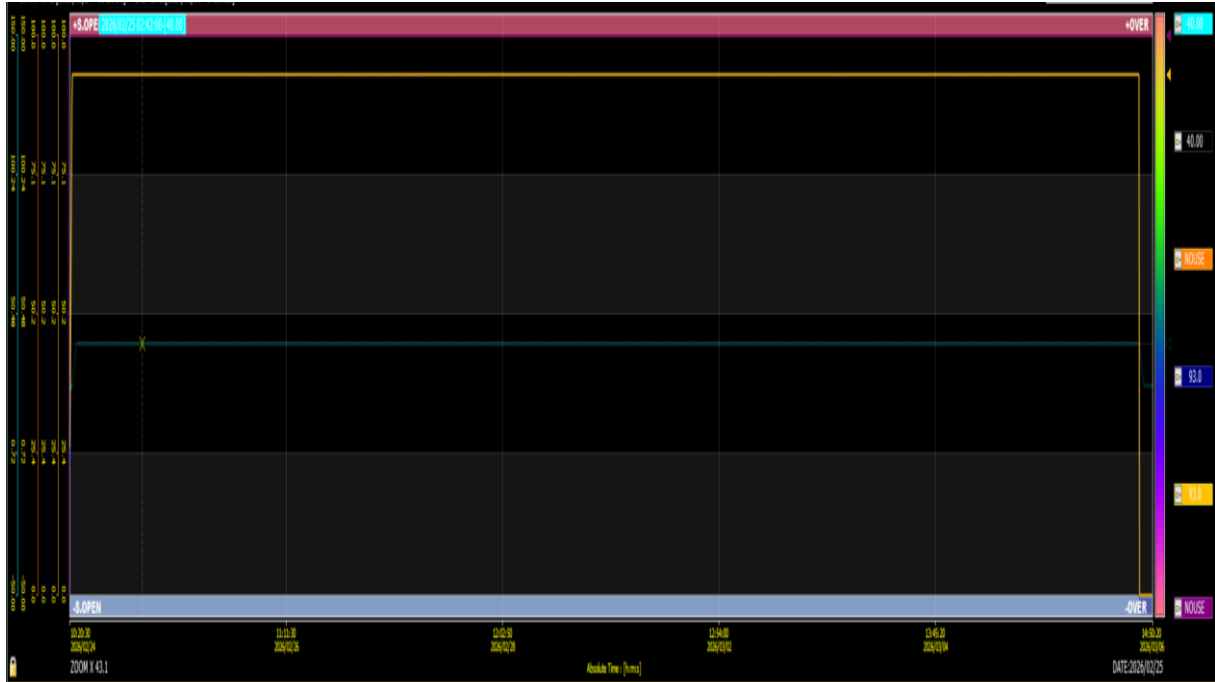
Temperature Data

### 8.5.1 Test data and graph
