# TEST REPORT

REPORT No.:  
CTK-2026-01029  
Page (1) / (31) pages

NETWORK THERMAL CAMERA / TNO-C4080T

NEMA TS-2:2021 2.2.7.3 Test C ~ 2.2.7.8 Test H,  
NEMA TS-2:2021 2.2.8, NEMA TS-2:2021 2.2.9  
Temperature: (25 ± 10) °C, Humidity: (50 ± 25) % R.H.

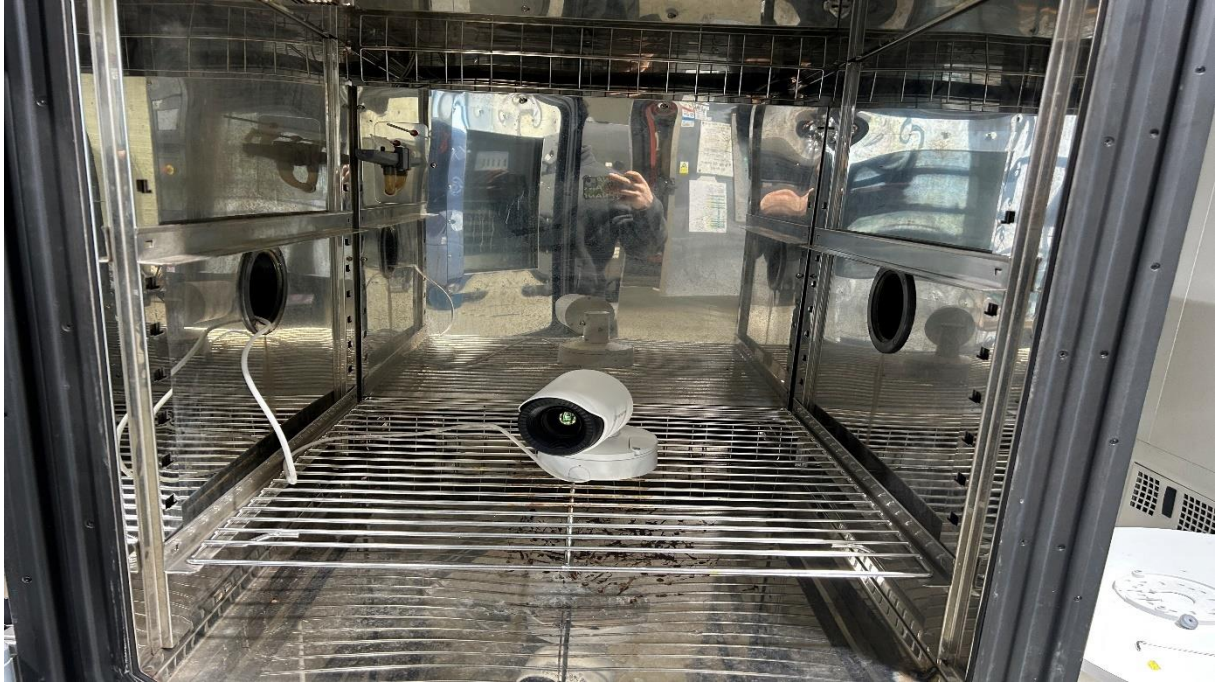
#### 3.9.1 Evidence of test setting
