# TEST REPORT

Security Camera / TNO-C9083ER

IEC 60529:1989 +A1:1999+A2:2013

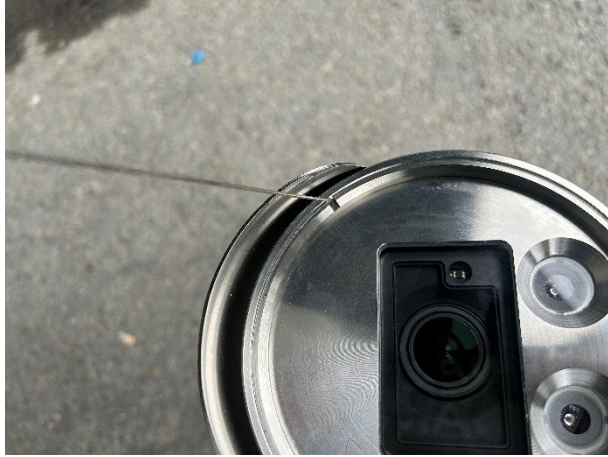
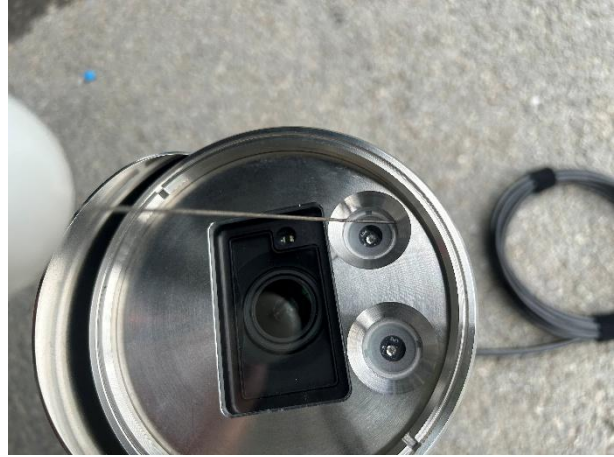
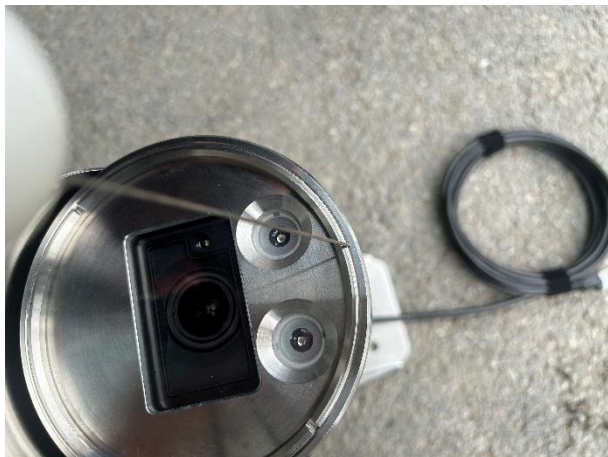
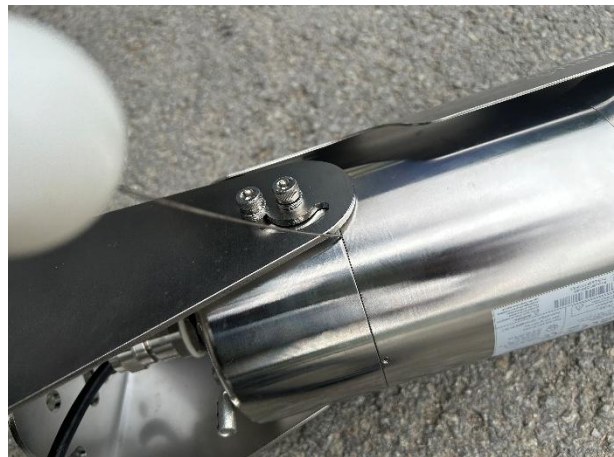
Probe test(1)

Probe test(2)

Probe test(3)

Probe test(4)

| First characteristic numeral | Degree of protection | Application |
|---|---|---|
| 6 | Protected against access to hazardous parts with a wire.<br>The access probe of 1.0 mmØ, shall not penetrate.<br>Test force: 1 N ± 10 % | <input checked="" type="checkbox"/> |

| IP code | Evaluation Criteria | Test Results | Remark |
|---|---|---|---|
| IP 6X | No ingress of Probe | Normal | - |

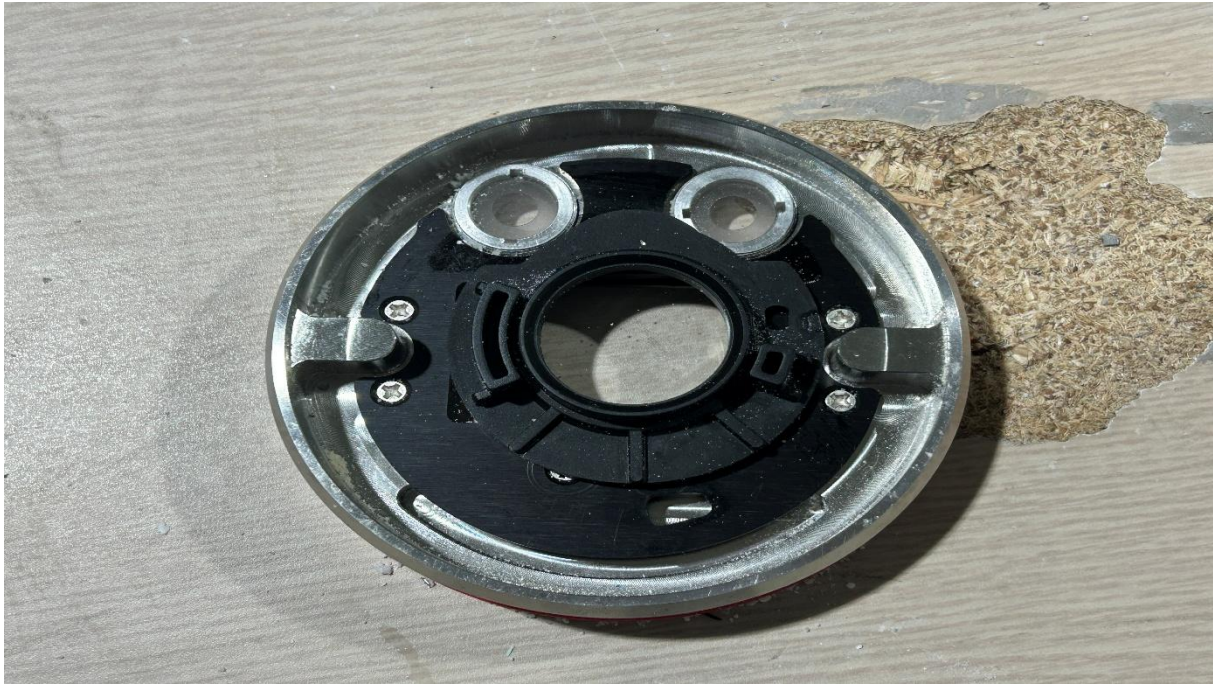
#### 3.5.1 Sample internal images after test [The first characteristic numeral test](1)

| IP code | Evaluation Criteria | Test Results | Remark |
|---|---|---|---|
| | No ingress of dust | Normal | - |

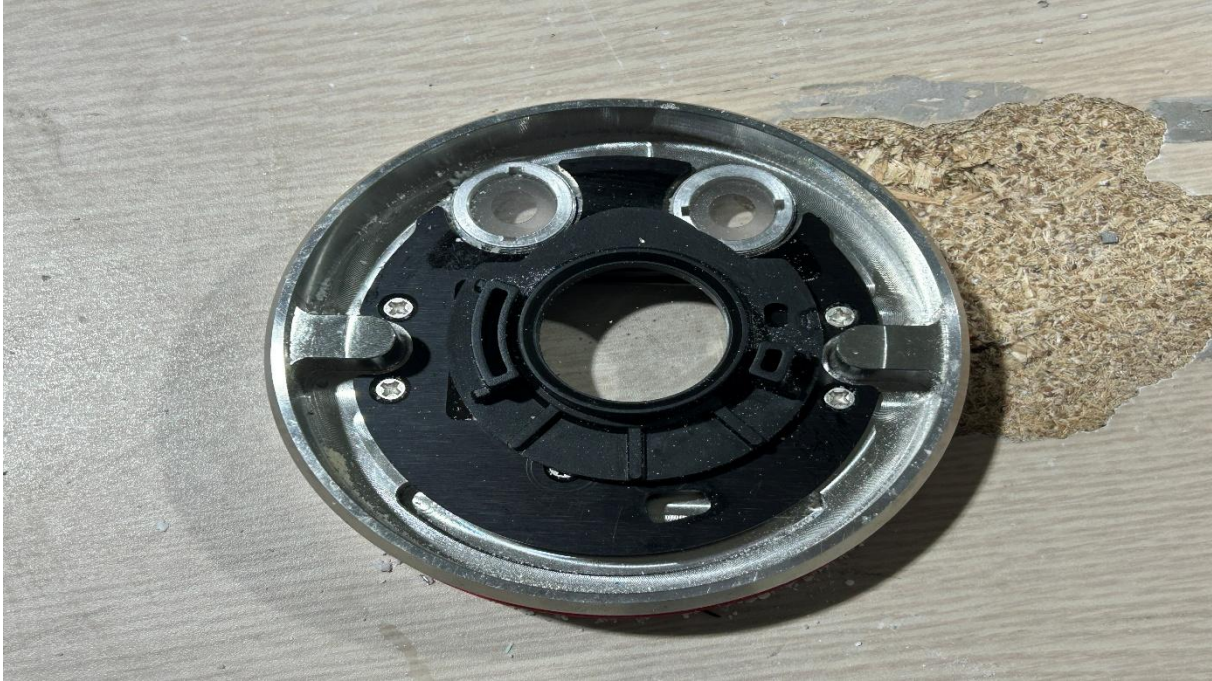
### 3.5.2 Sample internal images after test [The second characteristic numeral test](1)

| IP code | Evaluation Criteria | Test Results | Remark |
|---|---|---|---|
| IP X6 | No ingress of water | Normal | - |
