# TEST REPORT

REPORT No.:  
CTK-2025-01144  
Page (1) / (13) pages

NETWORK CAMERA / TNP-A9430RW

IEC 62262:2002+AMD1:2021

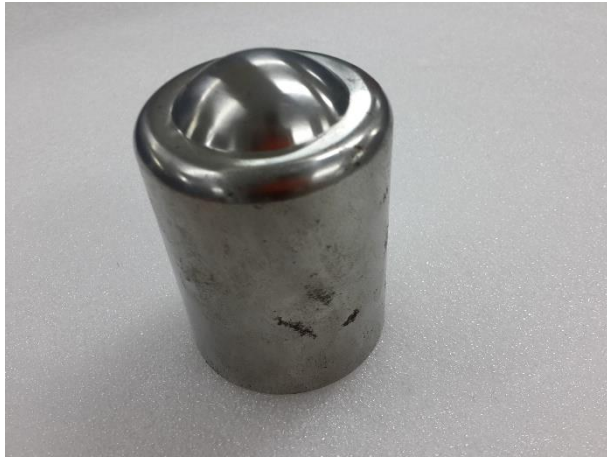
Vertical Hammer

| Testing equipment | Model Name | Manufacturer | Manufacturing Number | Next Cal. Date |
|---|---|---|---|---|
| Vertical Hammer | 5J | Kingpo | TX028-1 | - |

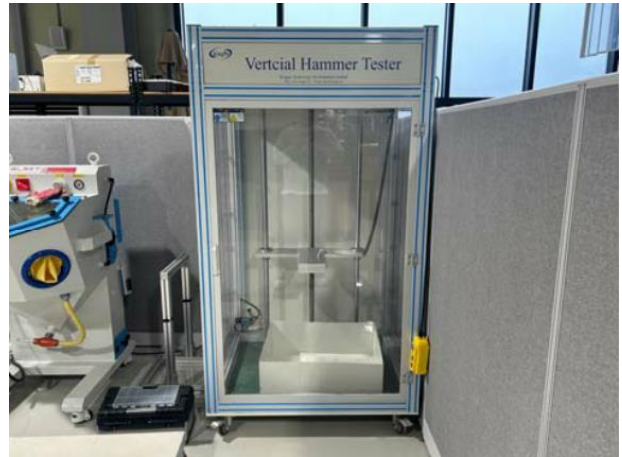
Vertical Hammer Tester

| Testing equipment | Model Name | Manufacturer | Manufacturing Number | Next Cal. Date |
|---|---|---|---|---|
| Vertical Hammer Tester | Vertical Hammer | Kingpo | 0190605A01002 | - |

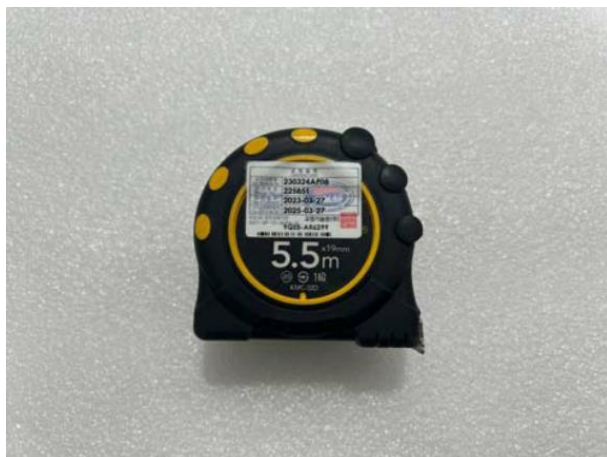
Steel measuring meter

| Testing equipment | Model Name | Manufacturer | Manufacturing Number | Next Cal. Date |
|---|---|---|---|---|
| Steel measuring meter | 5.5 m | KOMELON | 225851 | Jan. 16, 2026 |

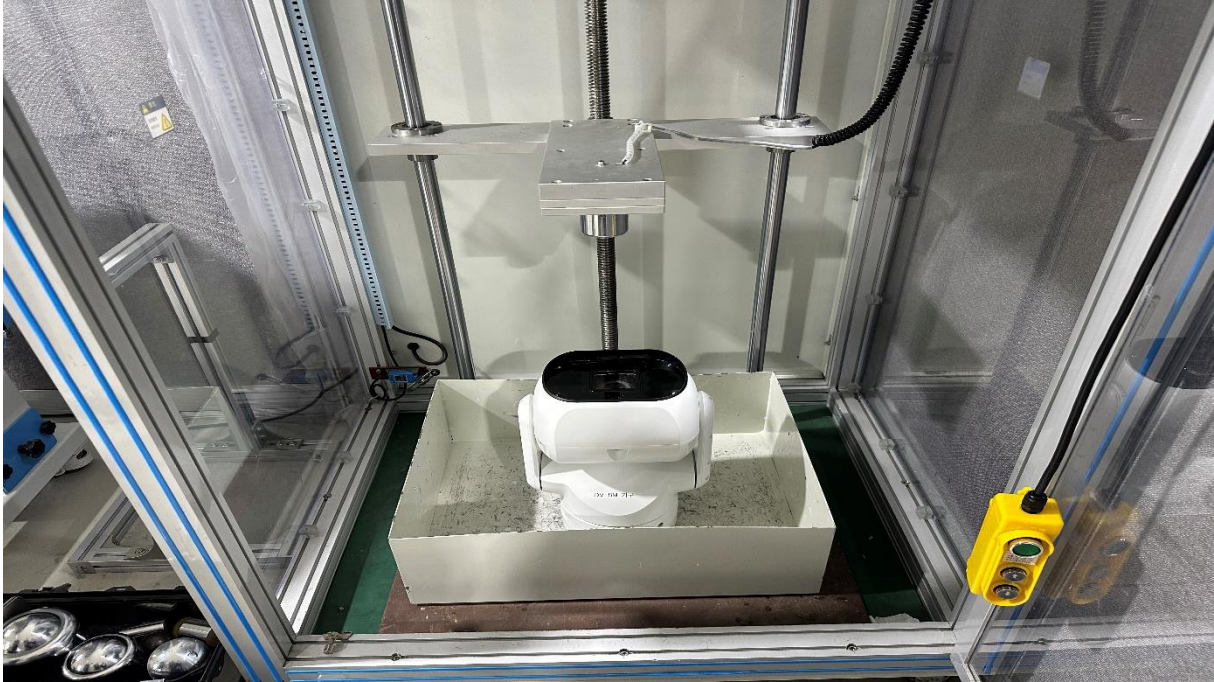
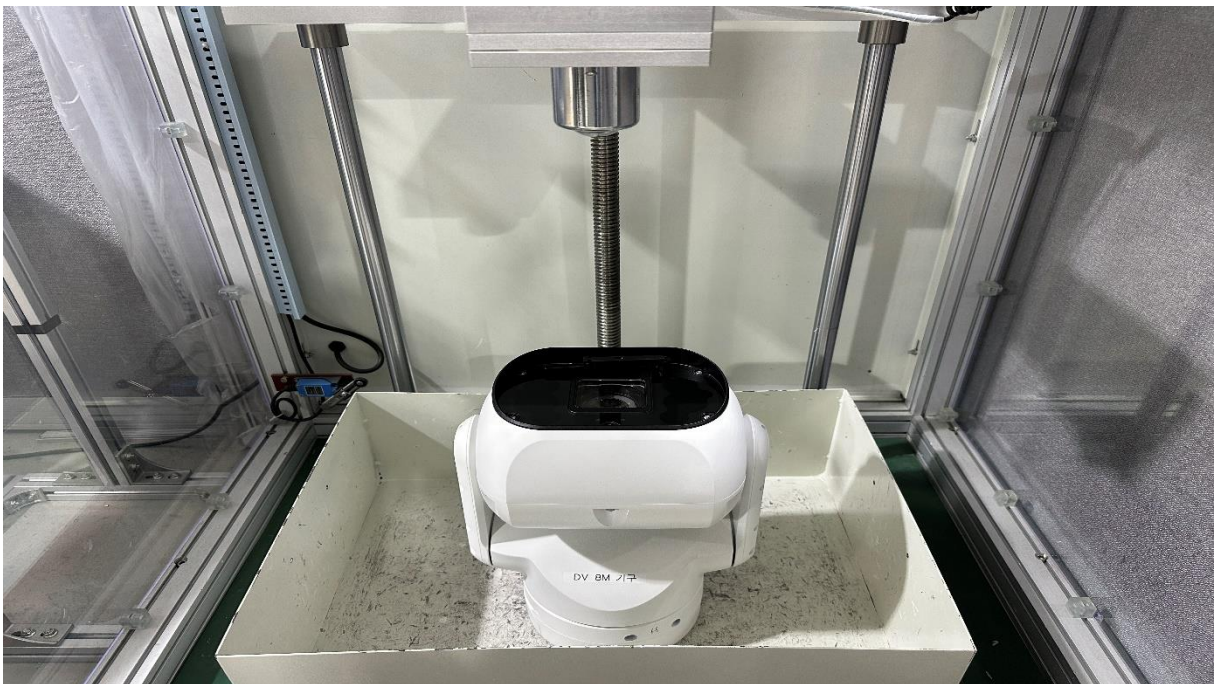
#### 3.3.1 Evidence of test setting

| IK code | Impact Energy (J) | Equivalent mass (kg) | Drop height (mm $\pm$ 1%) | Application |
|---|---|---|---|---|
| 08 | 5.00 | 1.70 | 300 | <input checked="" type="checkbox"/> |

Impact times: five times for each of the exposed surface. (Do not impact more than 3 times in the same spot)

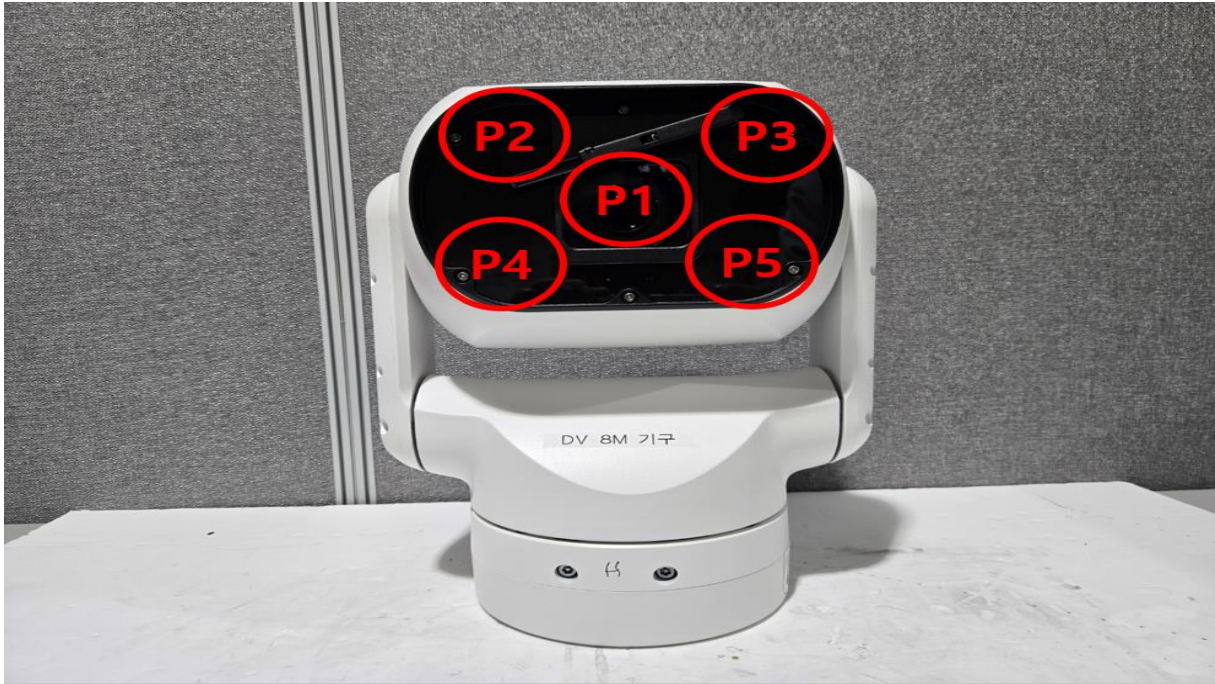
Check the hit area the test

| Evaluation Criteria | Test Results | Remark |
|---|---|---|
| Visual Inspection | Some scratches were generated on the outside of the product. | Impacted to the window part except the body part |
