# TEST REPORT

REPORT No.:  
CTK-2025-02415  
Page (1) / (15) pages

NETWORK CAMERA / TNP-A9430RW

IEC 60529:1989 +A1:1999+A2:2013

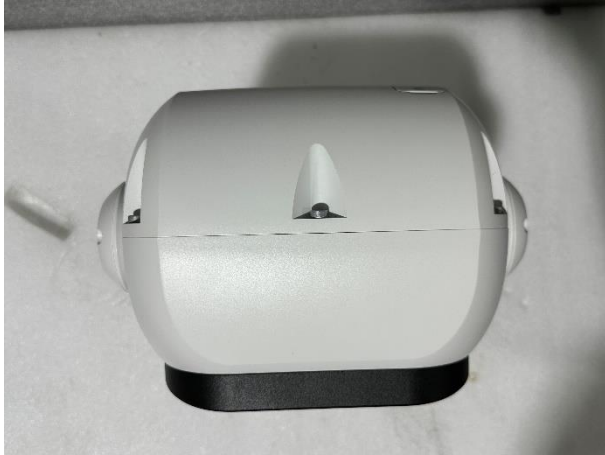
Top

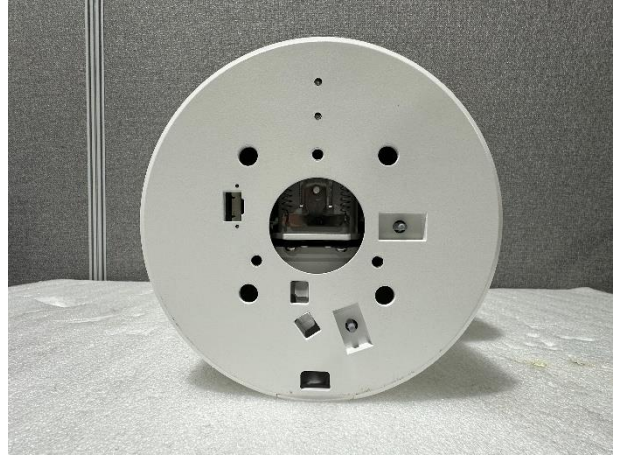
Bottom

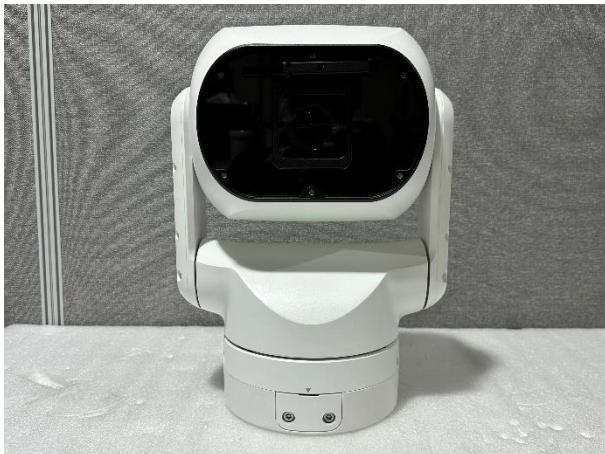
Front

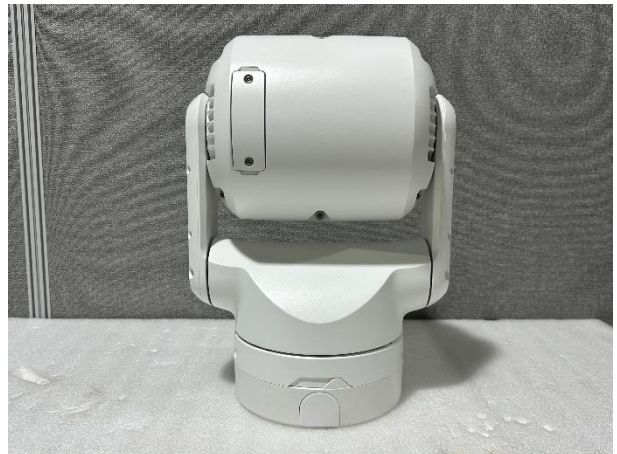
Rear

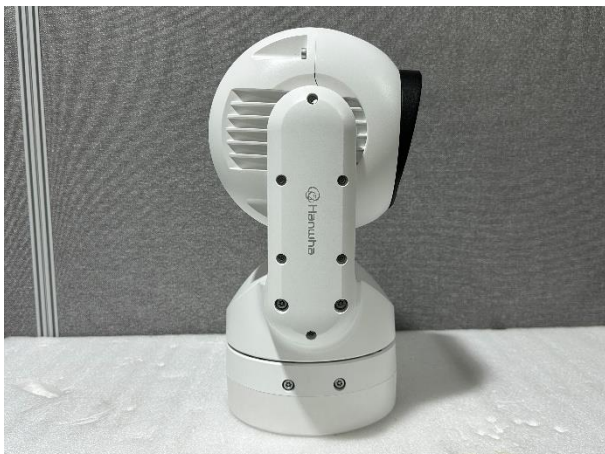
Left side

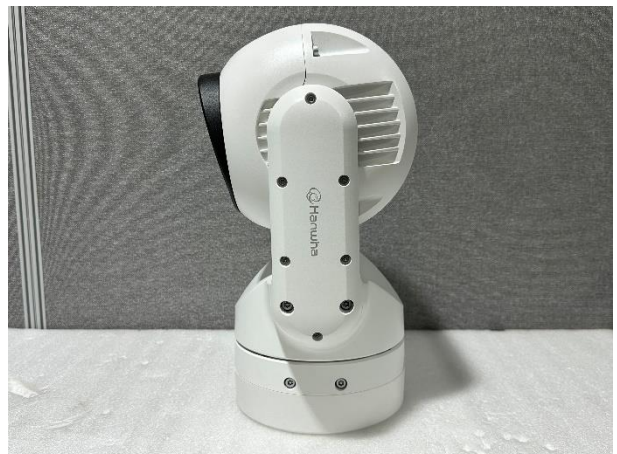
Right side

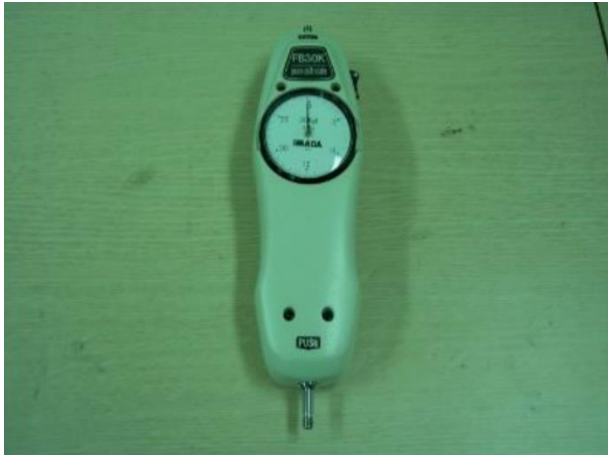
Push Pull Gage

| Testing equipment | Model Name | Manufacturer | Manufacturing Number | Next Cal. Date |
|---|---|---|---|---|
| Push Pull Gage | FB30K | Imada | 83805 | Jan. 16, 2026 |

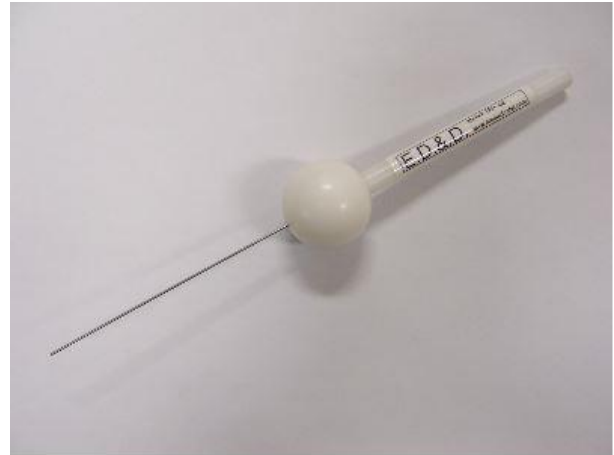
Test Rod Probe Ø1.0

| Testing equipment | Model Name | Manufacturer | Manufacturing Number | Next Cal. Date |
|---|---|---|---|---|
| Test Rod Probe Ø1.0 | TRP-02 | ED&D | S1-J15 | May. 16, 2027 |

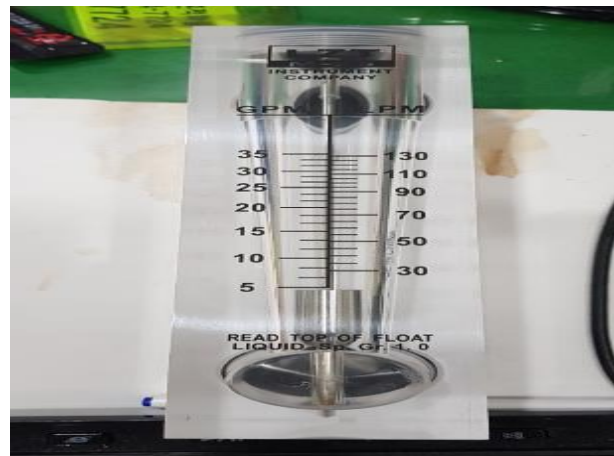
Water flow meter with IPX6

| Testing equipment | Model Name | Manufacturer | Manufacturing Number | Next Cal. Date |
|---|---|---|---|---|
| Water flow meter with IPX6 | M-25 | LZT | 1903 | Feb. 17, 2026 |

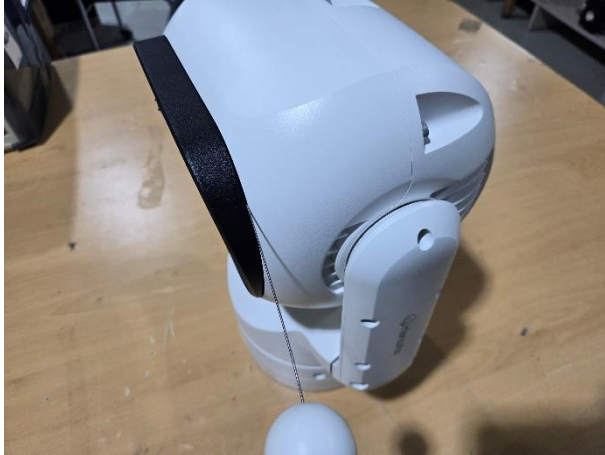
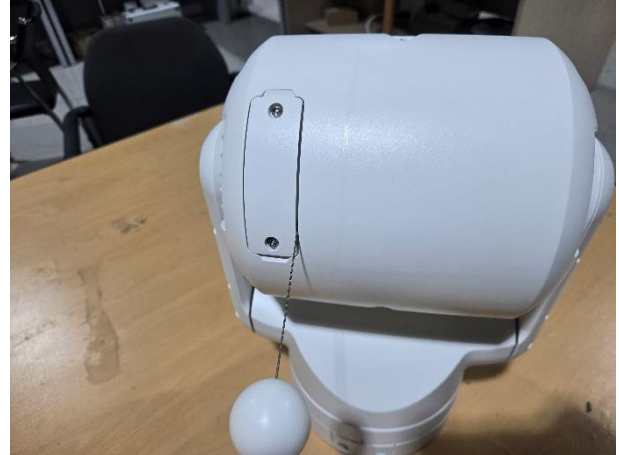
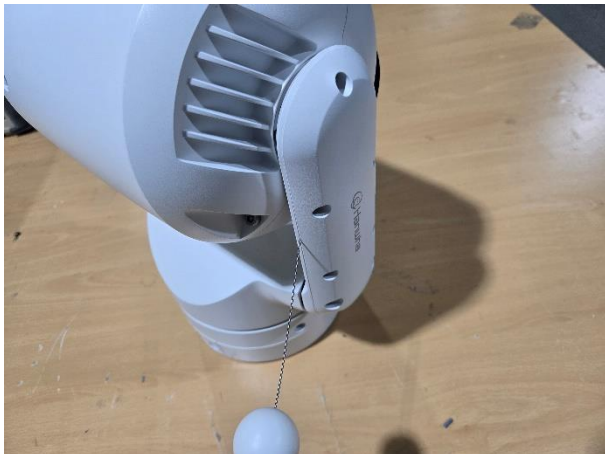
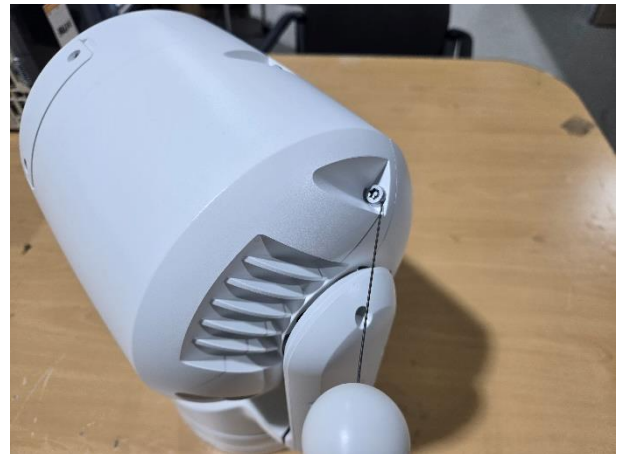
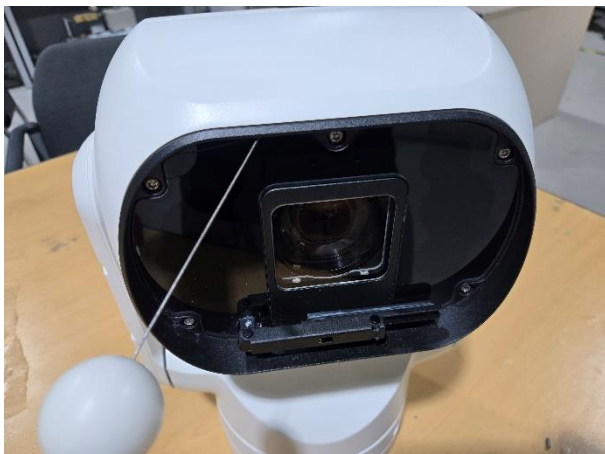
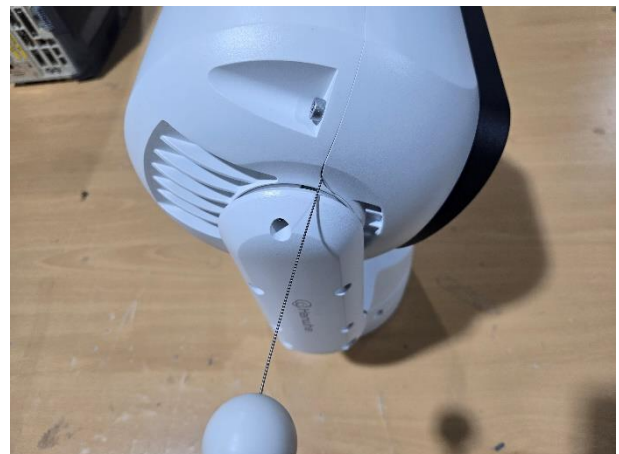
Probe test

| First characteristic numeral | Degree of protection | Application |
|---|---|---|
| 6 | Protected against access to hazardous parts with a wire.<br>The access probe of 1.0 mmØ, shall not penetrate.<br>Test force: 1 N ± 10 % | <input checked="" type="checkbox"/> |

| IP code | Evaluation Criteria | Test Results | Remark |
|---|---|---|---|
| IP 6X | No ingress of Probe | Normal | - |

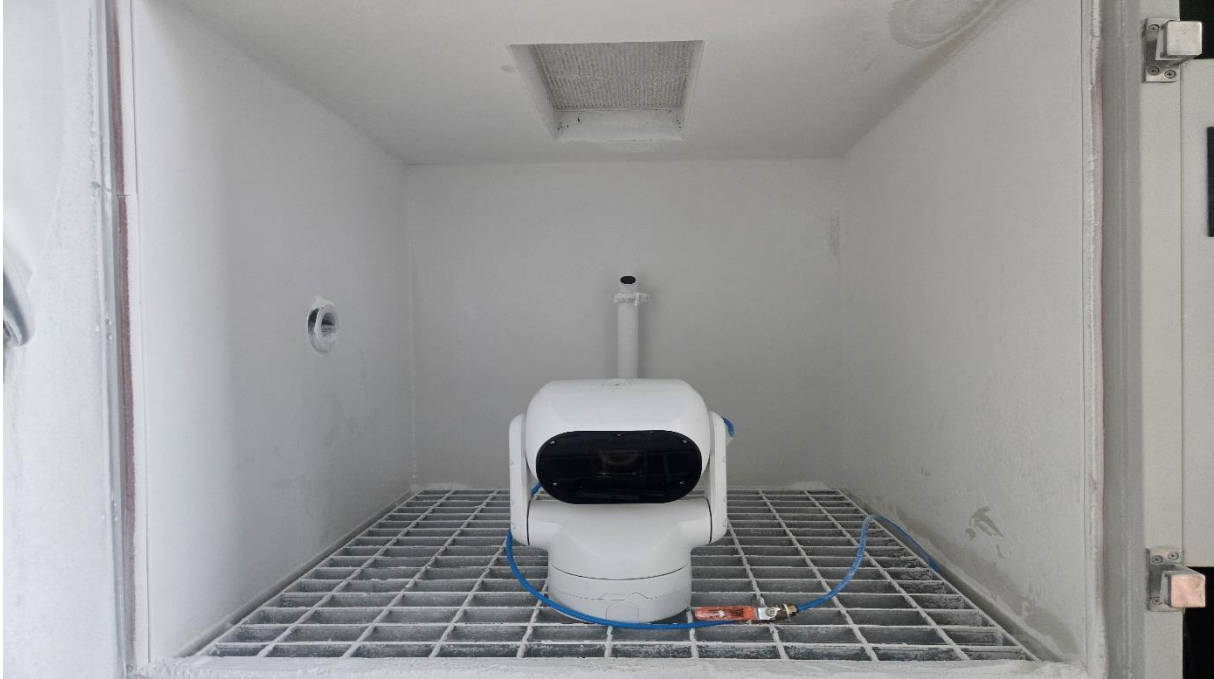
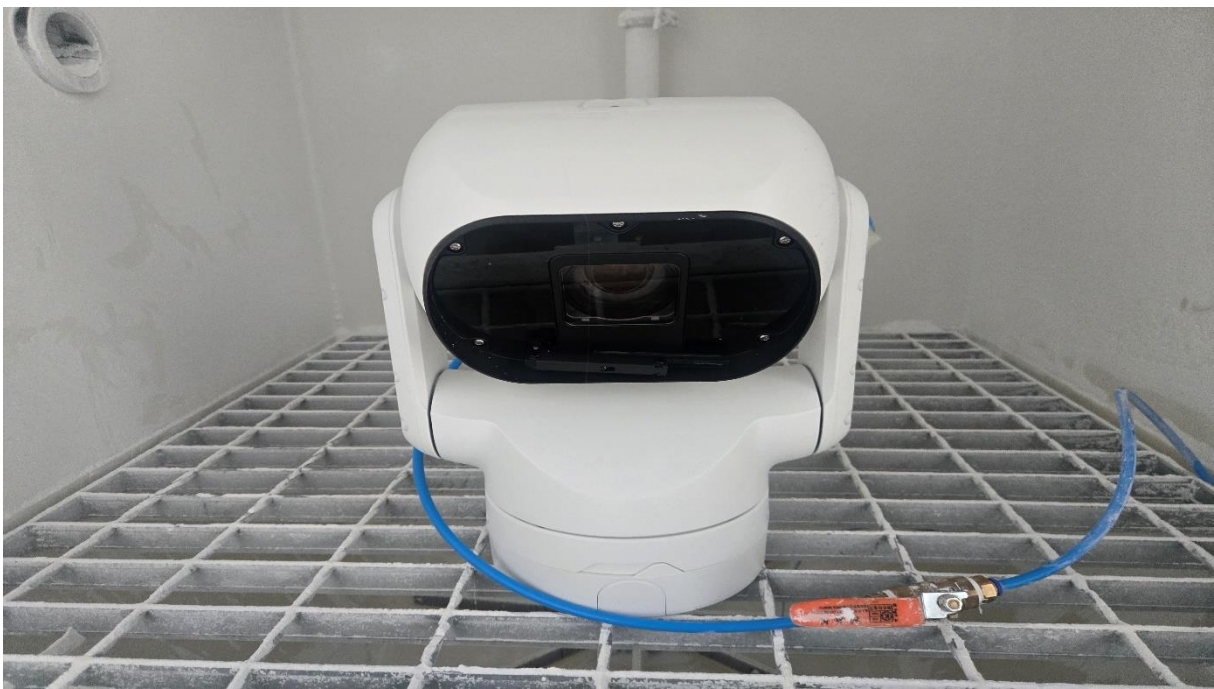
Dust test

| First characteristic numeral | Degree of protection | Application |
|---|---|---|
| 6 | <p>In Dust Testing Equipment, the test sample must have no ingress of dust after testing atmospheric pressure present condition for 8 h.</p> <p>(The talcum powder must pass through a calibrated sieve with a 50 µm wire mesh, spaced at 75 µm intervals in a square pattern. Additionally, the bulk density of the talcum powder should be 2 kg/m<sup>3</sup>)</p> <p>Products in volume .....: <b>24 122.733 cm<sup>3</sup> → 24.122 L</b></p> <p>Target intake volume (Products in volume 80) : <b>1 929.818 L</b></p> <p>Suction volume (Max product in volume 60) ...: <b>1 447.363 LPH → 24.122 LPM</b></p> <p>Actual Suction volume .....: <b>24.012 L</b></p> <p>Suction pressure (Up to 2 kPa) .....: <b>2 kPa</b></p> <p>Test time (Up to 8 time) .....: <b>8 시간</b></p> | <input checked="" type="checkbox"/> |

| IP code | Evaluation Criteria | Test Results | Remark |
|---|---|---|---|
| | No ingress of dust | Normal | |

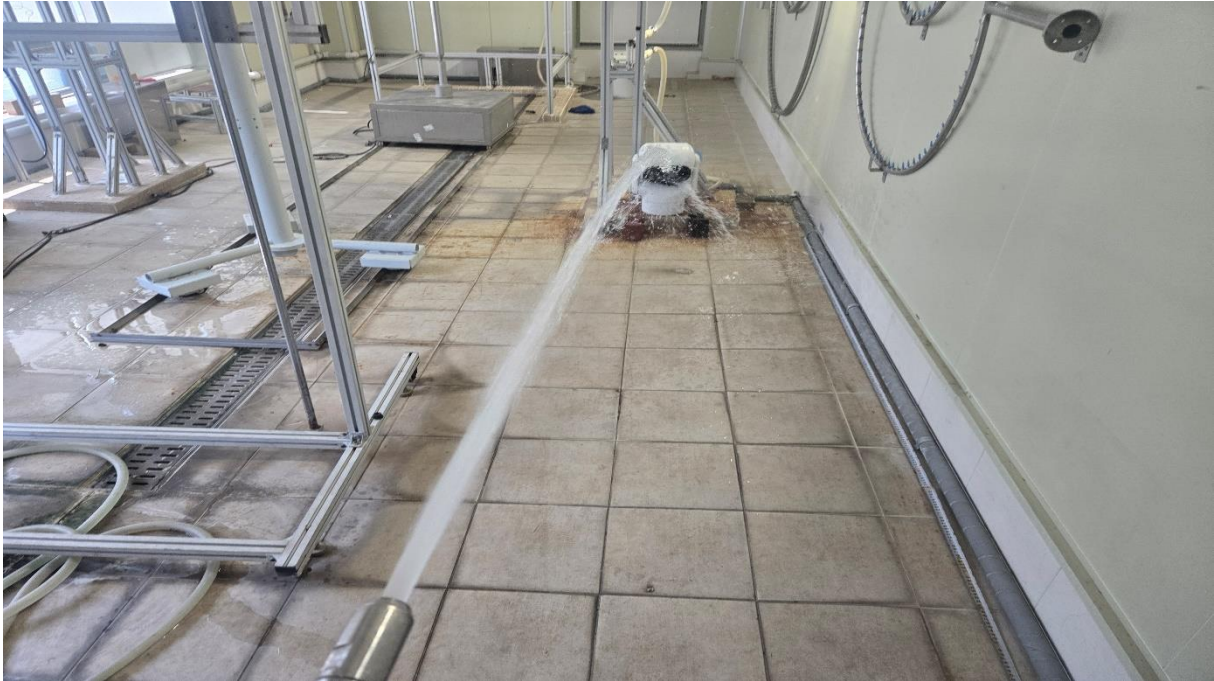
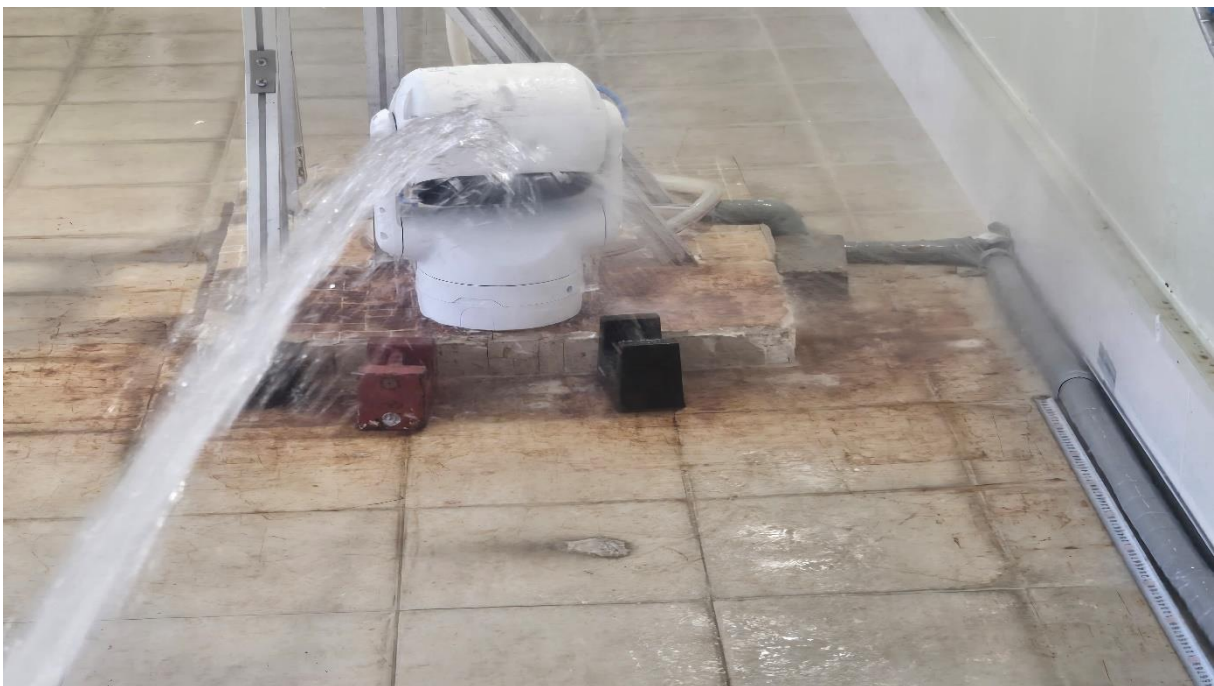
Water test

| Second characteristic numeral | Degrees of protection | Application |
|---|---|---|
| 6 | <p>The product must not be harmed in any direction even strong jet water.</p> <p>Water jet hose nozzle Fig.6, Nozzle 12.5 mm diameter</p> <p>Water flow rate: 100 l/min ± 5 % : <b>100 LPM</b></p> <p>Distance: 2.5 m to 3 m: <b>3 m</b></p> <p>Duration of test: 1 min/m<sup>2</sup> at least 3 min: <b>3 min</b></p> | <input checked="" type="checkbox"/> |

| IP code | Evaluation Criteria | Test Results | Remark |
|---|---|---|---|
| IP X6 | No ingress of water | Normal | |

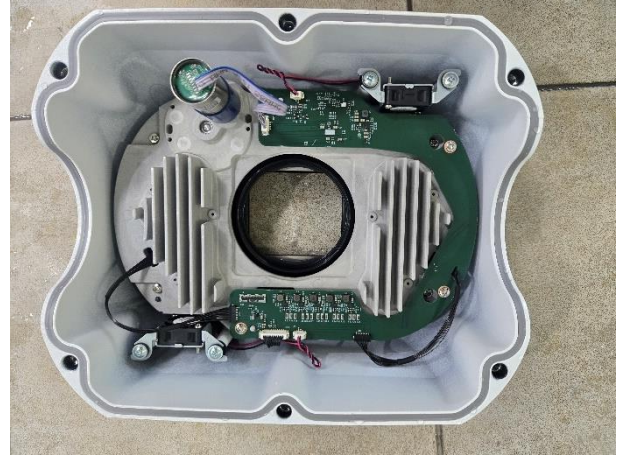
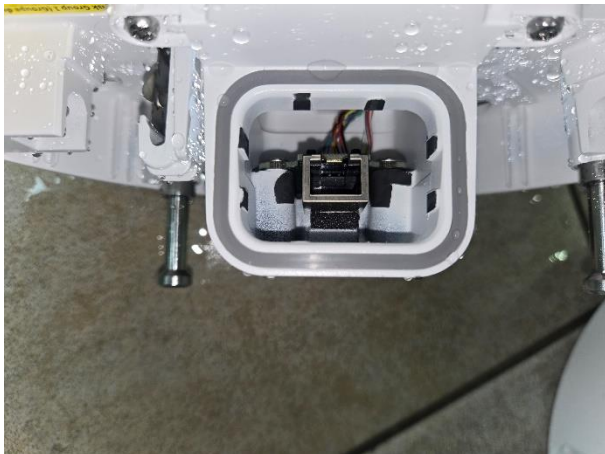
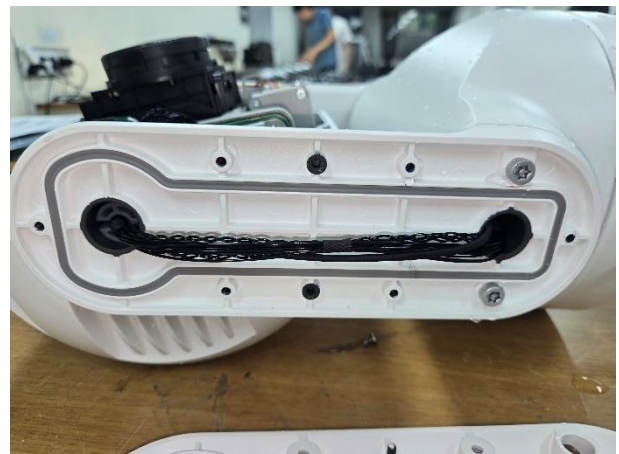
#### 3.5.1 Product internal images after test [The first characteristic numeral test]

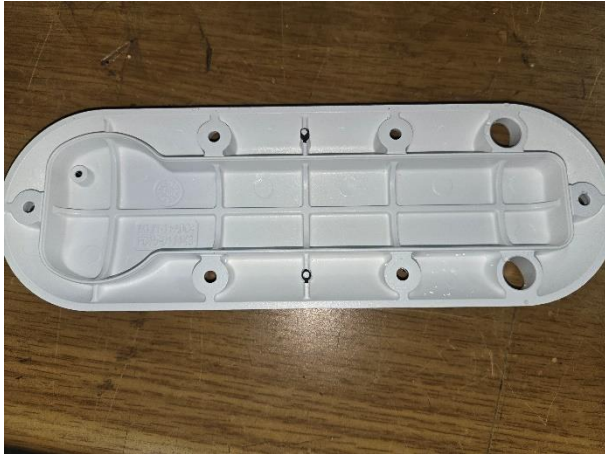
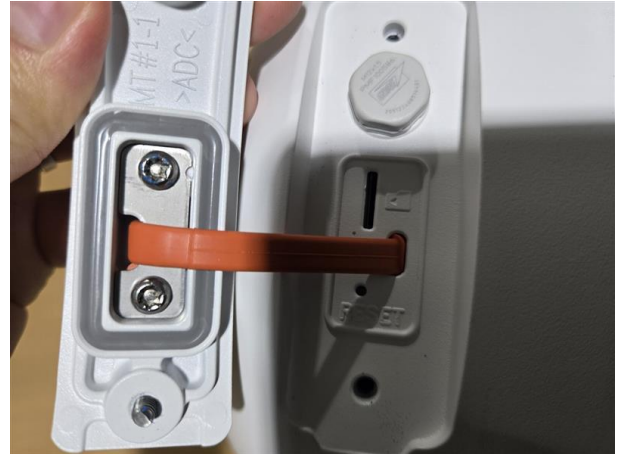
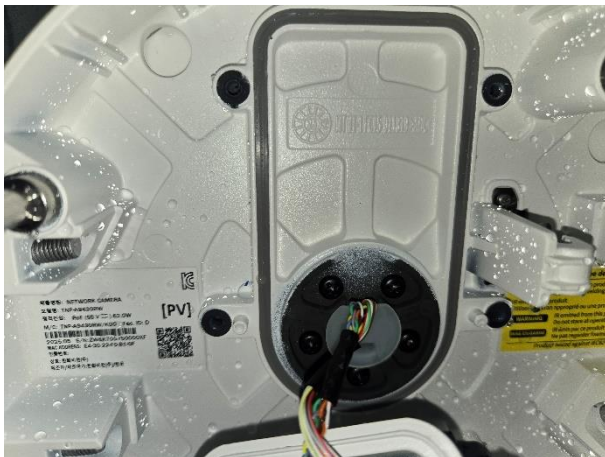
### 3.5.2 Product internal images after test [The first, second characteristic numeral test]
