# TEST REPORT

REPORT No.:  
CTK-2025-01508  
Page (1) / (14) pages

BARCODE READER / TNS-7000M

IEC 60529:1989 +A1:1999+A2:2013

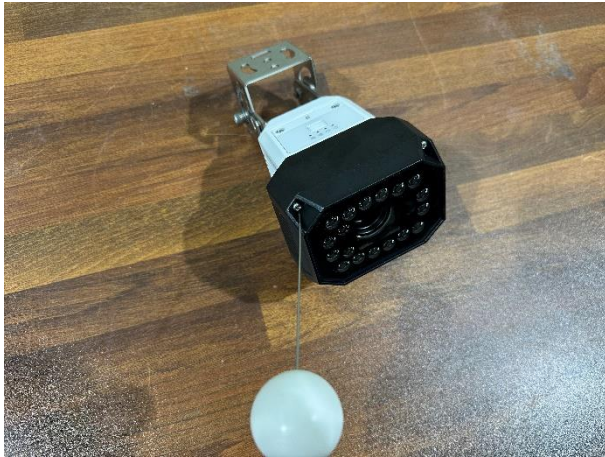
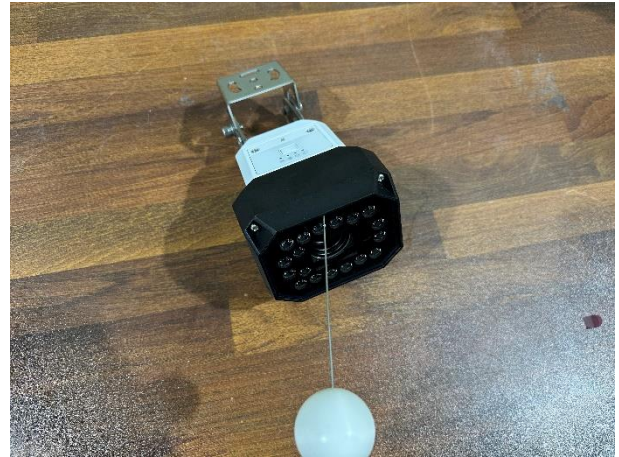
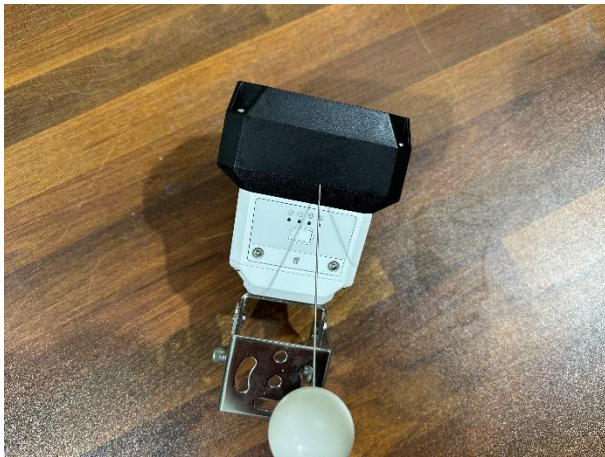
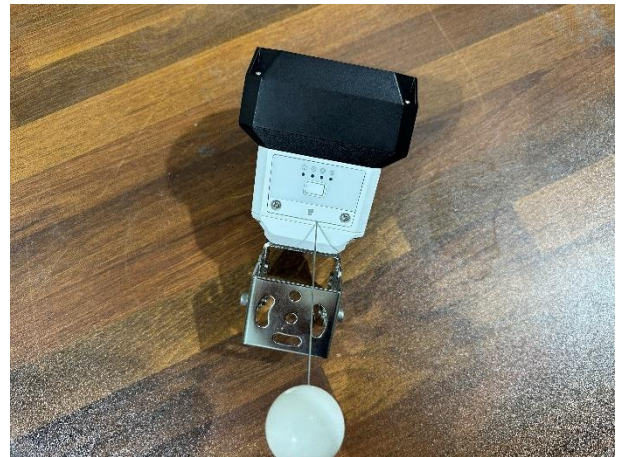
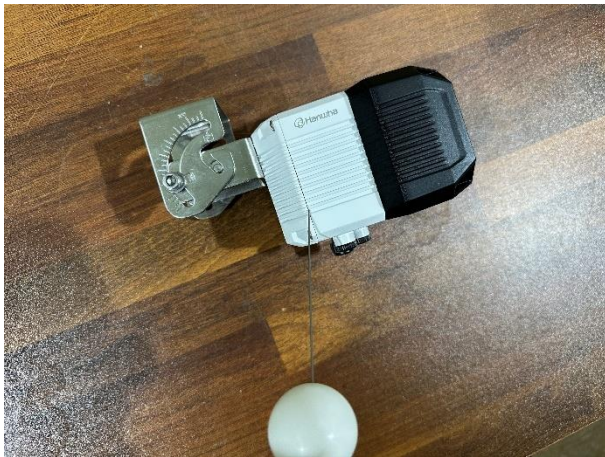
#### 3.3.1 Evidence of test setting (1)

| First characteristic numeral | Degree of protection | Application |
|---|---|---|
| 6 | Protected against access to hazardous parts with a wire.<br>The access probe of 1.0 mmØ, shall not penetrate.<br>Test force: 1 N ± 10 % | <input checked="" type="checkbox"/> |

Probe test

| IP code | Evaluation Criteria | Test Results | Remark |
|---|---|---|---|
| IP 6X | No ingress of Probe | Normal | - |

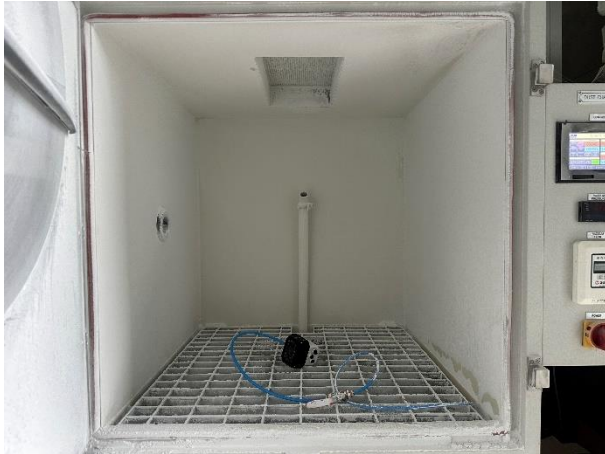
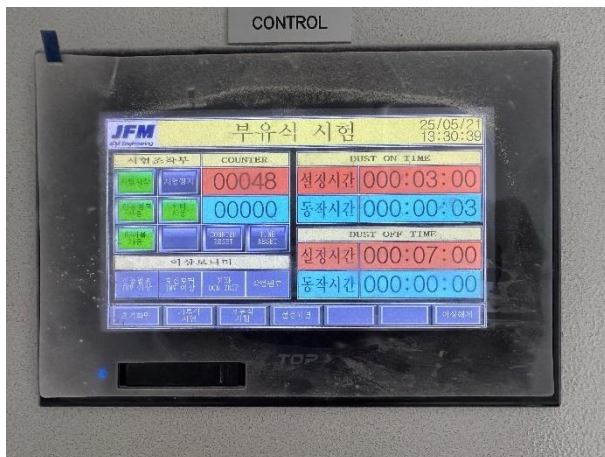
### 3.3.2 Evidence of test setting (2)

| First characteristic numeral | Degree of protection | Application |
|---|---|---|
| 6 | <p>In Dust Testing Equipment, the test sample must have no ingress of dust after testing atmospheric pressure present condition for 8 h.</p> <p>(The talcum powder must pass through a calibrated sieve with a 50 µm wire mesh, spaced at 75 µm intervals in a square pattern. Additionally, the bulk density of the talcum powder should be 2 kg/m<sup>3</sup>)</p> <p>Products in volume .....: <b>451.8 cm<sup>3</sup> → 0.451 L</b></p> <p>Target intake volume (Products in volume 80) : <b>36.1 L</b></p> <p>Suction volume (Max product in volume 60) ...: <b>27.10 LPH → 0.45 LPM</b></p> <p>Actual Suction volume .....: <b>0.41 L</b></p> <p>Suction pressure (Up to 2 kPa) .....: <b>1.85 kPa</b></p> <p>Test time (Up to 8 time) .....: <b>8 hr</b></p> | <input checked="" type="checkbox"/> |

Dust test

Dust test Monitor

Digital Vacuum Pressure

| IP code | Evaluation Criteria | Test Results | Remark |
|---|---|---|---|
| | No ingress of dust | Normal | - |

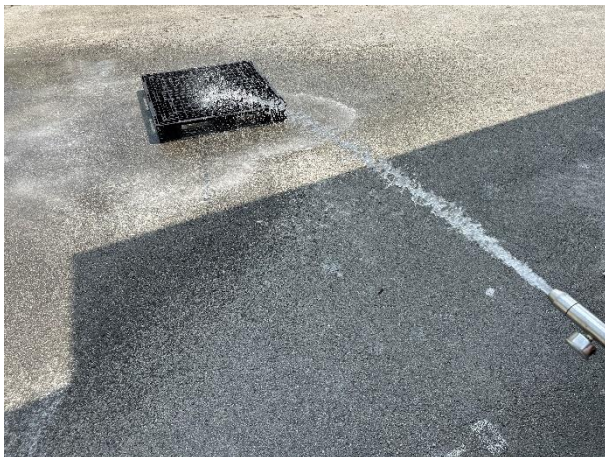
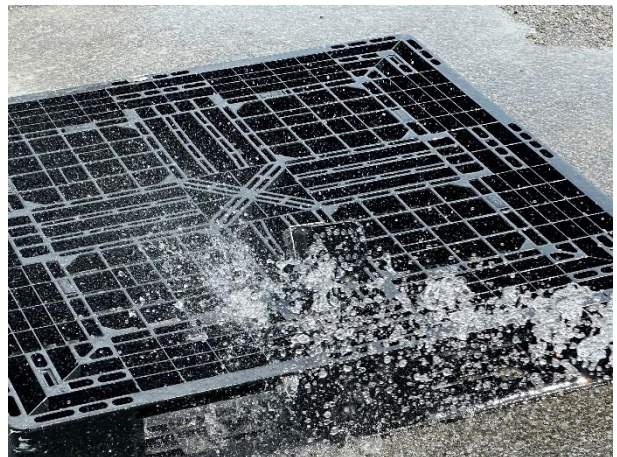
| Second characteristic numeral | Degrees of protection | Application |
|---|---|---|
| 6 | <p>The product must not be harmed in any direction even strong jet water.</p> <p>Water jet hose nozzle Fig.6, Nozzle 12.5 mm diameter</p> <p>Water flow rate: 100 l/min ± 5 % : <b>100 LPM</b></p> <p>Distance: 2.5 m to 3 m: <b>3 m</b></p> <p>Duration of test: 1 min/m<sup>2</sup> at least 3 min: <b>3 min</b></p> | <input checked="" type="checkbox"/> |

Water test

| IP code | Evaluation Criteria | Test Results | Remark |
|---|---|---|---|
| IP X6 | No ingress of water | Normal | - |
