# TEST REPORT

REPORT No.:  
CTK-2025-02582  
Page (1) / (13) pages

NETWORK CAMERA / XNF-A9014R

IEC 60529:1989 +A1:1999+A2:2013

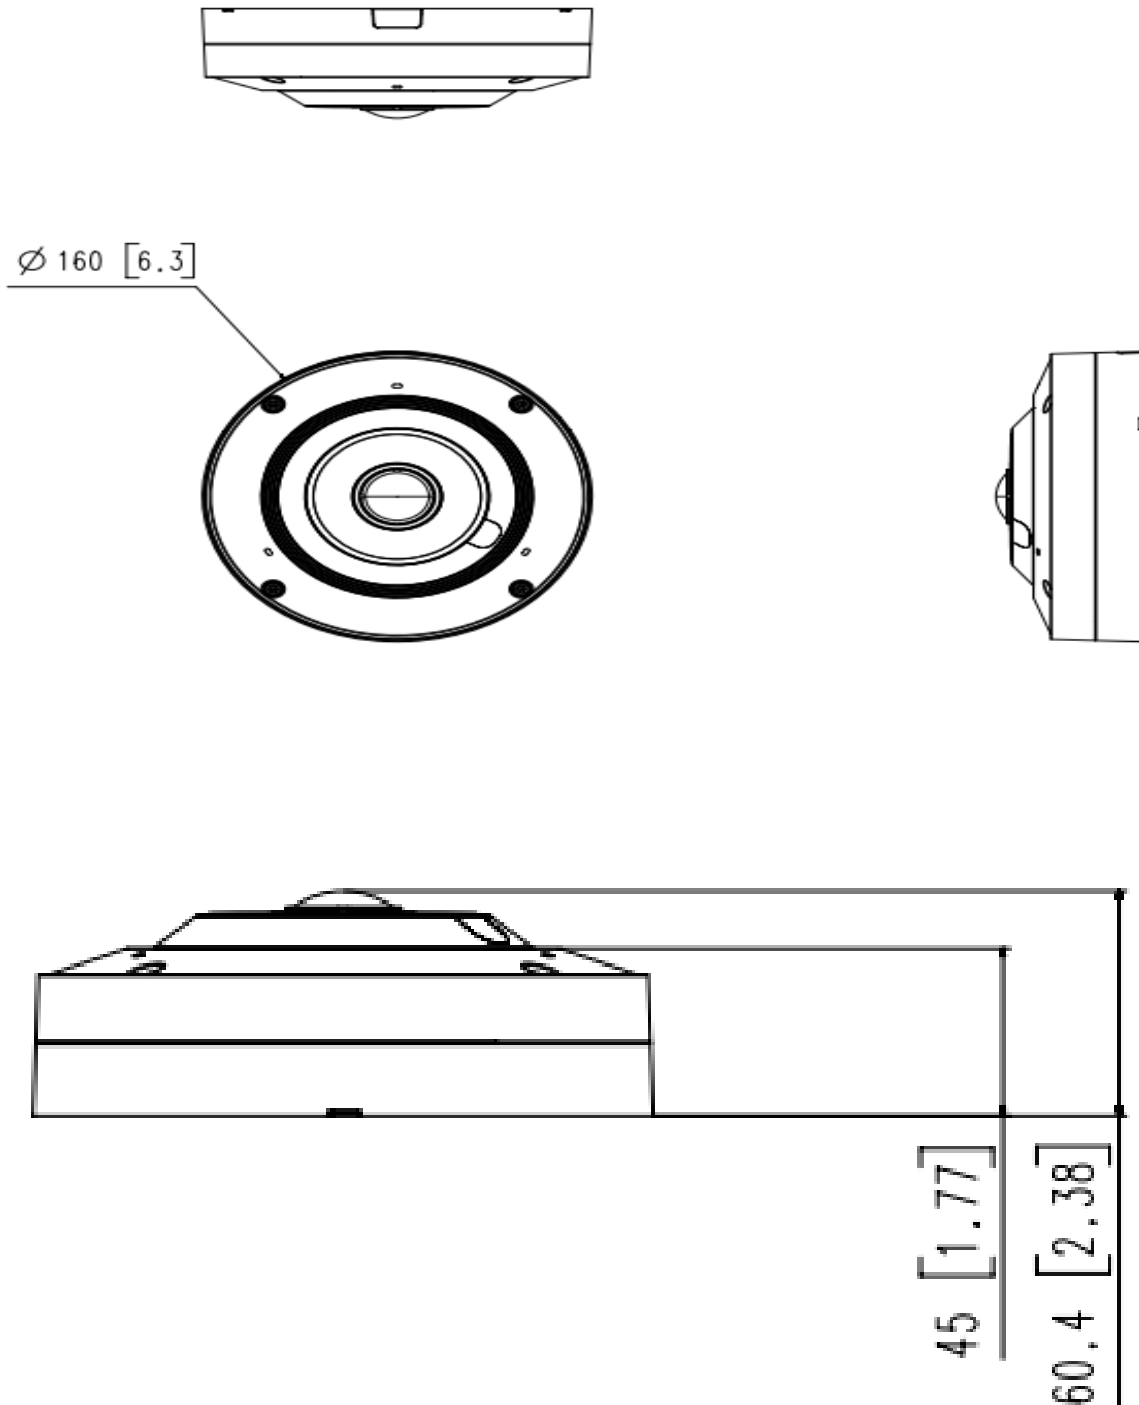
Enclosure dimensions [unit : mm]

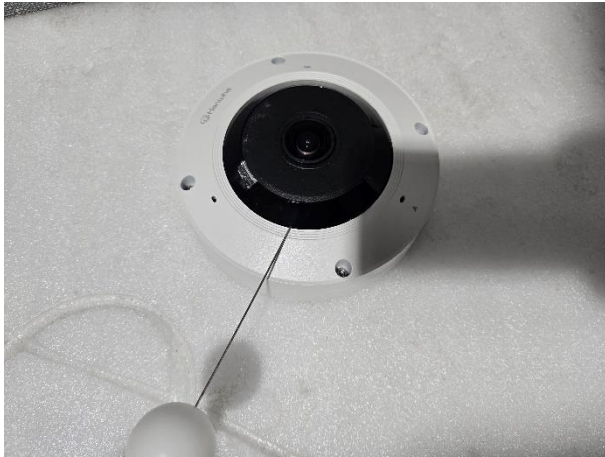
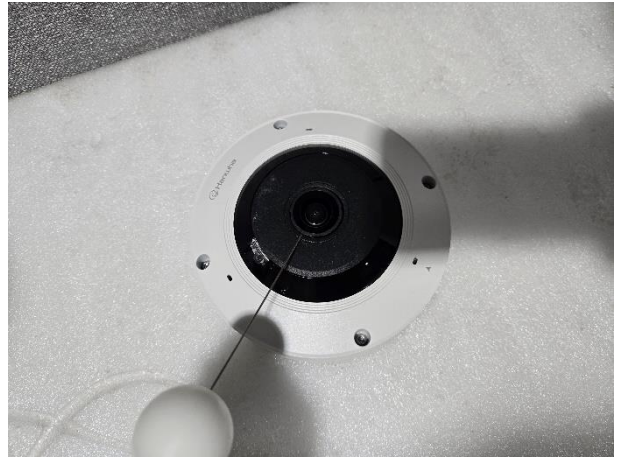
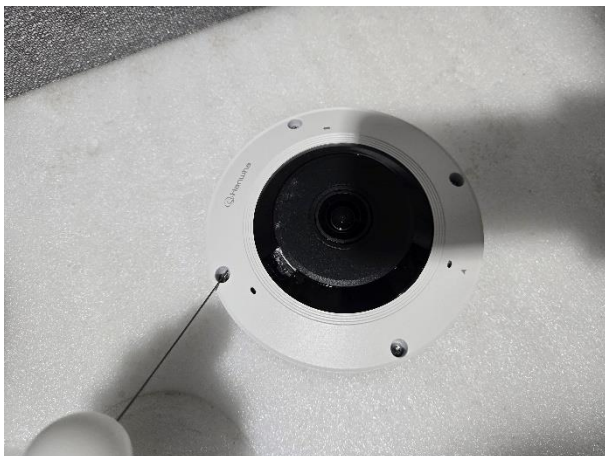
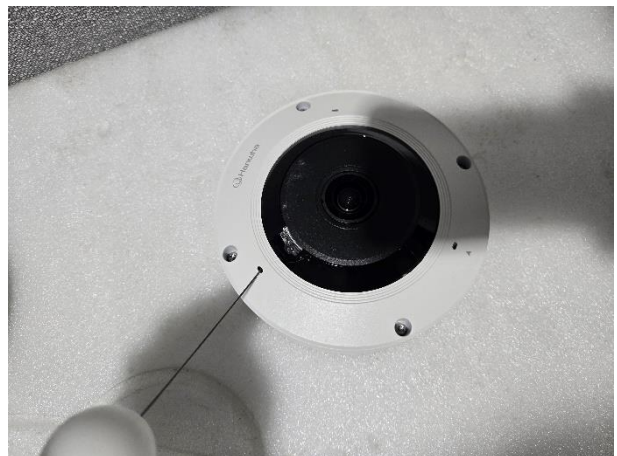
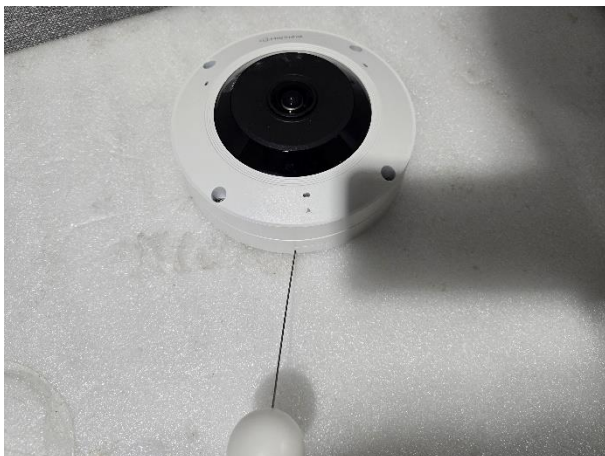
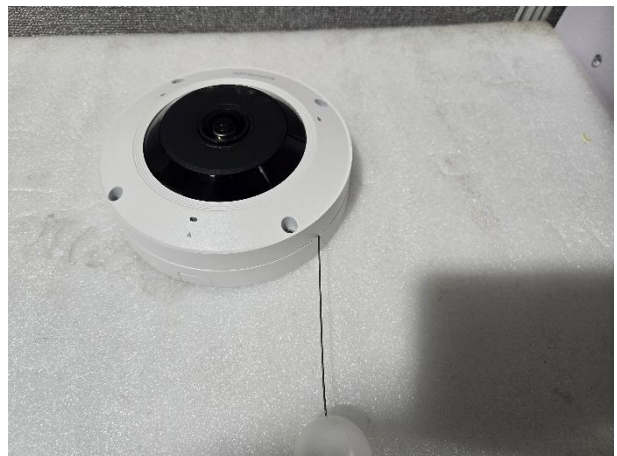
#### 3.3.1 Evidence of test setting (1)

| First characteristic numeral | Degree of protection | Application |
|---|---|---|
| 4 | Protected against access to hazardous parts with a wire.<br>The access probe of 1.0 mmØ, shall not penetrate.<br>Test force: 1 N ± 10 % | <input checked="" type="checkbox"/> |

| First characteristic numeral | Degree of protection | Application |
|---|---|---|
| 4 | Protected against solid foreign objects of 1.0 mmØ and greater.<br>The object probe, sphere of 1.0 mmØ, shall not penetrate at all <sup>1)</sup> .<br>Test force: 1 N ± 10 % | <input checked="" type="checkbox"/> |

Probe test

| IP code | Evaluation Criteria | Test Results | Remark |
|---|---|---|---|
| IP 4X | No ingress of Probe | Normal | - |

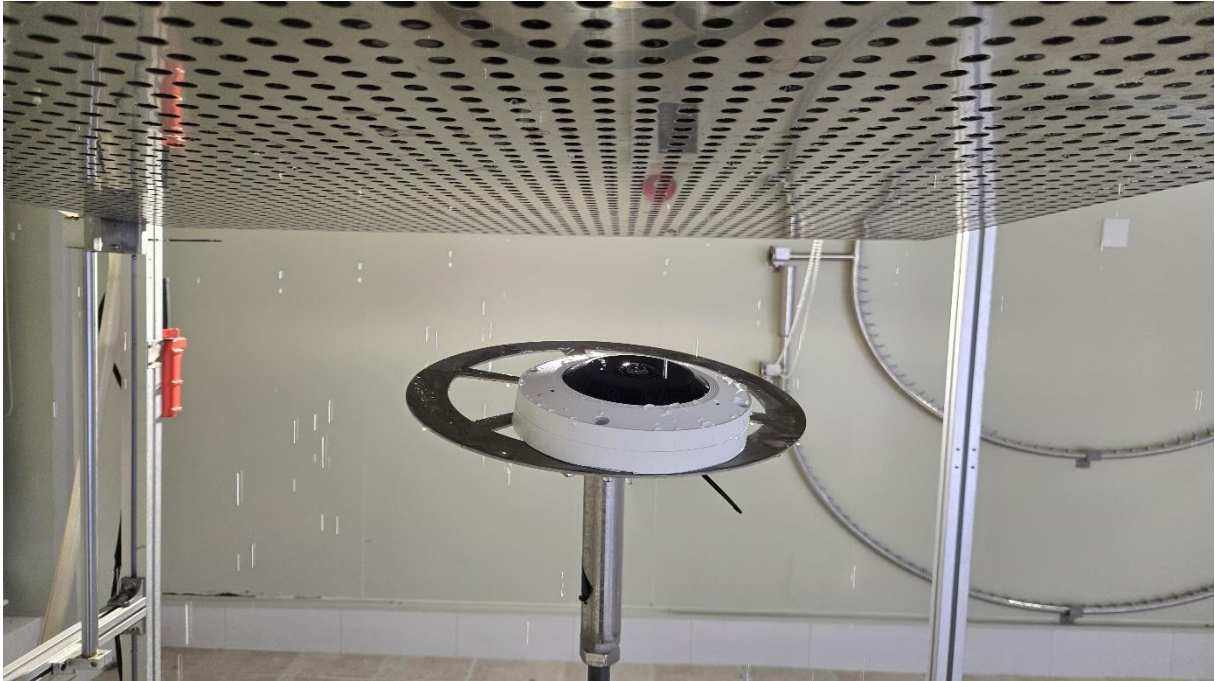
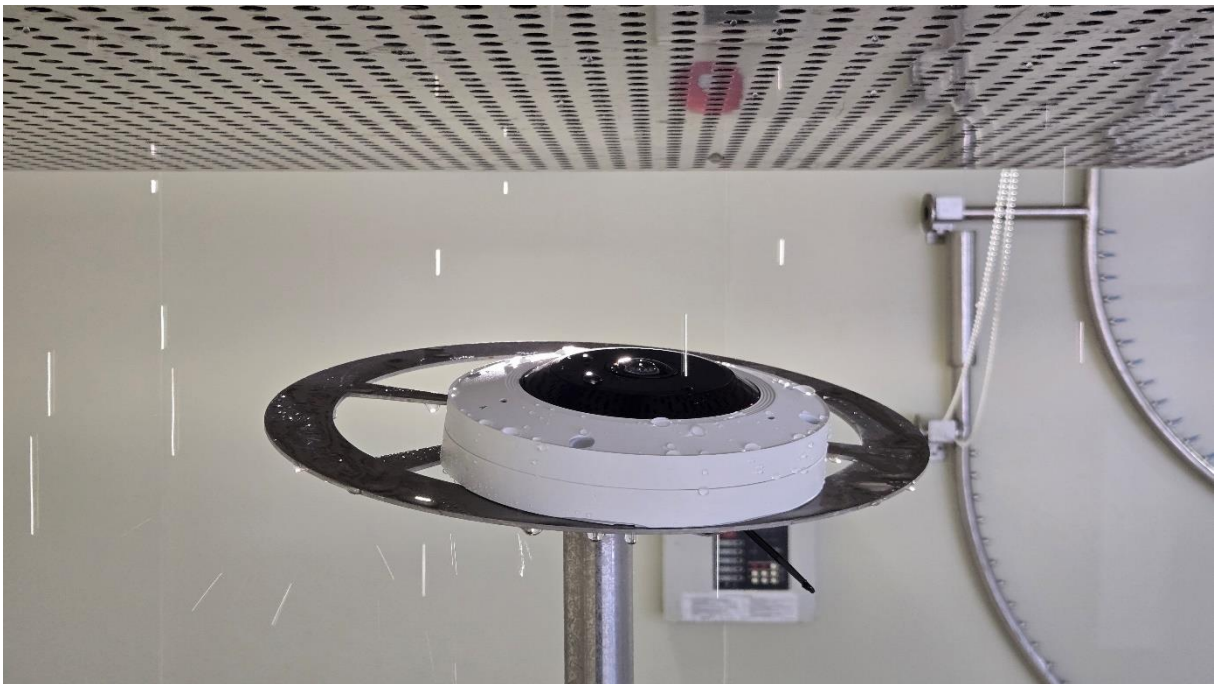
### 3.3.2 Evidence of test setting (2)

| Second characteristic numeral | Degrees of protection | Application |
|---|---|---|
| 2 | When outskirts of the product have been tilted by 15° Water that drops vertically has to be harmless.<br>Drip box Fig.3, Enclosure in 4 fixed positions of 15° tilt<br>Water flow rate: 3 mm/min<br>Duration of test: 2.5 min for each position of tilt | <input checked="" type="checkbox"/> |

Water test

| IP code | Evaluation Criteria | Test Results | Remark |
|---|---|---|---|
| IP X2 | No ingress of water | Normal | |

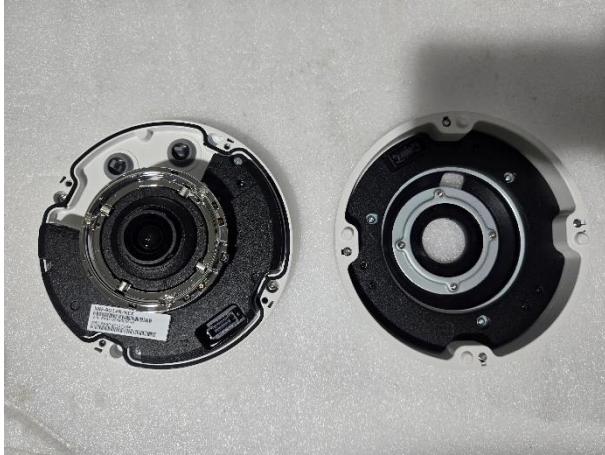
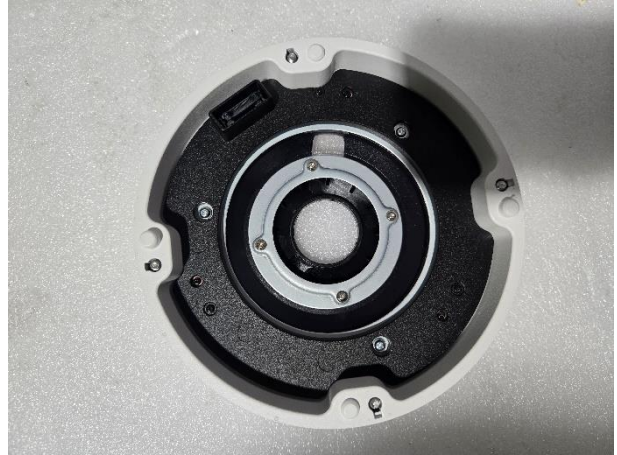
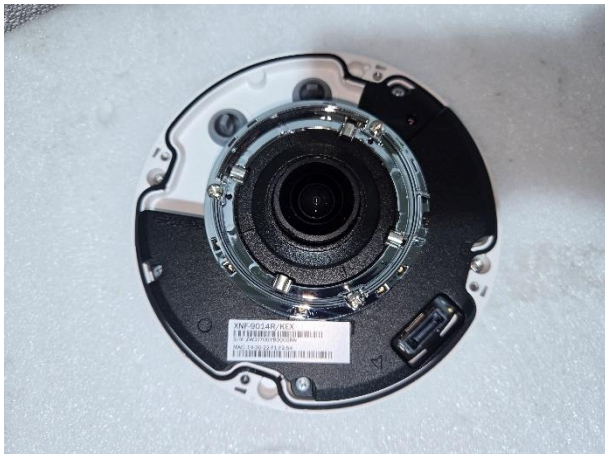
#### 3.5.1 Product internal images after test [The second characteristic numeral test]

※ Refer to the product photos after the completion of testing in section 3.5.
