# TEST REPORT

REPORT No.:  
CTK-2025-02266  
Page (1) / (14) pages

NETWORK CAMERA / XNO-A9084R

IEC 62262:2002+AMD1:2021

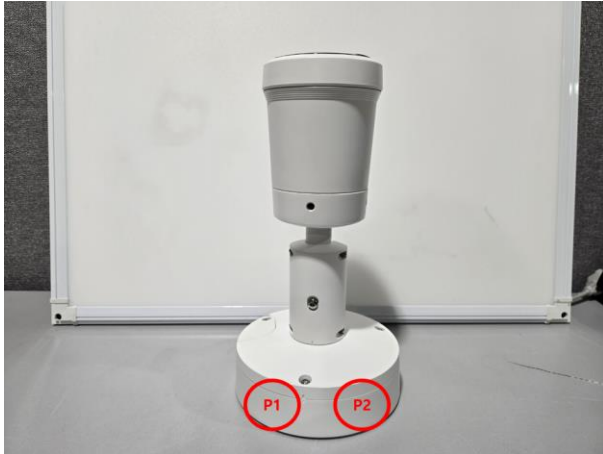
Check the hit area the test\_6

| Evaluation Criteria | Test Results | Remark |
|---|---|---|
| Visual Inspection | Some scratches were generated on the outside of the product. | - |

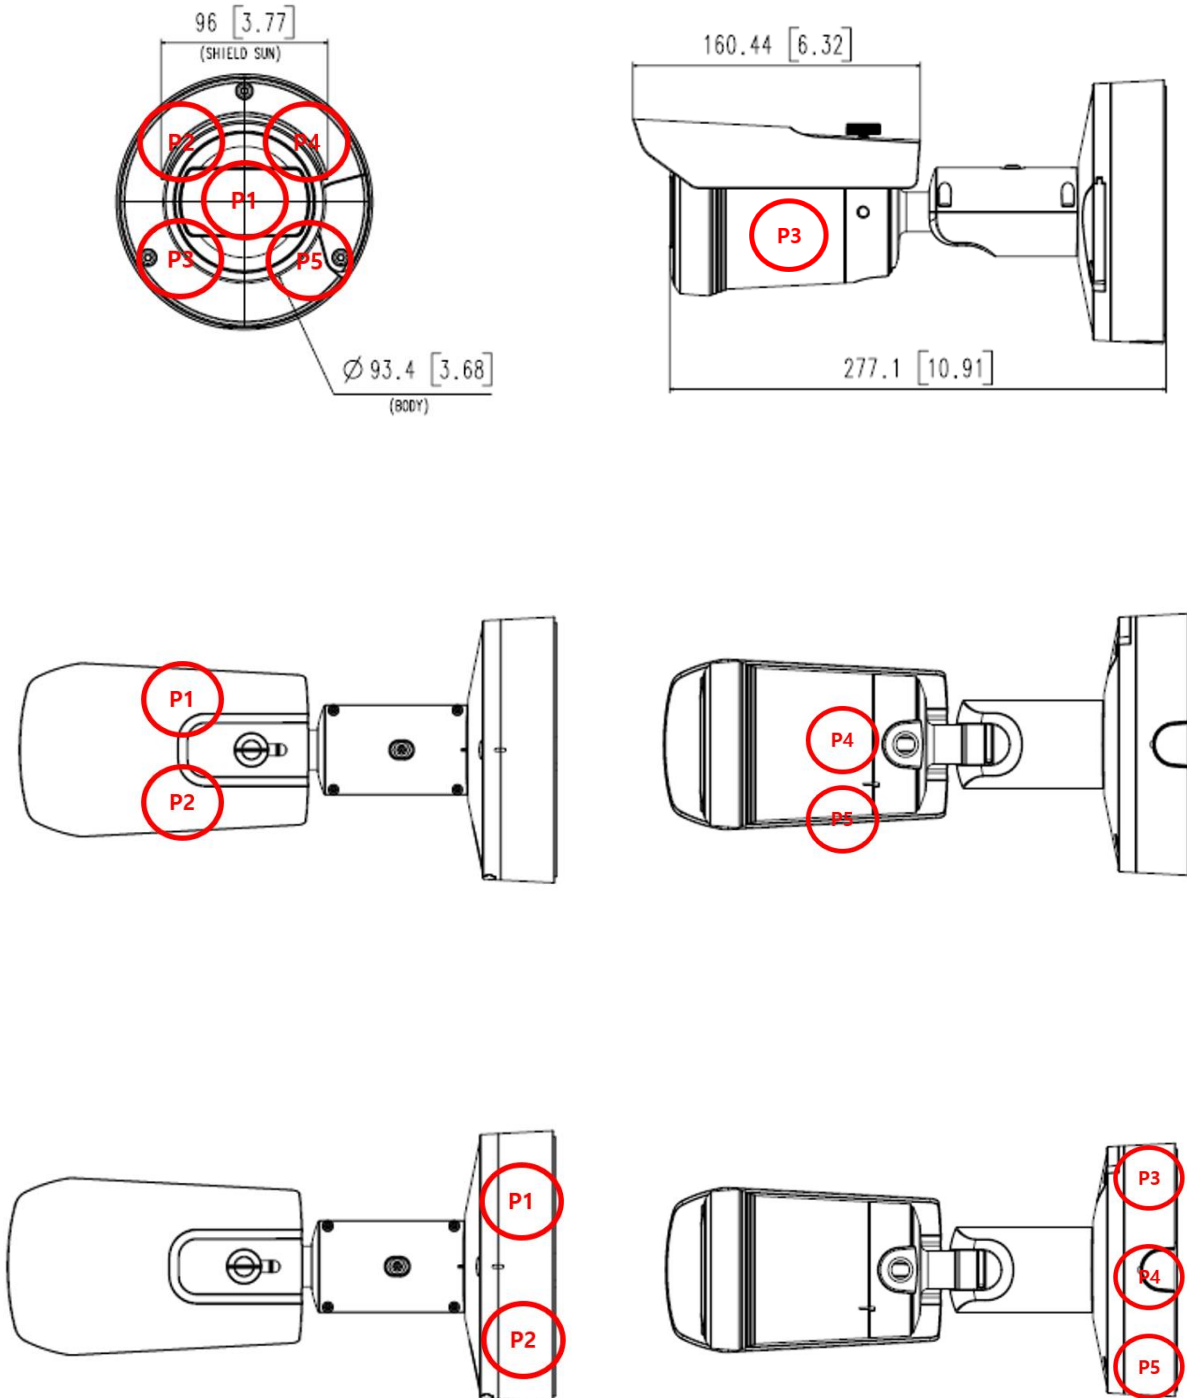
### 3.6.2 Impact Point

Impact times: five times for each of the exposed surface. (Do not impact more than 3 times in the same spot)
