# TEST REPORT

REPORT No.:  
CTK-2025-02262  
Page (1) / (14) pages

NETWORK CAMERA / XNO-A9084R

IEC 60529:1989 +A1:1999+A2:2013

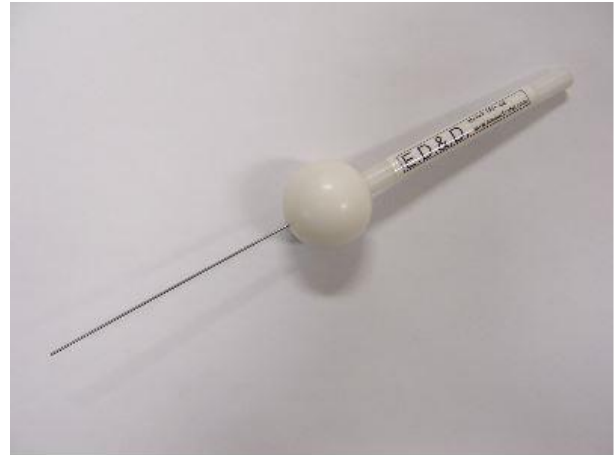
Test Rod Probe Ø1.0

| First characteristic numeral | Degree of protection | Application |
|---|---|---|
| 6 | Protected against access to hazardous parts with a wire.<br>The access probe of 1.0 mmØ, shall not penetrate.<br>Test force: 1 N ± 10 % | <input checked="" type="checkbox"/> |

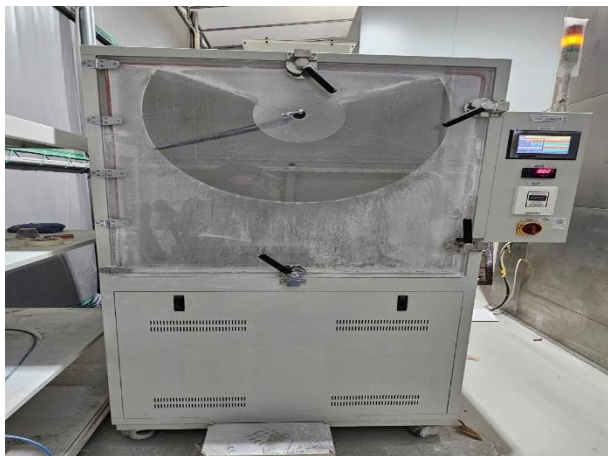
Dust Chamber

| First characteristic numeral | Degree of protection | Application |
|---|---|---|
| 6 | <p>In Dust Testing Equipment, the test sample must have no ingress of dust after testing atmospheric pressure present condition for 8 h.</p> <p>(The talcum powder must pass through a calibrated sieve with a 50 µm wire mesh, spaced at 75 µm intervals in a square pattern. Additionally, the bulk density of the talcum powder should be 2 kg/m<sup>3</sup>)</p> <p>Products in volume .....: <b>5 996 cm<sup>3</sup> → 6 L</b></p> <p>Target intake volume (Products in volume 80) : <b>479.68 L</b></p> <p>Suction volume (Max product in volume 60) ...: <b>359.76 LPH → 6 LPM</b></p> <p>Actual Suction volume .....: <b>6 L</b></p> <p>Suction pressure (Up to 2 kPa) .....: <b>1.80 kPa</b></p> <p>Test time (Up to 8 time) .....: <b>8 hr</b></p> | <input checked="" type="checkbox"/> |

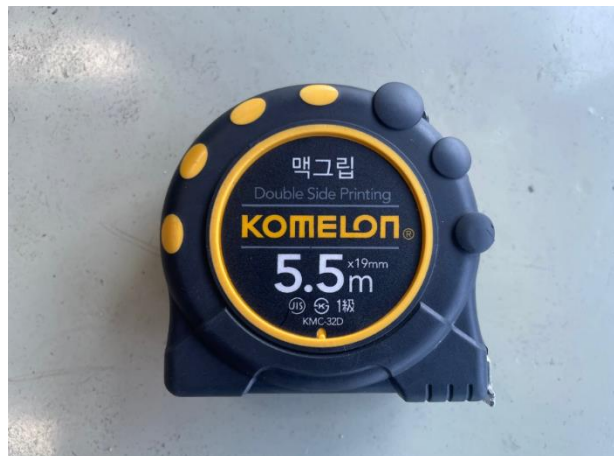
Steel measuring meter

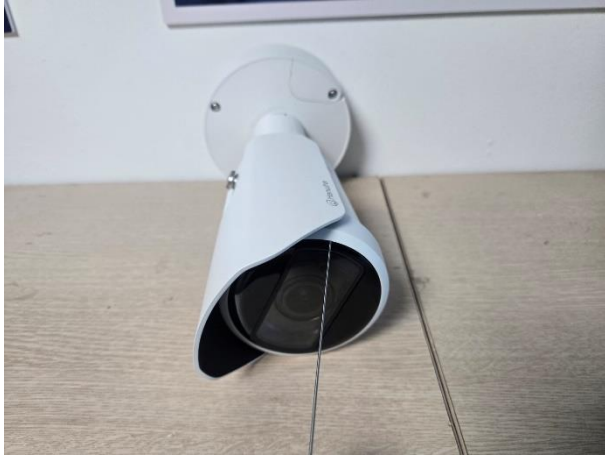
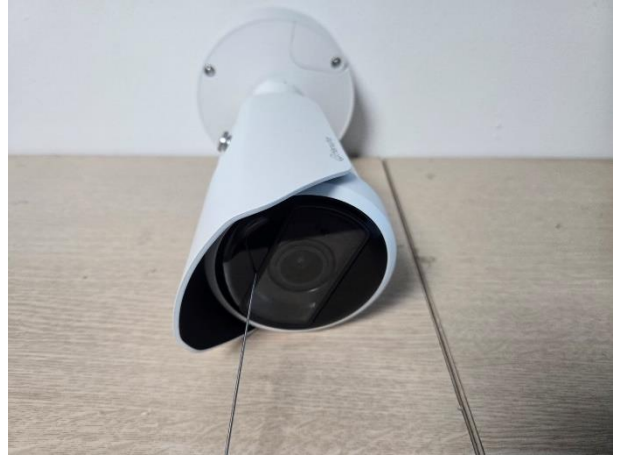
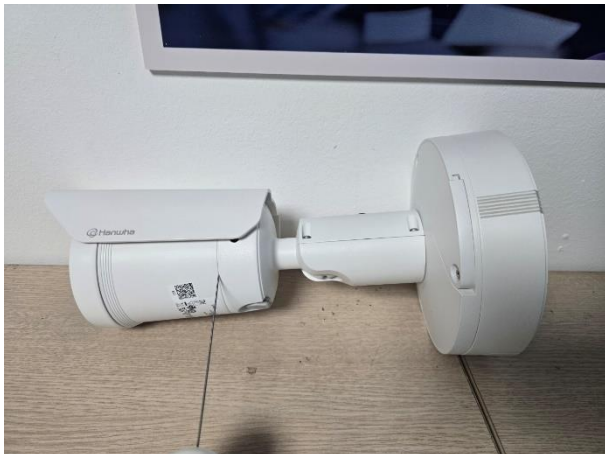
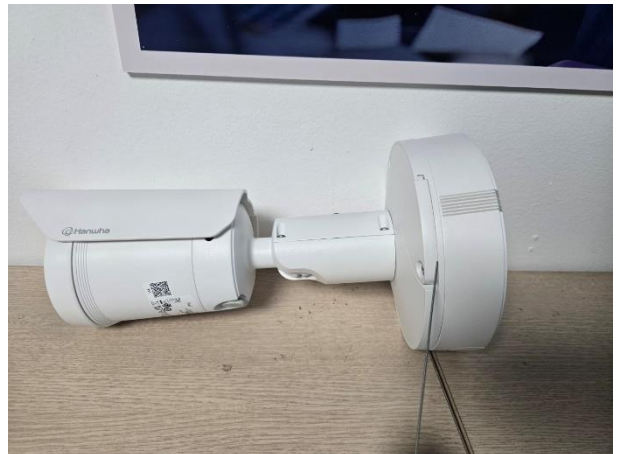
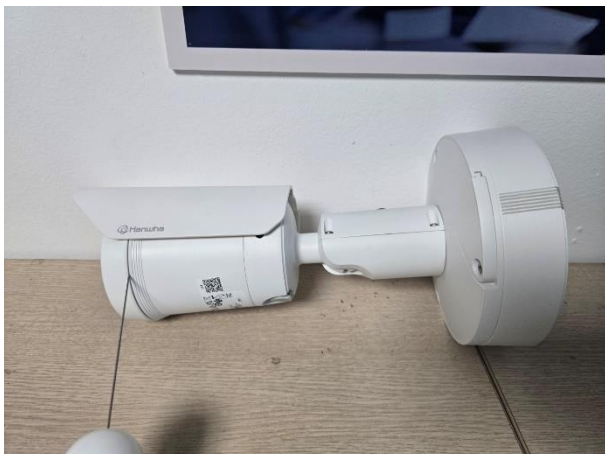
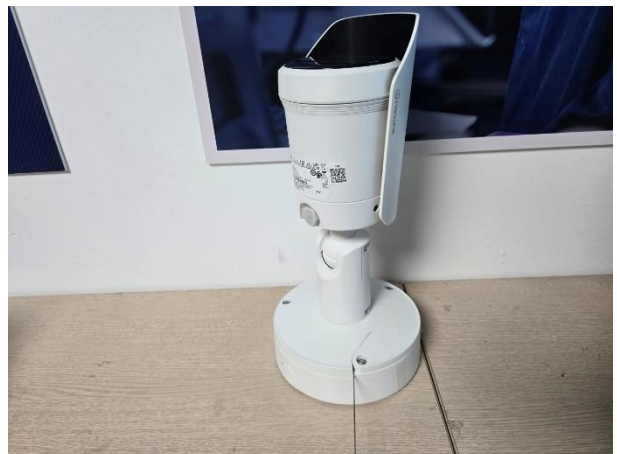
Probe test

| IP code | Evaluation Criteria | Test Results | Remark |
|---|---|---|---|
| IP 6X | No ingress of Probe | Normal | - |

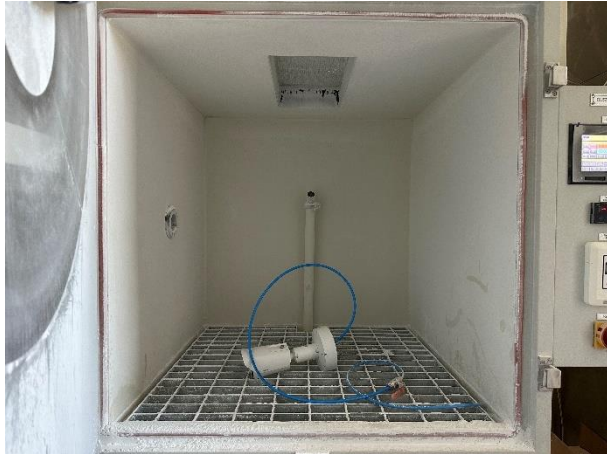
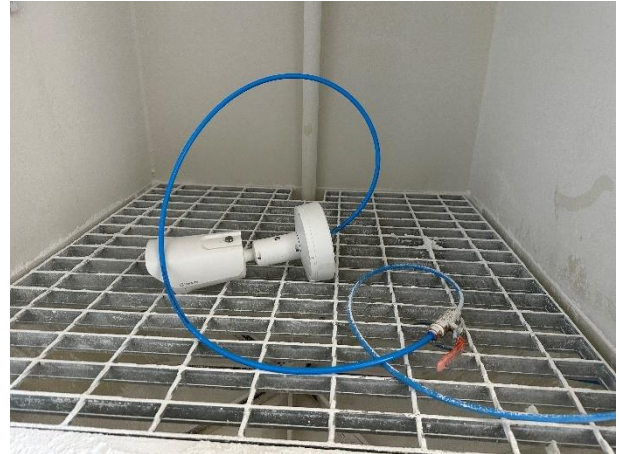
Dust test

| IP code | Evaluation Criteria | Test Results | Remark |
|---|---|---|---|
| | No ingress of dust | Normal | - |

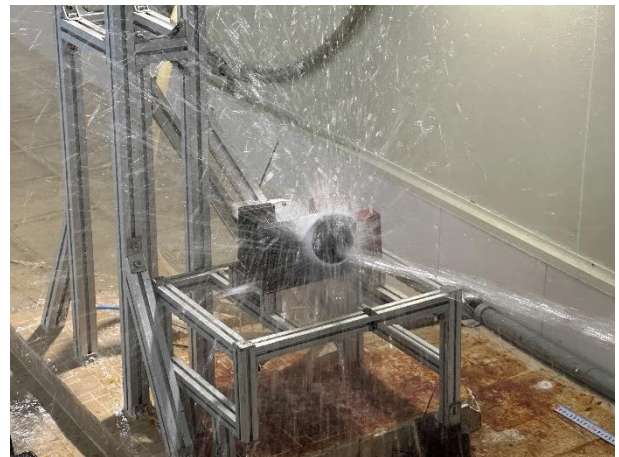
Water test

| Second characteristic numeral | Degrees of protection | Application |
|---|---|---|
| 6 | <p>The product must not be harmed in any direction even strong jet water.</p> <p>Water jet hose nozzle Fig.6, Nozzle 12.5 mm diameter</p> <p>Water flow rate: 100 l/min ± 5 % : <b>100 LPM</b></p> <p>Distance: 2.5 m to 3 m: <b>3 m</b></p> <p>Duration of test: 1 min/m<sup>2</sup> at least 3 min: <b>3 min</b></p> | <input checked="" type="checkbox"/> |

| IP code | Evaluation Criteria | Test Results | Remark |
|---|---|---|---|
| IP X6 | No ingress of water | Normal | - |

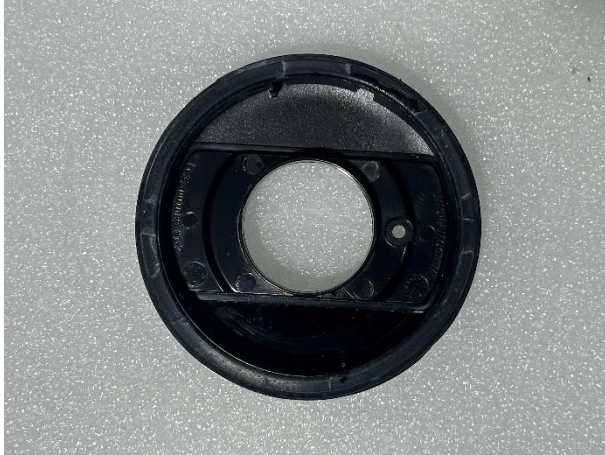
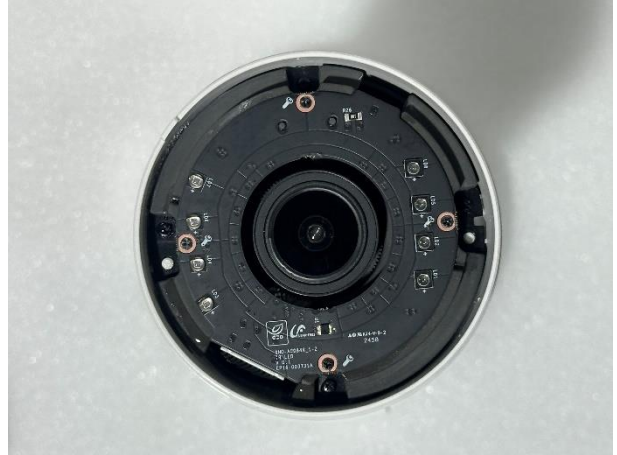
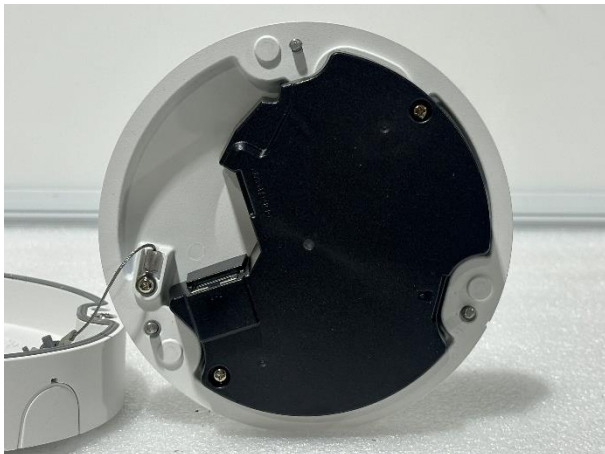
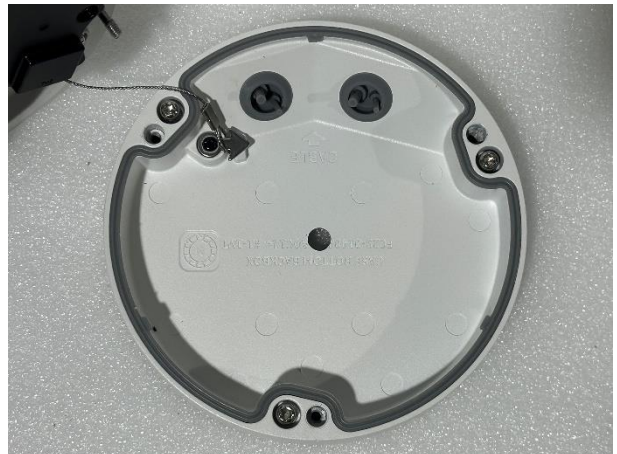
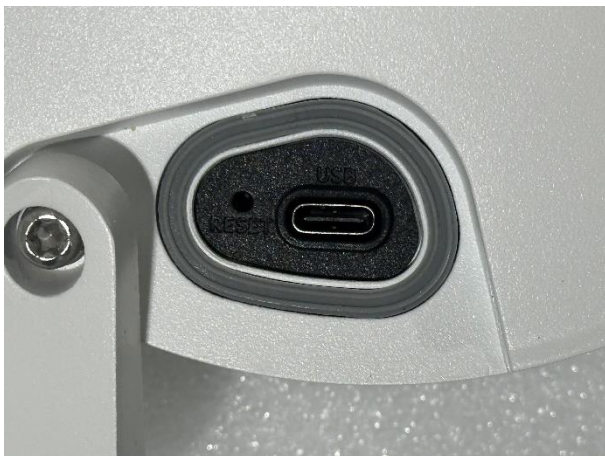
#### 3.5.1 Product internal images after test [The first characteristic numeral test]

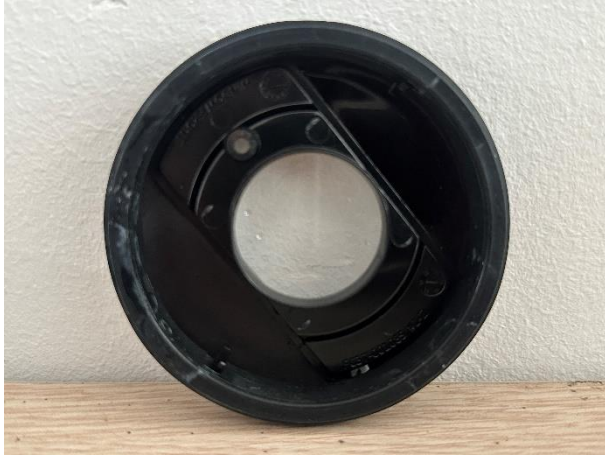
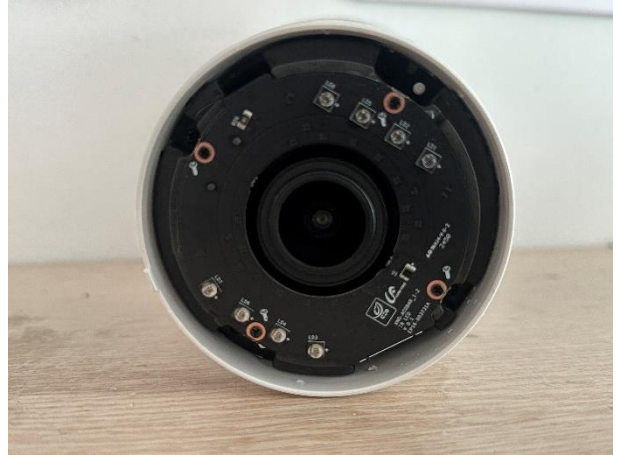
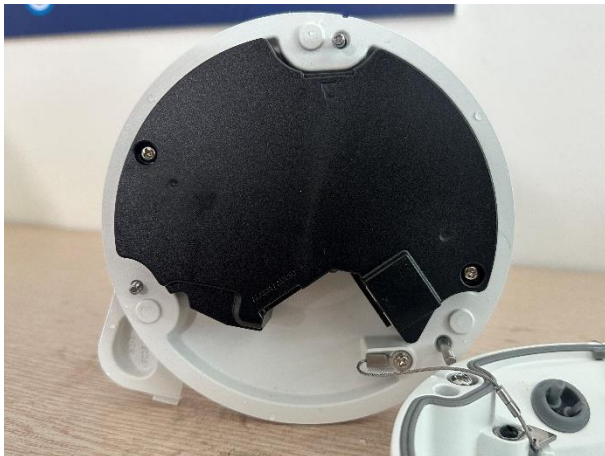
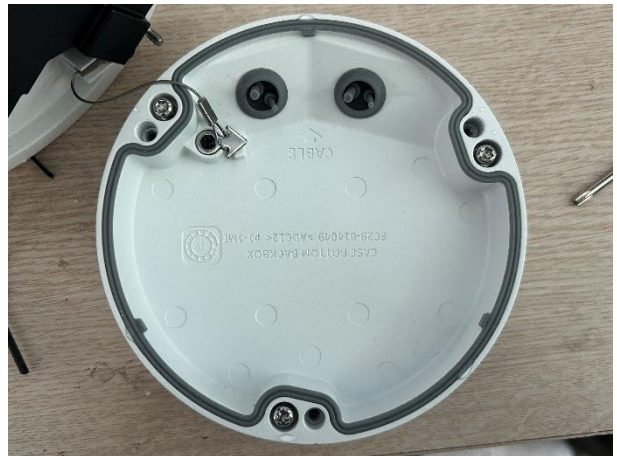
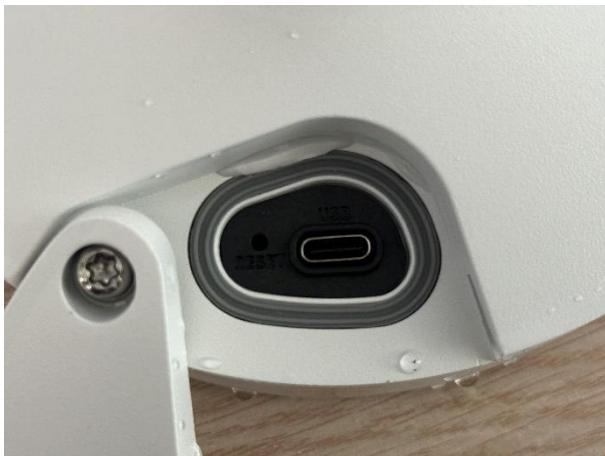
### 3.5.2 Product internal images after test [The second characteristic numeral test]
