# TEST REPORT

REPORT No.:  
CTK-2025-02264  
Page (1) / (14) pages

NETWORK CAMERA / XNO-A9084R

IEC 60529:1989 +A1:1999+A2:2013

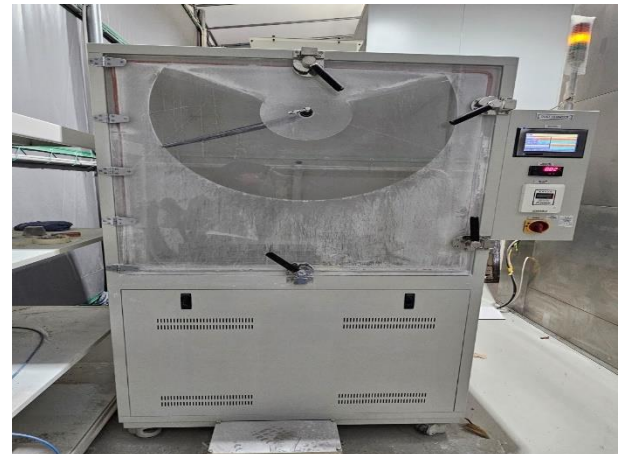
Dust Chamber

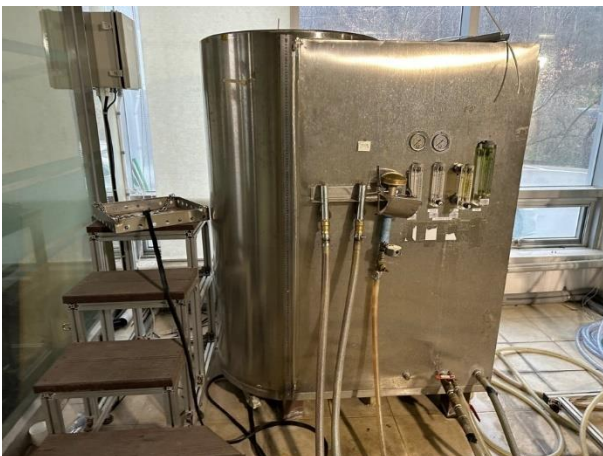
Immersion tank

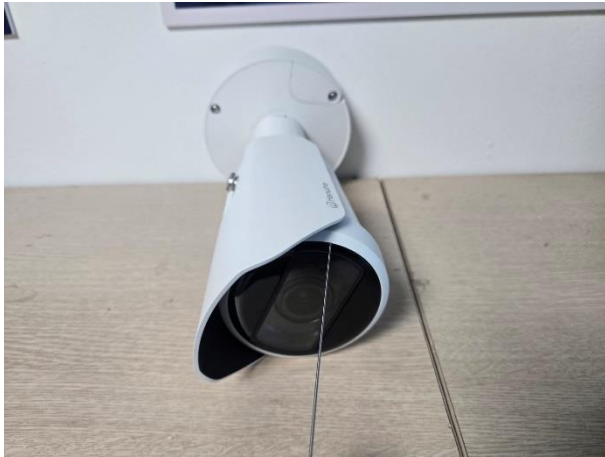
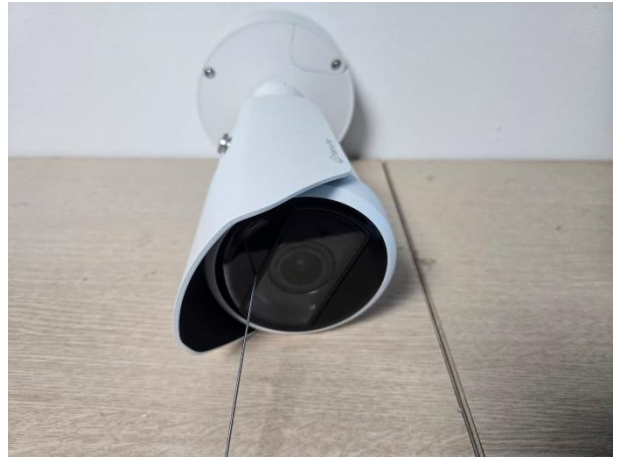
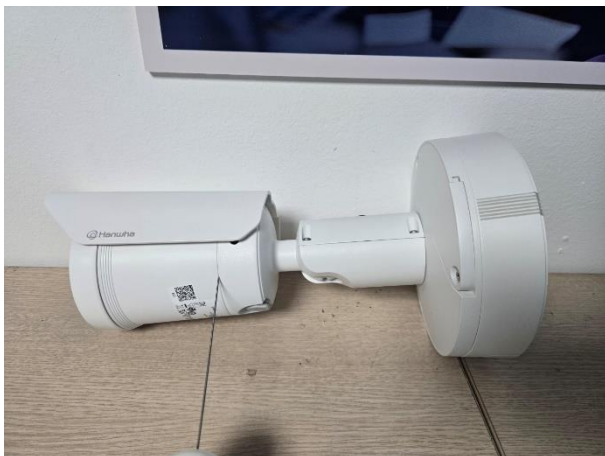
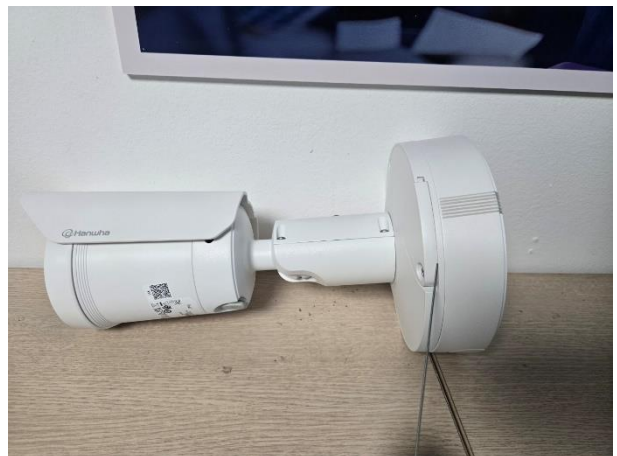
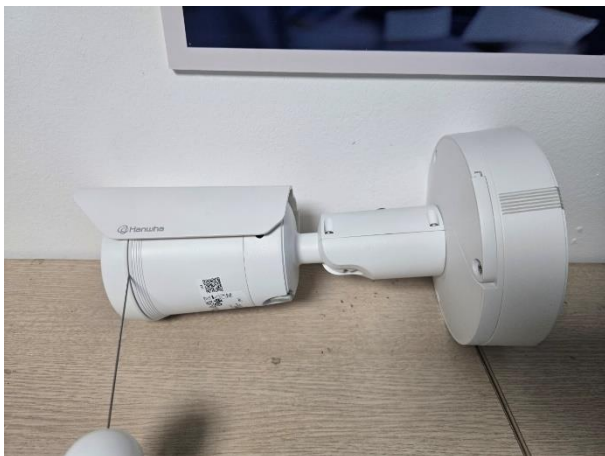
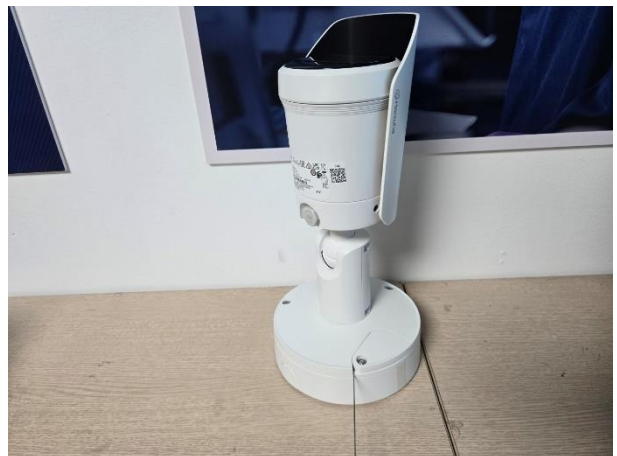
#### 3.3.1 Evidence of test setting (1)

| First characteristic numeral | Degree of protection | Application |
|---|---|---|
| 6 | Protected against access to hazardous parts with a wire.<br>The access probe of 1.0 mmØ, shall not penetrate.<br>Test force: 1 N ± 10 % | <input checked="" type="checkbox"/> |

Probe test

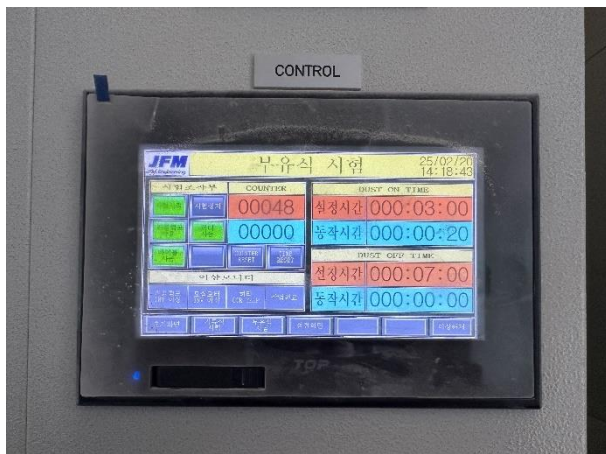
Dust test Monitor

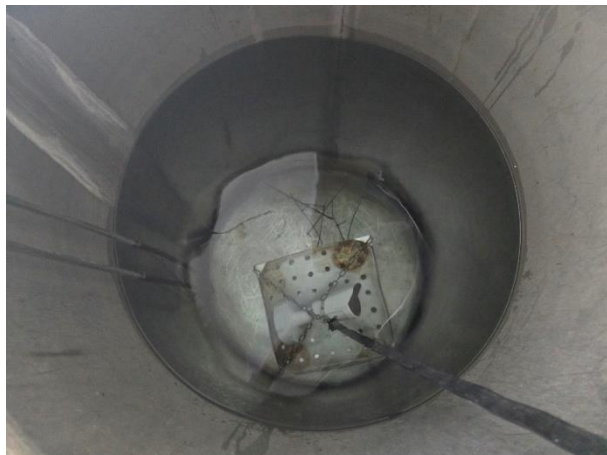
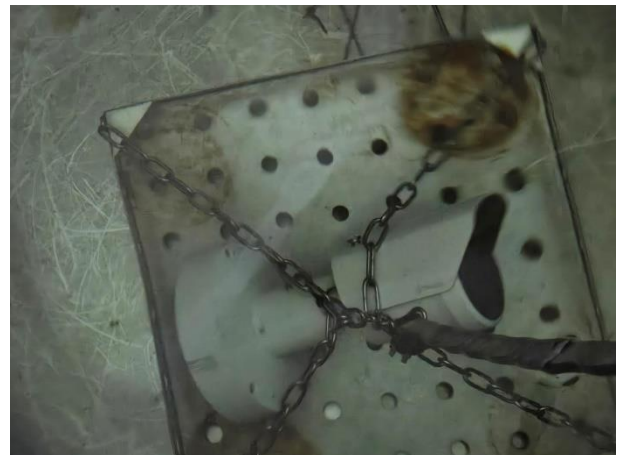
| Second characteristic numeral | Degrees of protection | Application |
|---|---|---|
| 7 | <p>Sink the product in the water by the Pressure and Time according to regulation and the product must not be harmed.</p> <p>Immersion tank water-level on enclosure with:</p> <p><input type="checkbox"/> height equal to or greater than 850 mm: the highest point of enclosures located 0.15 m below the surface of the water</p> <p><input checked="" type="checkbox"/> height less than 850 mm: the lowest point of enclosures located 1 m below the surface of the water</p> <p>Duration of test: 30 min</p> | <input checked="" type="checkbox"/> |

Water test

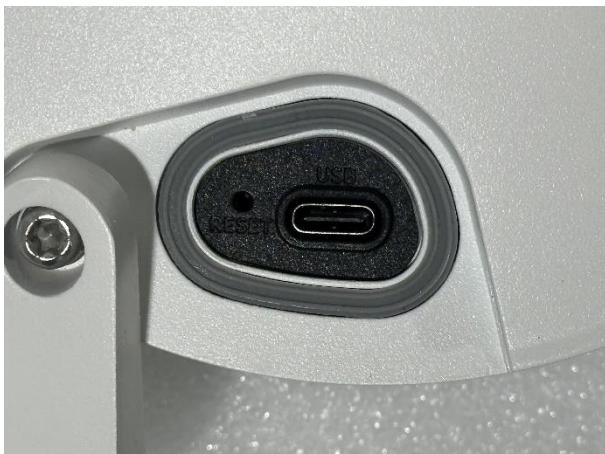
#### 3.5.1 Product internal images after test [The first characteristic numeral test]

| IP code | Evaluation Criteria | Test Results | Remark |
|---|---|---|---|
| IP 6X | No ingress of Probe | Normal | - |
| | No ingress of dust | Normal | - |
