# TEST REPORT

REPORT No.:  
CTK-2026-00542  
Page (1) / (31) pages

NETWORK CAMERA / XNP-A6374RH

NEMA TS 2-2021 2.2.7.3 Test C ~ 2.2.7.8 Test H,  
NEMA TS 2.2.8, NEMA TS 2.2.9

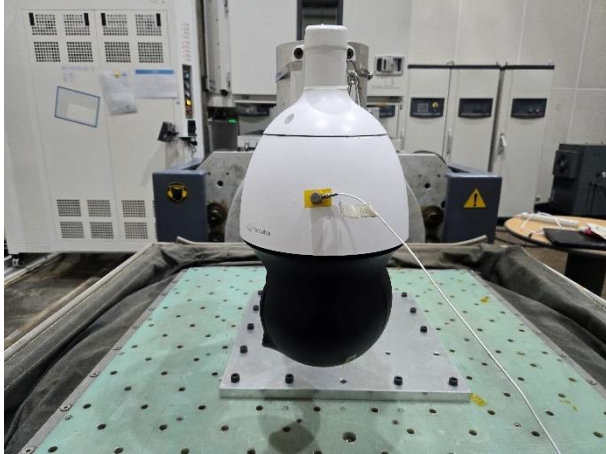
X axis

※ The control sensors for the X and Y axis are mounted on the vibration plate
