# TEST REPORT

REPORT No.:  
CTK-2026-00375  
Page (1) / (13) pages

**3. Use of Report :** For submission to customer**4. Test sample / Model :** NETWORK CAMERA / XNP-A9314R**5. Date(s) of test :** Jan. 06, 2026 ~ Jan. 09, 2026**6. Test Standard (Method) used :** IEC 60529:1989 +A1:1999+A2:2013**7. Testing Environment :** Temperature: (25 ±10) °C, Humidity: (50 ±25) % R.H.

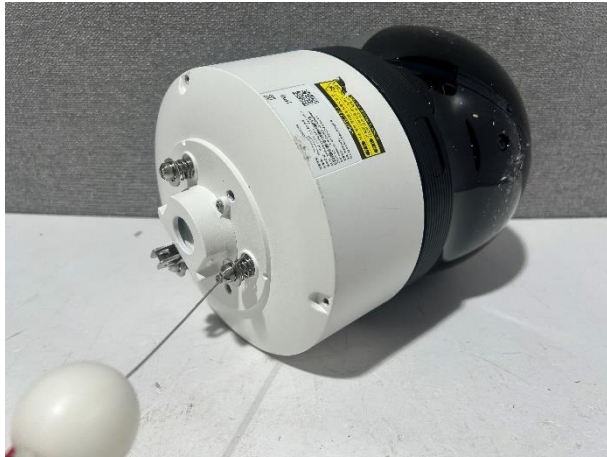
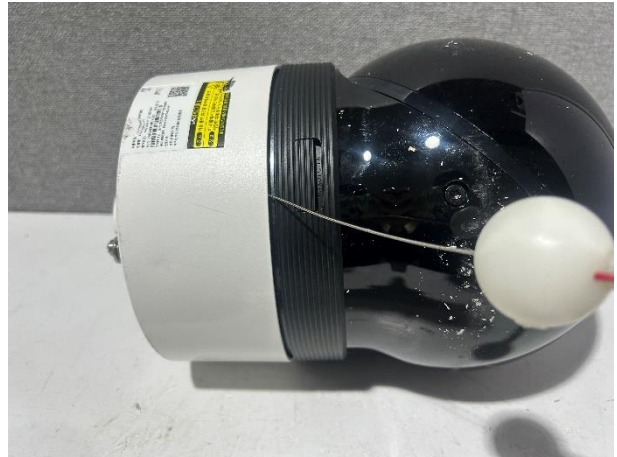
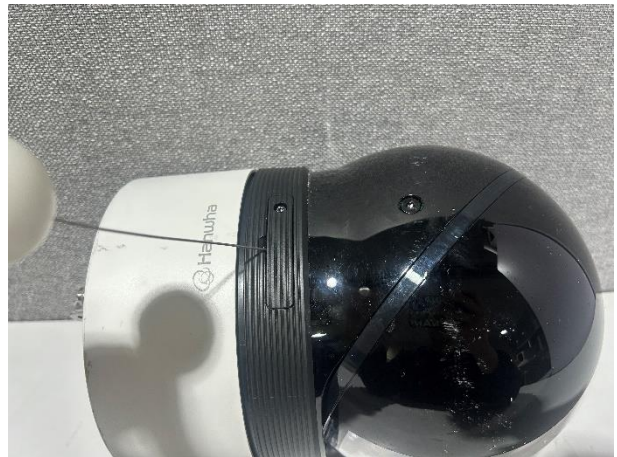
| First characteristic numeral | Degree of protection | Application |
|---|---|---|
| 6 | Protected against access to hazardous parts with a wire.<br>The access probe of 1.0 mmØ, shall not penetrate.<br>Test force: 1 N ± 10 % | <input checked="" type="checkbox"/> |

Probe test

| IP code | Evaluation Criteria | Test Results | Remark |
|---|---|---|---|
| IP 6X | No ingress of Probe | Normal | - |

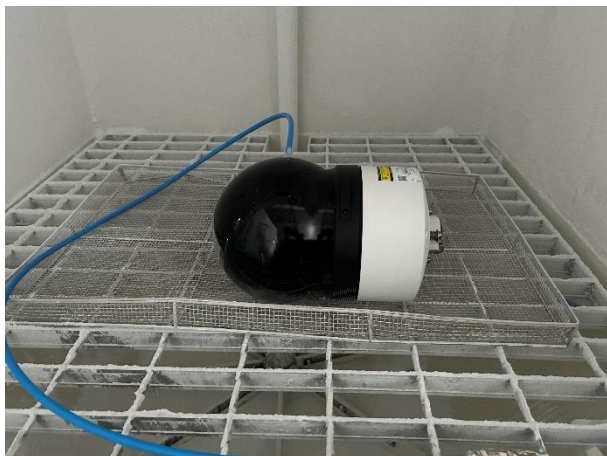
| First characteristic numeral | Degree of protection | Application |
|---|---|---|
| 6 | <p>In Dust Testing Equipment, the test sample must have no ingress of dust after testing atmospheric pressure present condition for 8 h.</p> <p>(The talcum powder must pass through a calibrated sieve with a 50 µm wire mesh, spaced at 75 µm intervals in a square pattern. Additionally, the bulk density of the talcum powder should be 2 kg/m<sup>3</sup>)</p> <p>Products in volume .....: <b>8 121.53 cm<sup>3</sup> → 8.12 L</b></p> <p>Target intake volume (Products in volume 80) : <b>657.00 L</b></p> <p>Suction volume (Max product in volume 60) ...: <b>492.75 LPH → 8.21 LPM</b></p> <p>Actual Suction volume .....: <b>5.47 L</b></p> <p>Suction pressure (Up to 2 kPa) .....: <b>2 kPa</b></p> <p>Test time (Up to 8 time) .....: <b>8 hr</b></p> | <input checked="" type="checkbox"/> |

Dust test

| IP code | Evaluation Criteria | Test Results | Remark |
|---|---|---|---|
| | No ingress of dust | Normal | - |

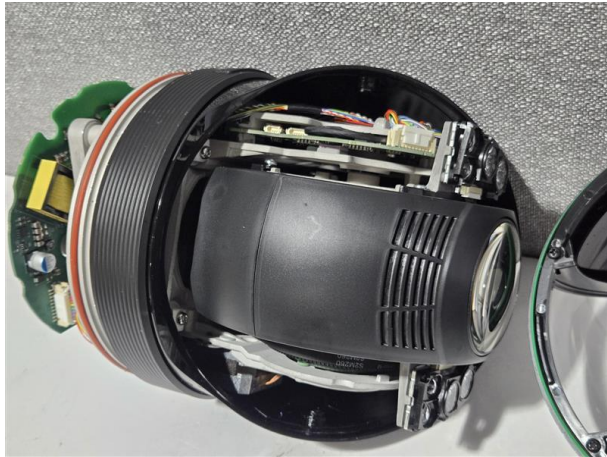
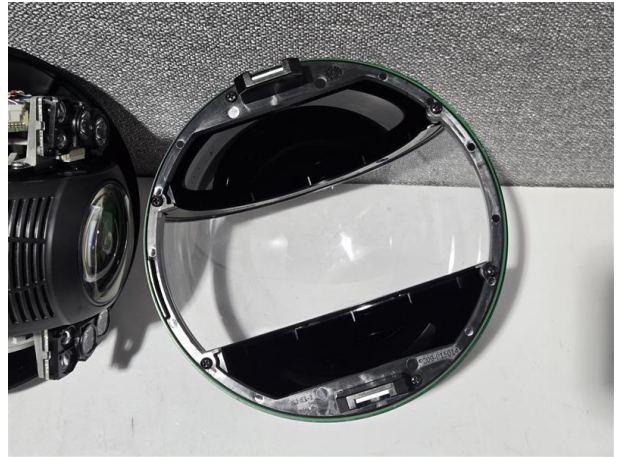
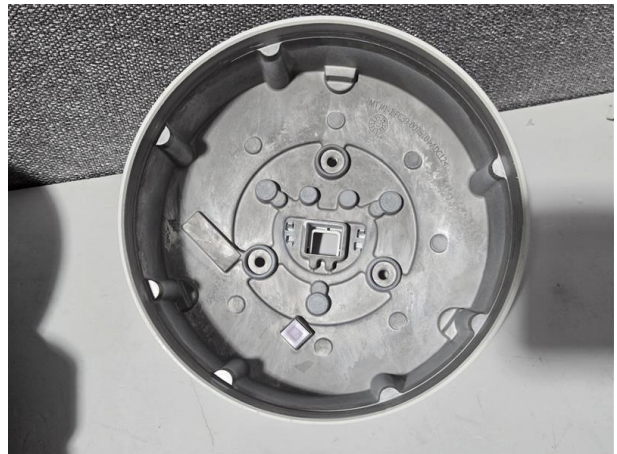
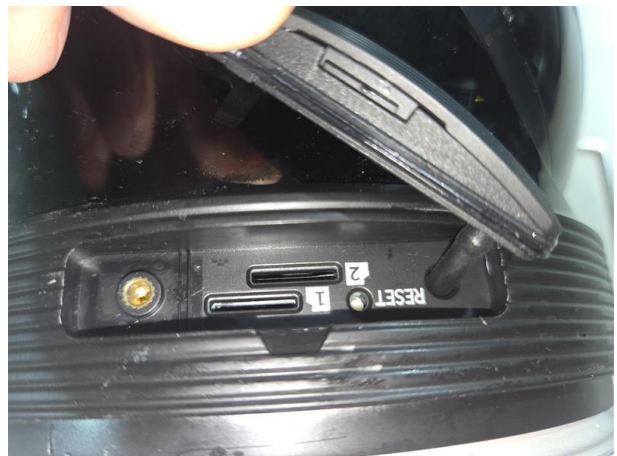
#### 3.5.1 Product internal images after test [The first characteristic numeral test]

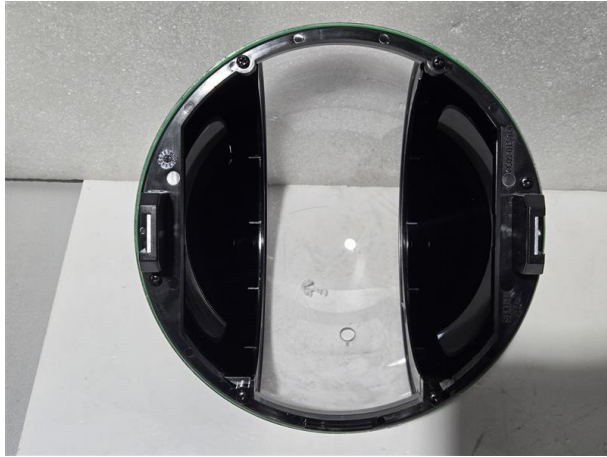
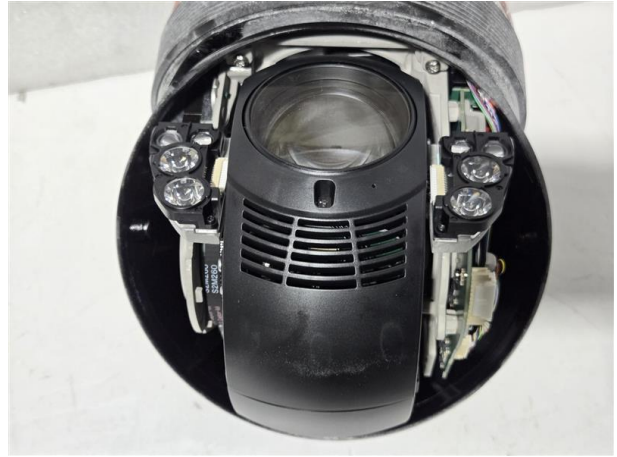
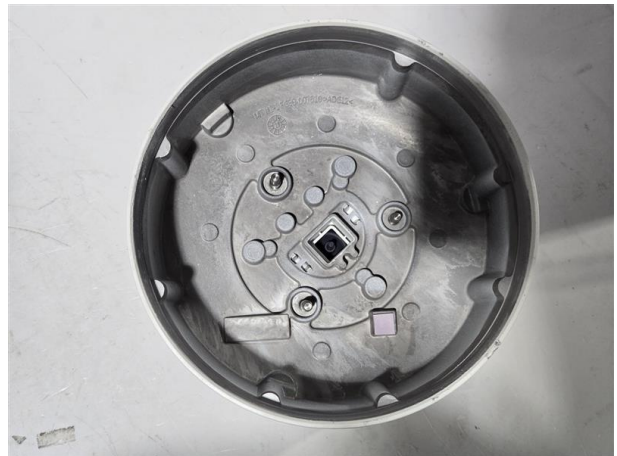
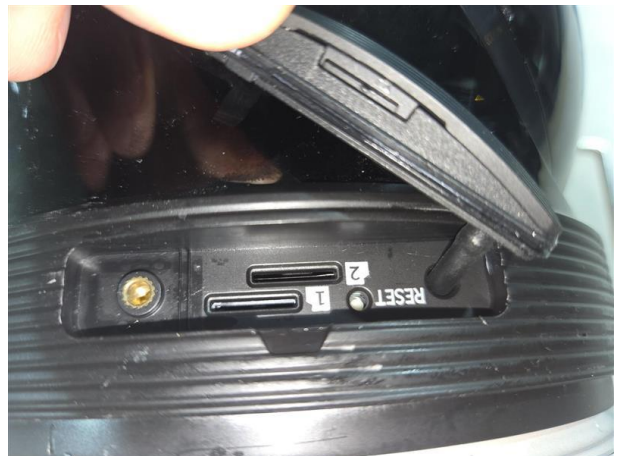
### 3.5.2 Product internal images after test [The second characteristic numeral test]

| IP code | Evaluation Criteria | Test Results | Remark |
|---|---|---|---|
| IP X7 | No ingress of water | Normal | - |
