# TEST REPORT

REPORT No.:  
CTK-2023-02178  
Page (1) / (7) pages

: NETWORK CAMERA / XNP-C6403RW  
PoE Injector / PT-PSE109GBRO-AH-S

: Requested Test Specification by applicant :  
NEMA TS 2-2013  
[2.2.7.2 Test B : Transient Tests  
(Power Service) - 13. C.]

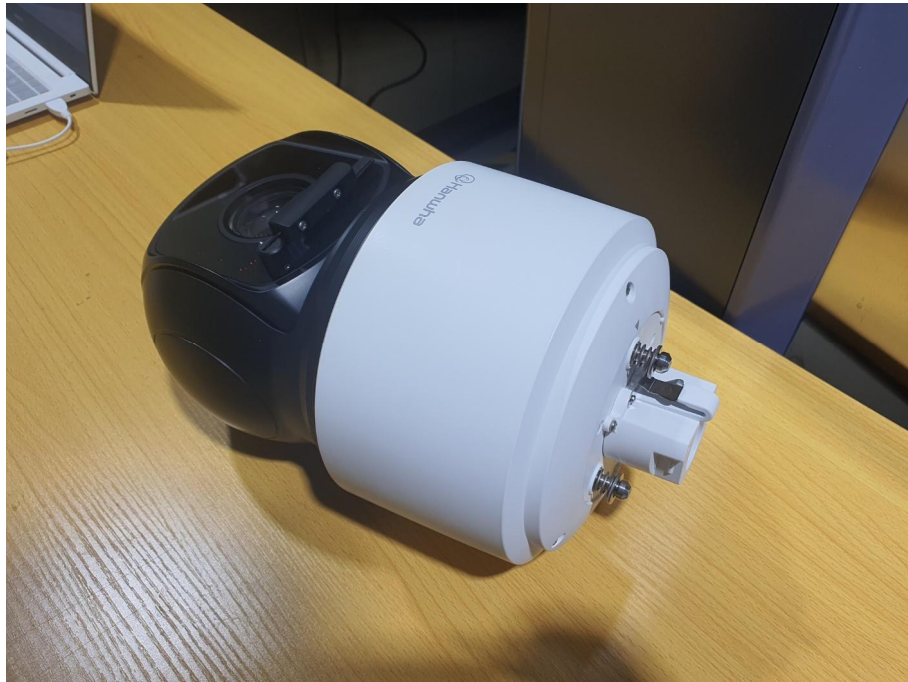
< Photo 1 > Product External view

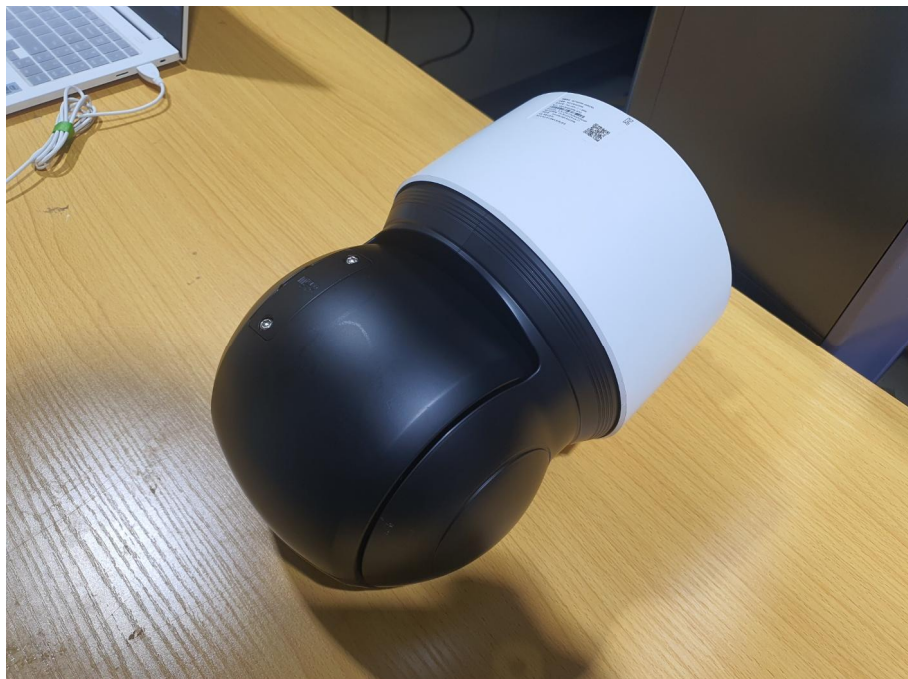
< Photo 2 > Product External view

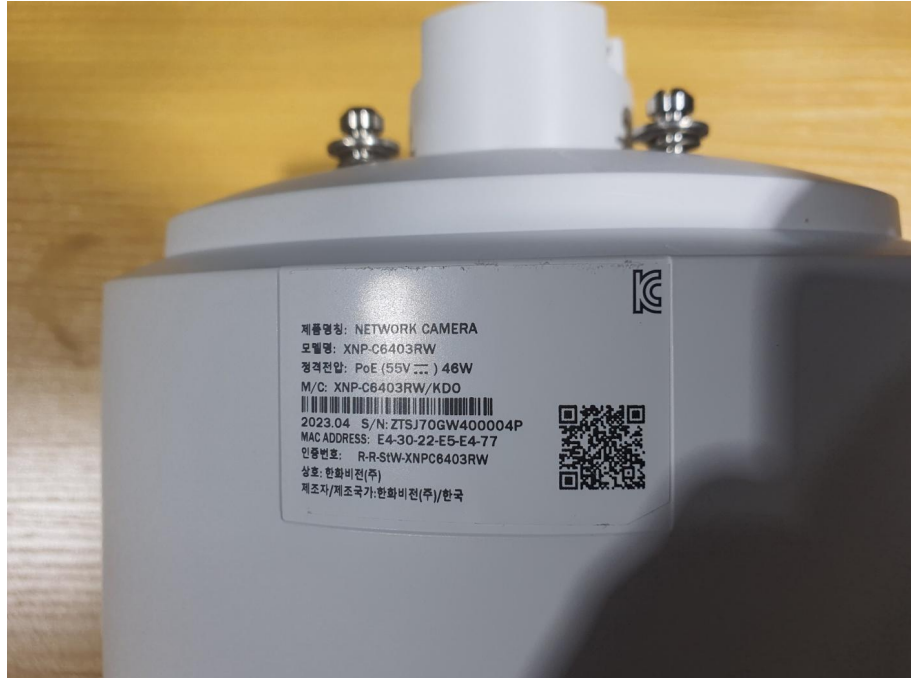
< Photo 3 > Product label

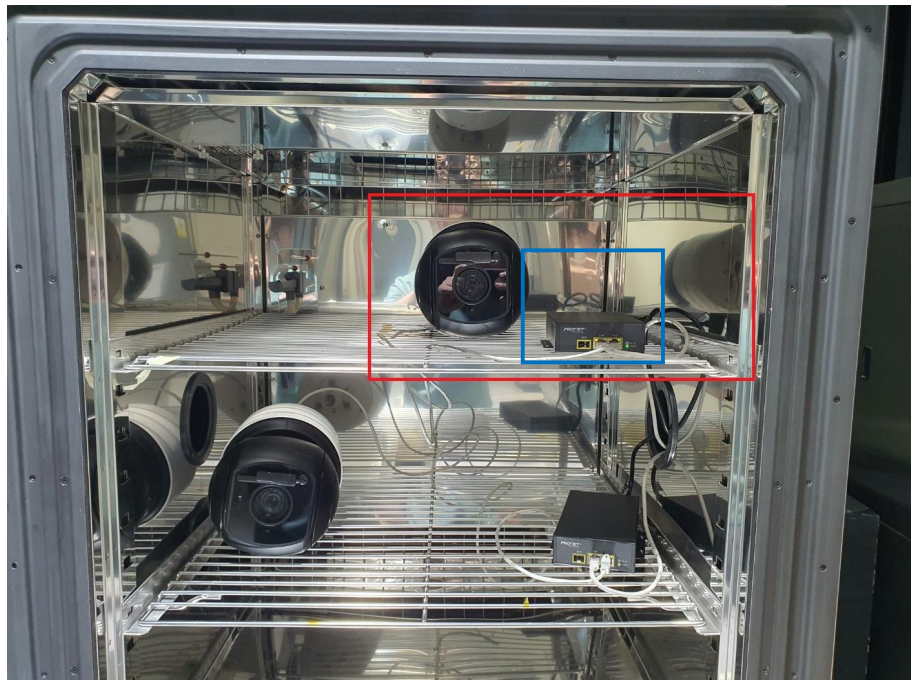
< Photo 5 >

[Red square, test sample, blue square PoE Injector]
