# TEST REPORT

Report No.:  
KR17-YYP0186

3. Name of Product and Model : Network Camera / XNV-6120R(\*N: NTSC / P: PAL)

6. Test method used : IEC 60529: 2013

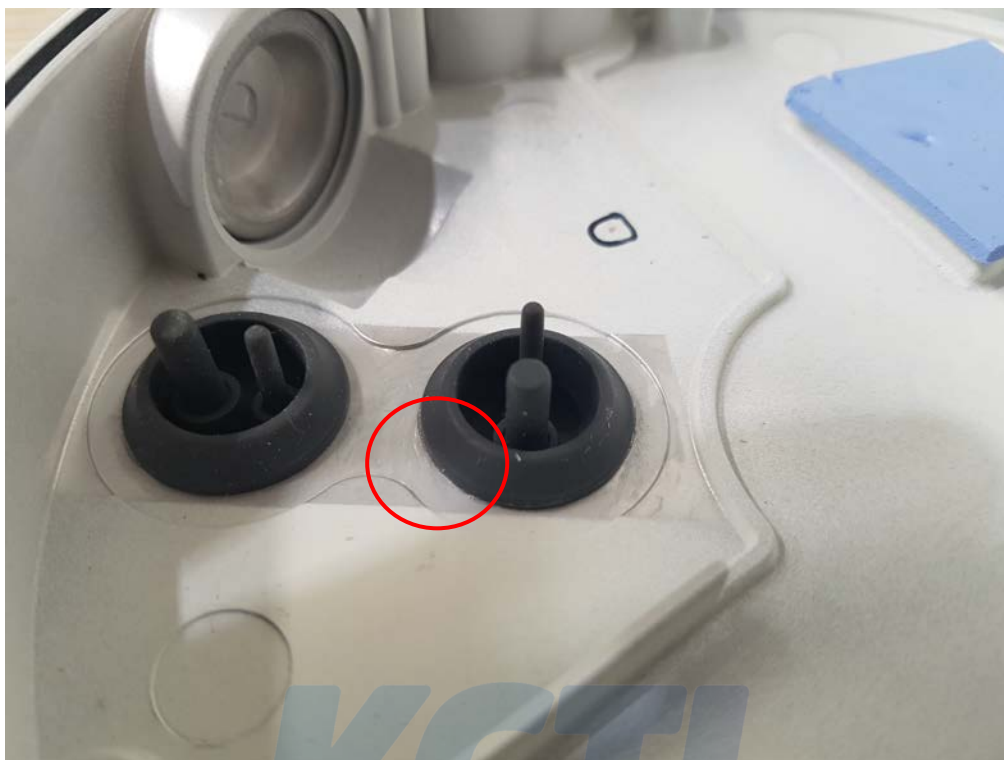
[Siliconized interior]

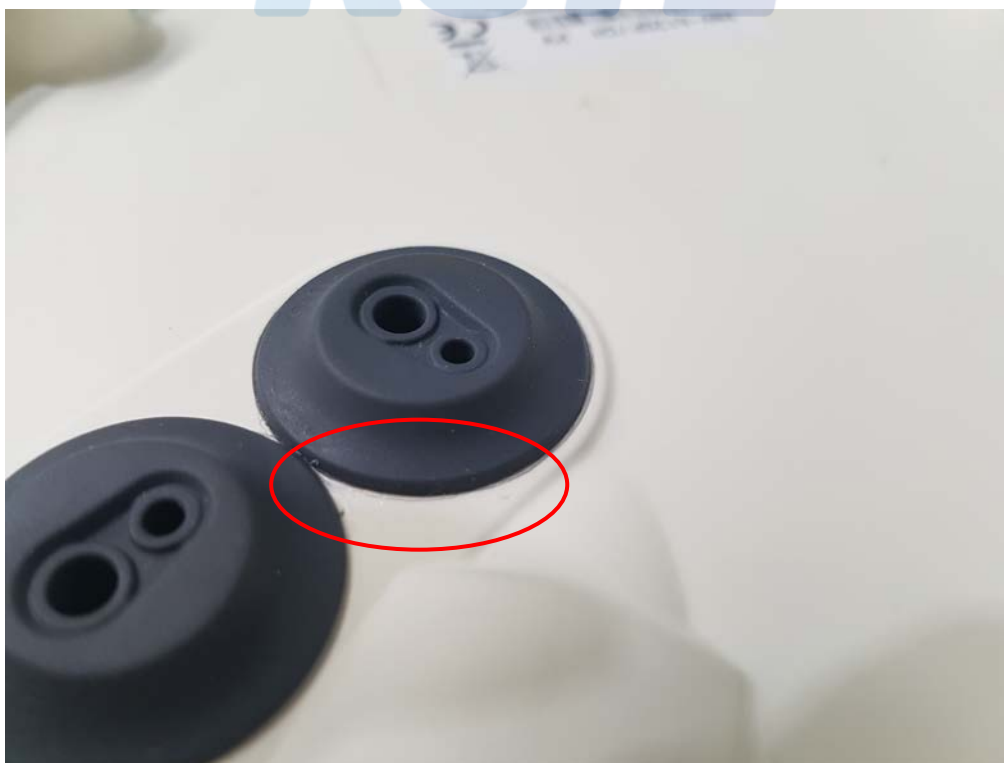
[Siliconized exterior]

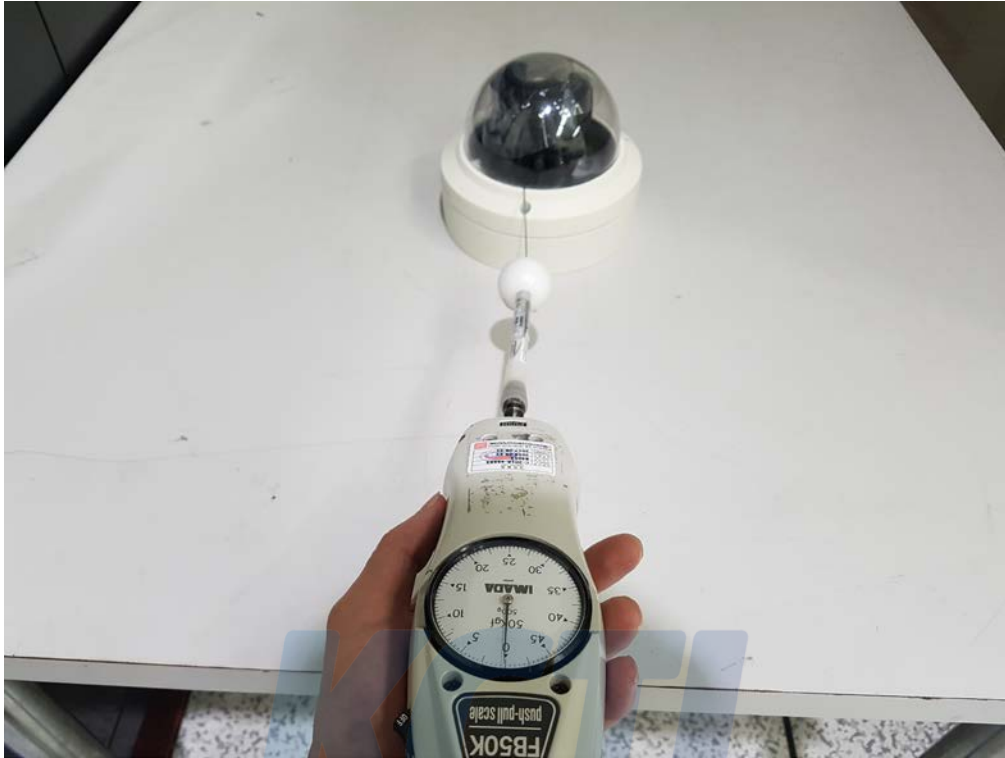
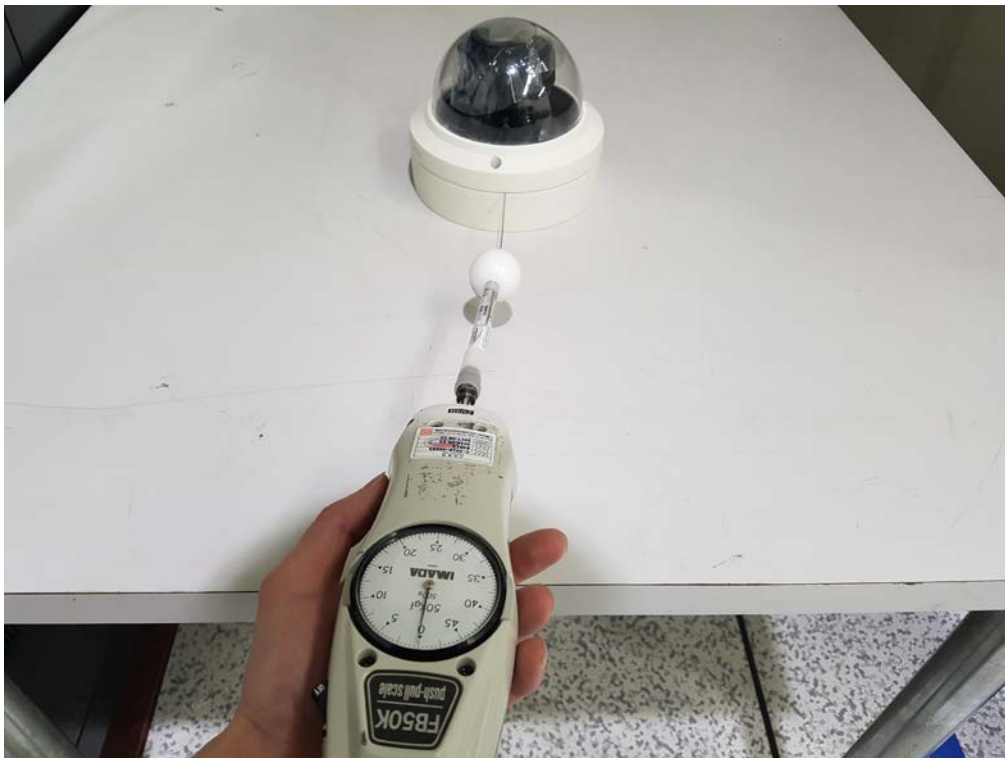
### 3.1.6 TEST Photograph

[During the test 01]

[During the test 02]

| Item | Description |
|---|---|
| Test condition | 1. Access probe: 1.0 mm $\varnothing$ , 100 mm length<br>2. Test force: 1 N $\pm$ 10 % |

- 1) The access probe is pushed against or (in case of the test for first characteristic numeral
- 2) inserted through any openings of the enclosure with the force specified

| Check List | Test Result |
|---|---|
| Protected against access to hazardous parts with a wire | No abnormal was found |

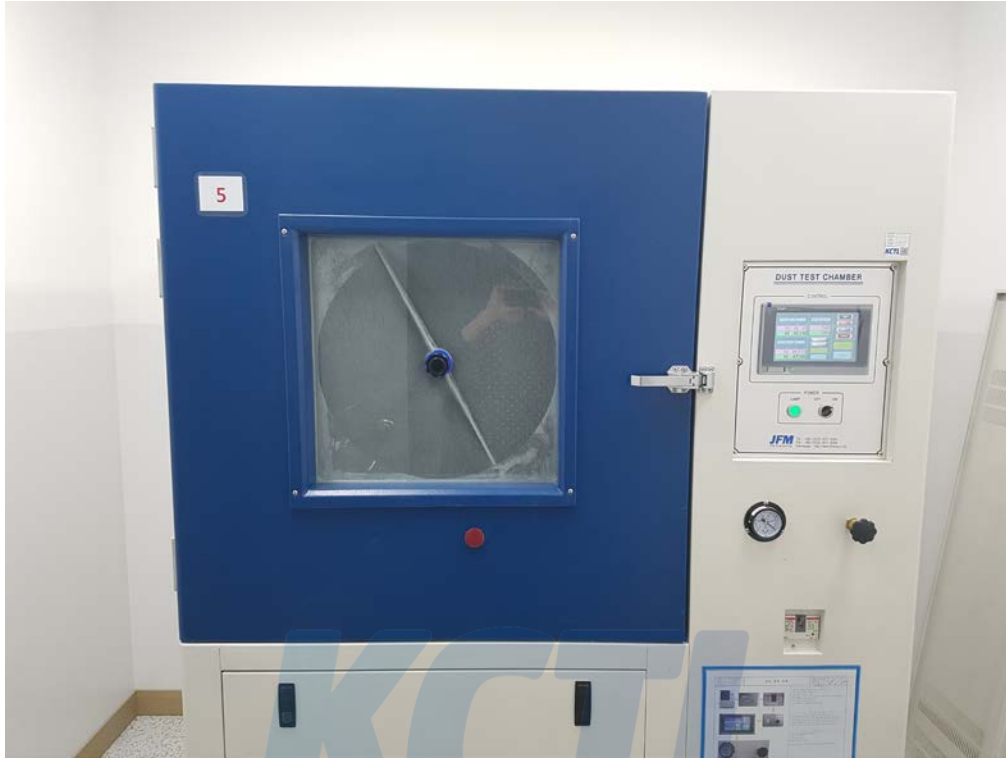
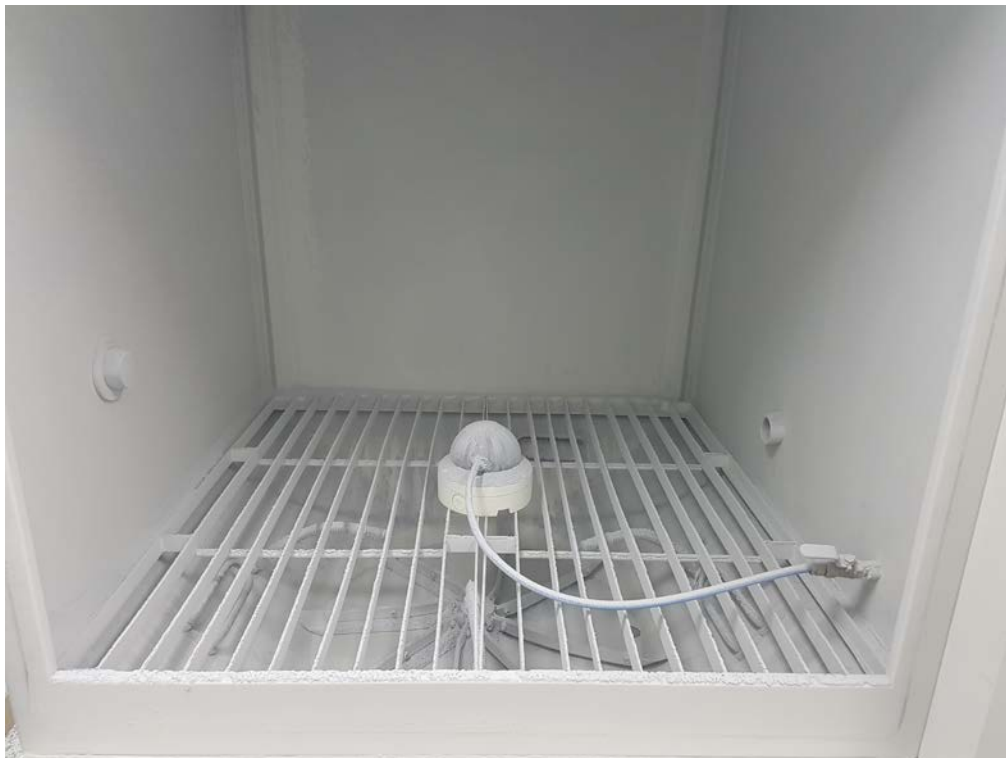
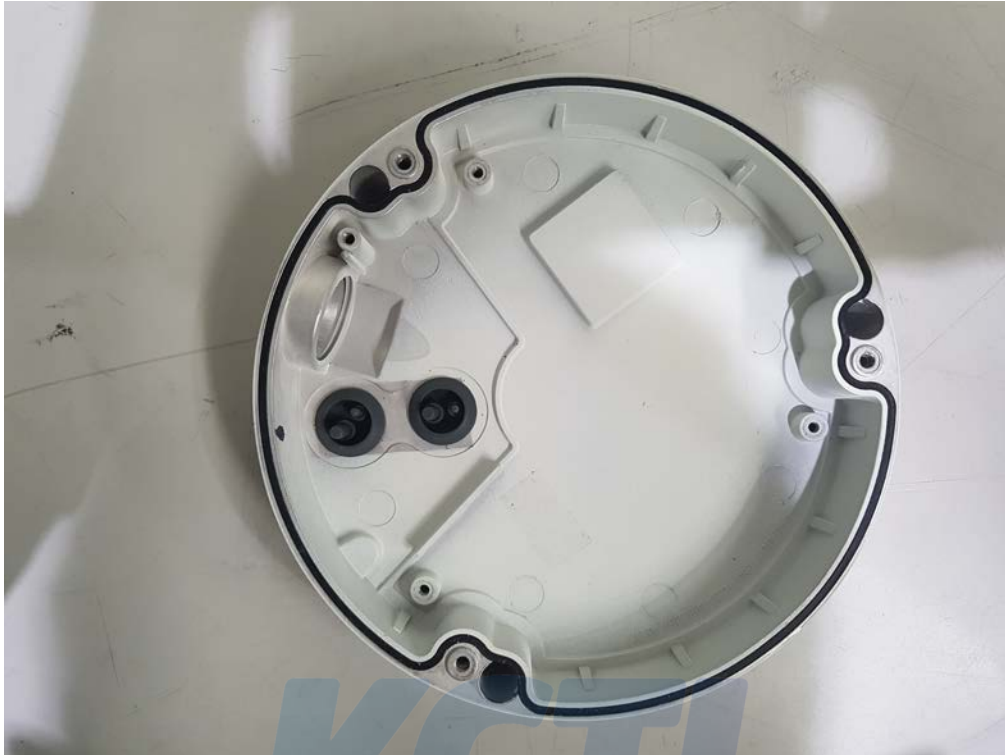
### 3.2.6 TEST Photograph

[During the test]

[After the test]

[Test result confirmation]

| Item | Description |
|---|---|
| Test condition | The talcum powder used shall be able to pass through a square-meshed sieve the nominal wire diameter of which is 50 µm and the nominal width of a gap between wires 75 µm. The amount of talcum powder to be used is 2 kg per cubic metre of the test chamber volume |

- 1) The enclosure under test is supported inside the test chamber and the pressure inside the enclosure is maintained below the surrounding atmospheric pressure by a vacuum pump
- 2) The suction connection shall be made to a hole specially provided for this test
- 3) The object of the test is to draw into the enclosure, by means of depression, a volume of air 80 times the volume of the sample enclosure tested without exceeding the extraction rate of 60 volumes per hour. In no event shall the depression exceed 2 kPa (20 mbar) on the manometer
- 4) If an extraction rate of 40 to 60 volumes per hour is obtained the duration of the test is 2 h.
- 5) If, with a maximum depression of 2 kPa (20 mbar), the extraction rate is less than 40 volumes per hour, the test is continued until 80 volumes have been drawn through, or a period of 8 h has elapsed.

| Check List | Test Result |
|---|---|
| No ingress of dust | No abnormal was found |

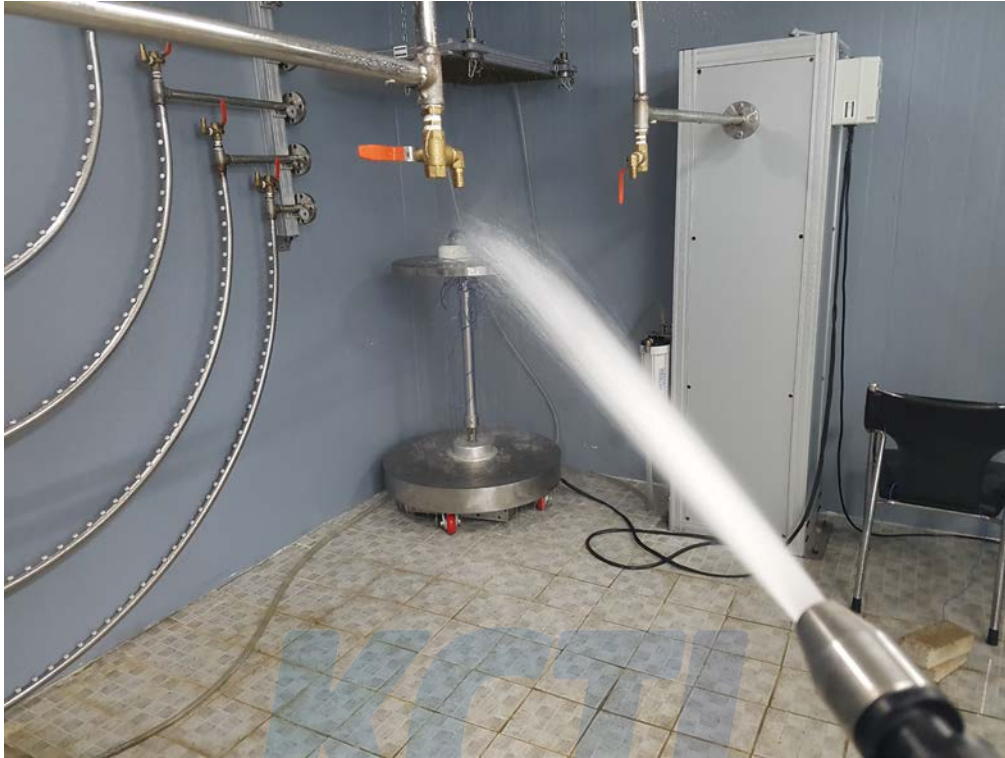
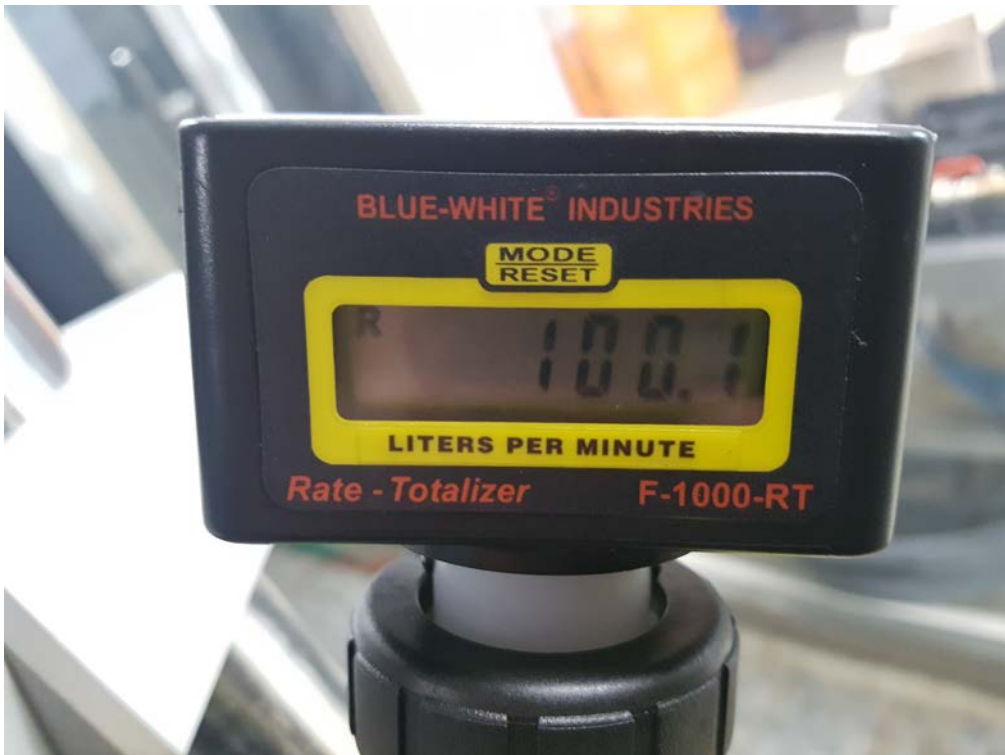
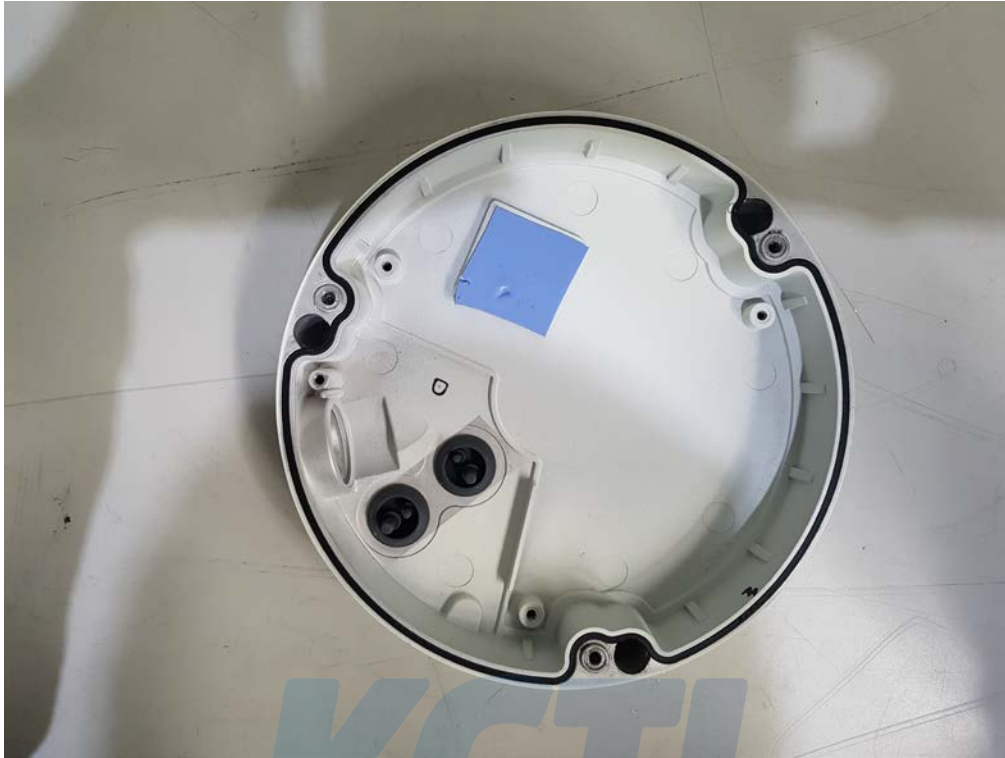
### 3.3.6 TEST Photograph

[During the test]

[During the test\_Water flow rate]

[Test result confirmation 01]

| Item | Description |
|---|---|
| Test condition | 1. Water jet hose nozzle diameter: 12.5 mm<br>2. Water flow rate: 100 L/min ± 5 %<br>3. Distance: 2.5 ~ 3.0 m |

- 1) The tests are conducted with fresh water
- 2) The water pressure is adjusted to give the specified delivery rate
- 3) The test is made by spraying the enclosure from all practicable directions with a stream of water from a standard test nozzle

| Check List | Test Result |
|---|---|
| Protected against powerful water jets | No abnormal was found |

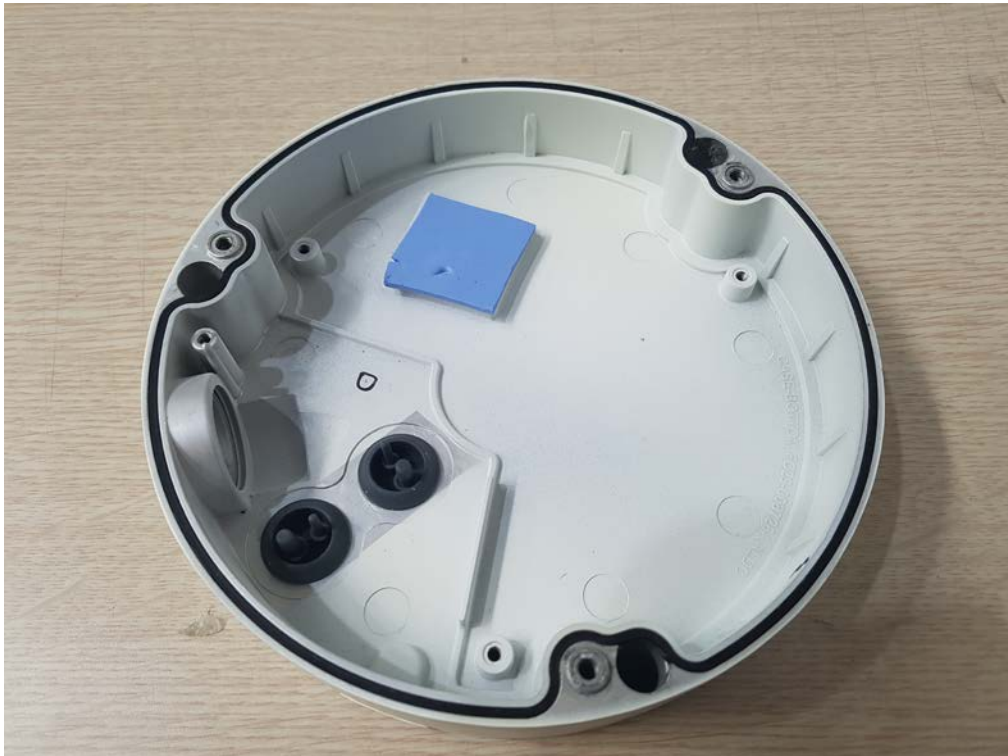
### 3.4.6 TEST Photograph

[During the test]

[Test result confirmation]

| Item | Description |
|---|---|
| Test condition | 1. Immersion tank<br>2. Water-level on enclosure<br>- 1 m above bottom |

| Check List | Test Result |
|---|---|
| Protected against powerful water jets | No abnormal was found |
