# TEST REPORT

REPORT No.:  
CTK-2025-02254  
Page (1) / (14) pages

NETWORK CAMERA / XNV-A9084R

IEC 60529:1989 +A1:1999+A2:2013

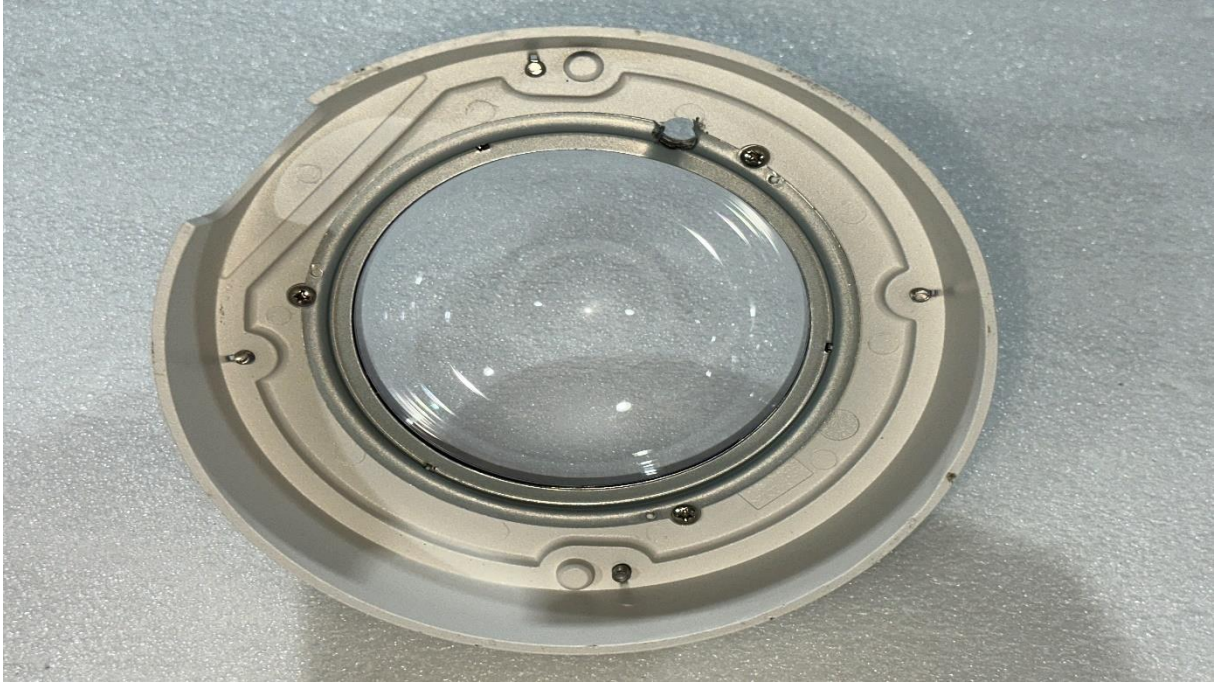
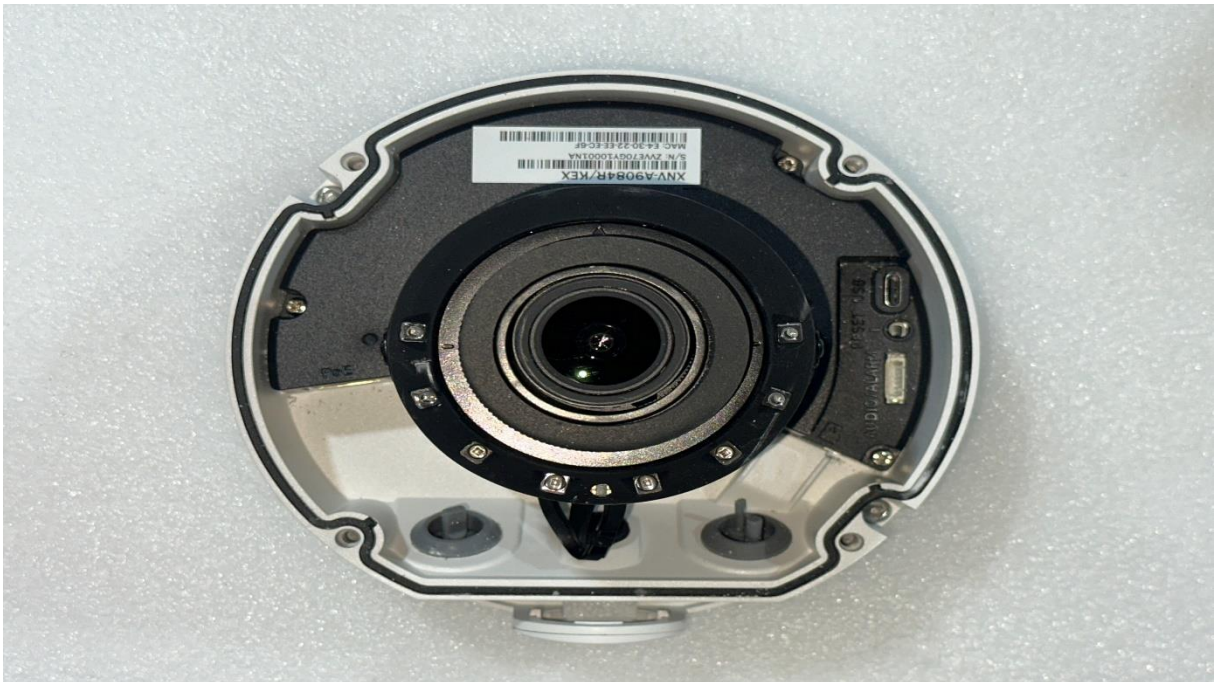
#### 3.5.1 Product internal images after test [The first characteristic numeral test]

| IP code | Evaluation Criteria | Test Results | Remark |
|---|---|---|---|
| IP 6X | No ingress of Probe | Normal | - |
| | No ingress of dust | Normal | - |

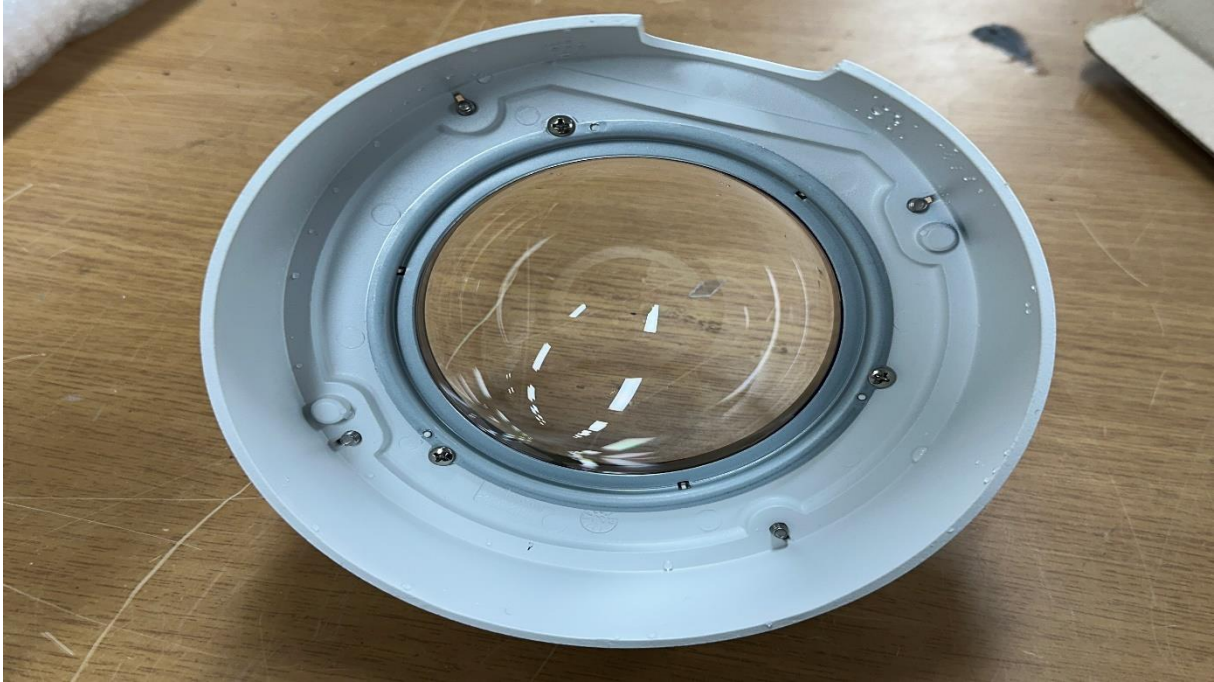
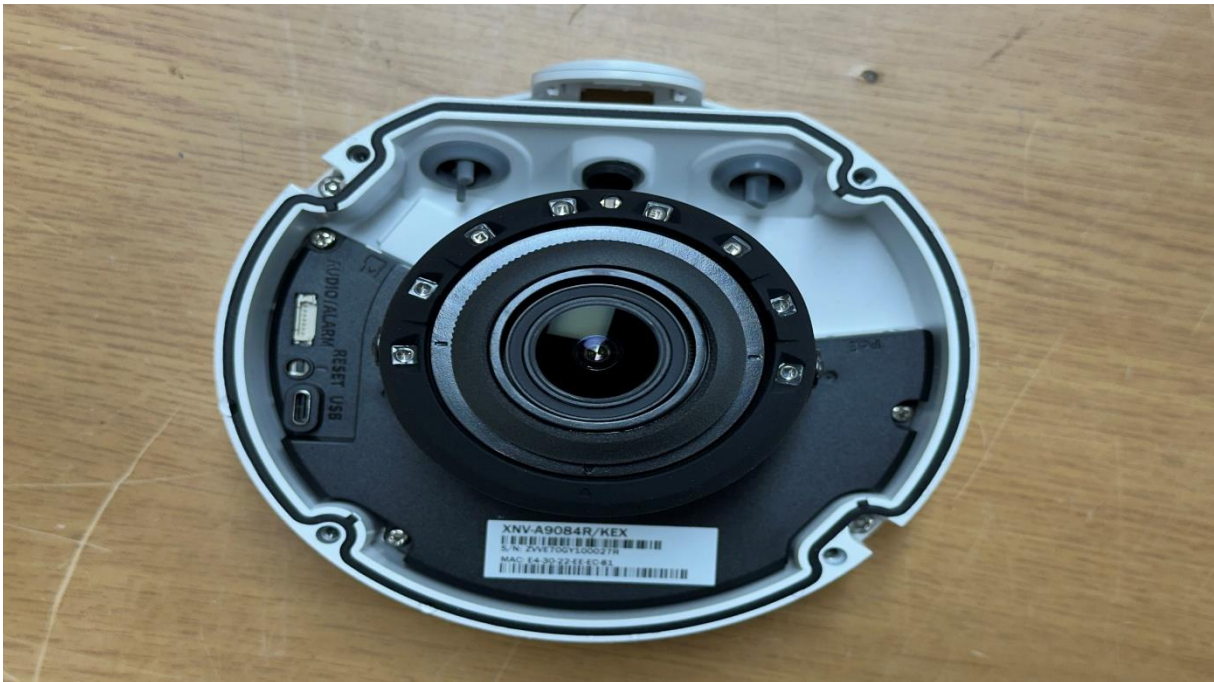
### 3.5.2 Product internal images after test [The second characteristic numeral test]

| IP code | Evaluation Criteria | Test Results | Remark |
|---|---|---|---|
| IP X7 | No ingress of water | Normal | - |
