# TEST REPORT

REPORT No.:  
CTK-2026-00728  
Page (1) / (31) pages

NETWORK CAMERA / XNV-A8014R

NEMA TS-2:2021 2.2.7.3 Test C ~ 2.2.7.8 Test H,  
NEMA TS-2 2.2.8, NEMA TS-2 2.2.9

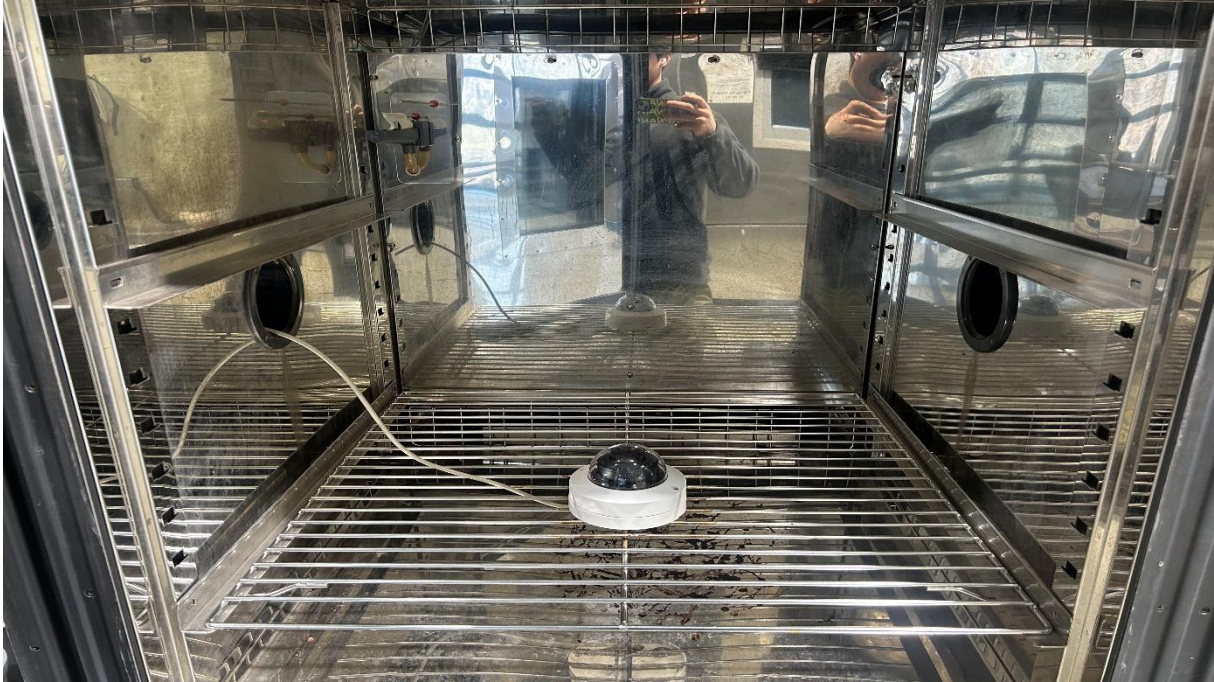
#### 3.9.1 Evidence of test setting

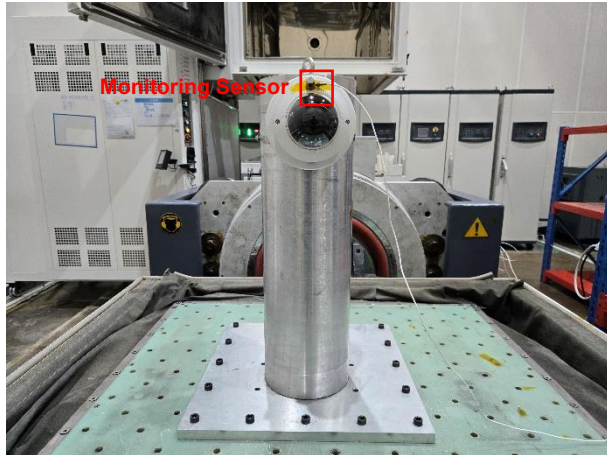
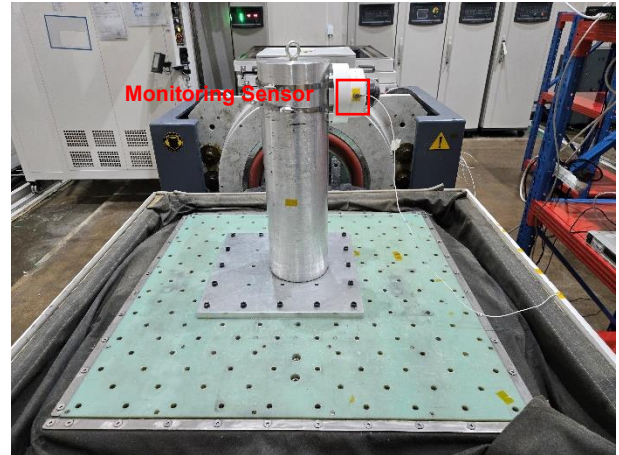
### 4.4.1 Evidence of test setting (NEMA TS-2:2021 2.2.8)

※ The control sensors for the X and Y axes are mounted on the vibration plate.

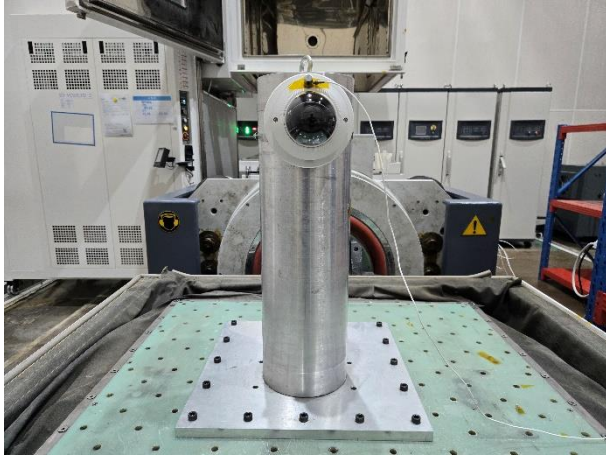
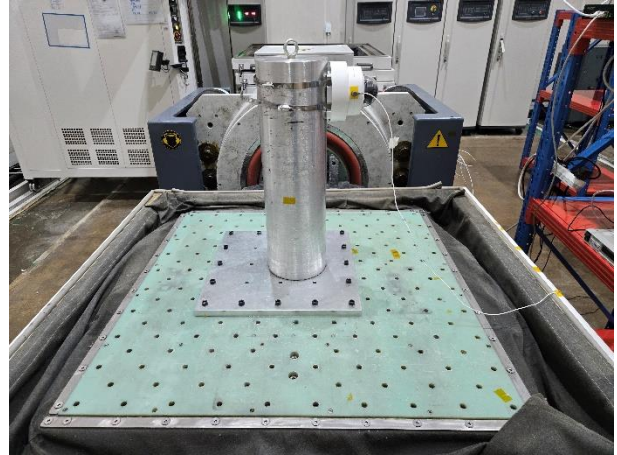
#### 5.3.1 Evidence of test setting (NEMA TS-2:2021 2.1.10)

※ The control sensors for the X and Y axes are mounted on the vibration plate.
