# TEST REPORT

REPORT No.:  
CTK-2026-00726  
Page (1) / (31) pages

NETWORK CAMERA / XNV-A9014R

NEMA TS-2:2021 2.2.7.3 Test C ~ 2.2.7.8 Test H,  
NEMA TS-2 2.2.8, NEMA TS-2 2.2.9

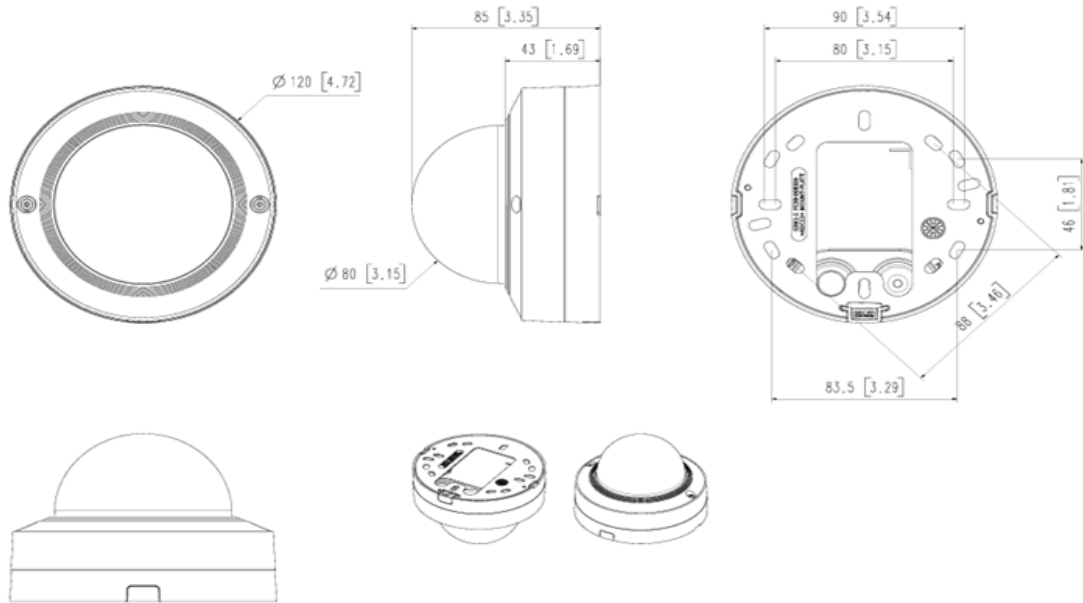
Enclosure dimensions [unit: mm]

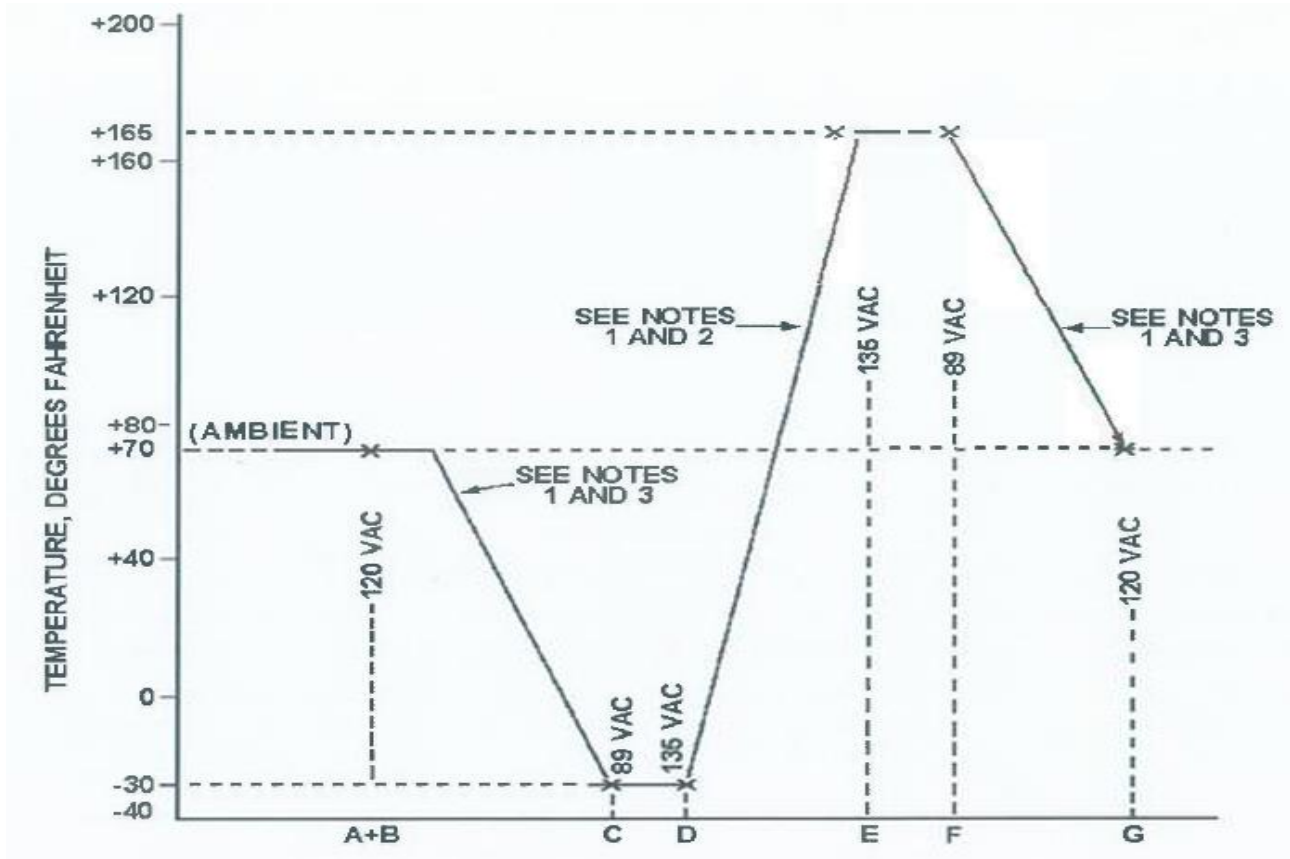
Table 2-1

### 3.8 Test Profile

- 2) Temperature: 74 °C (165 °F).
- 3) Low Voltage: 135 VAC.
- 4) Humidity Control: In accordance with the humidities given in Table 2-1.

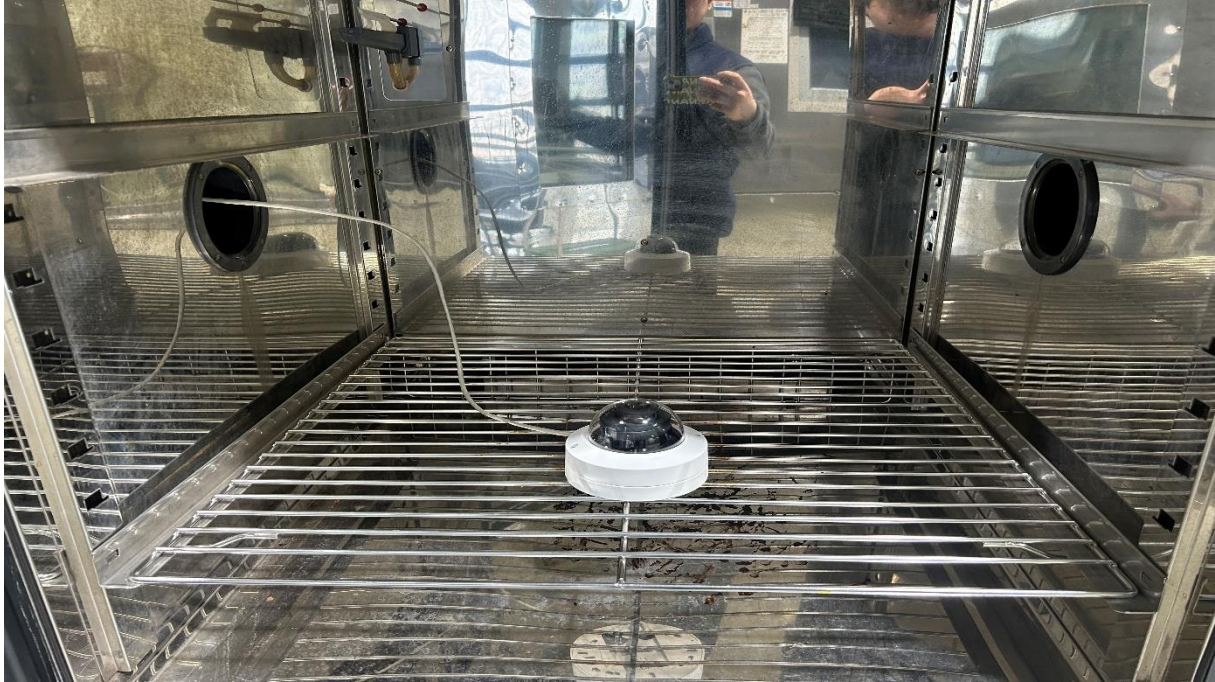
#### 3.9.1 Evidence of test setting

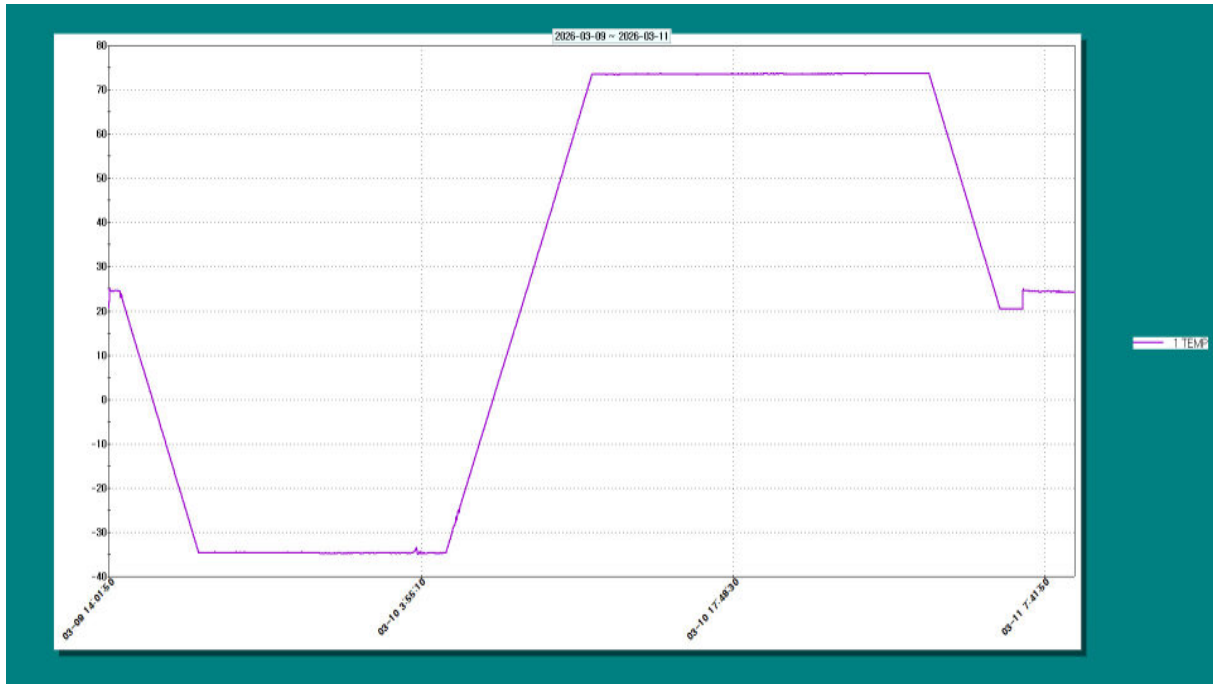
Temperature Data

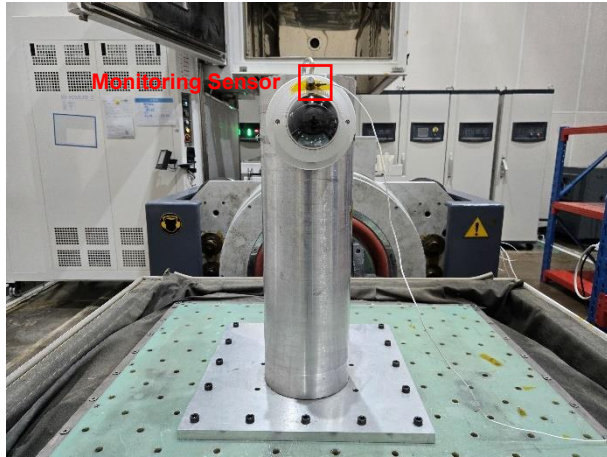
X axis

### 4.4.1 Evidence of test setting (NEMA TS-2:2021 2.2.8)

※ The control sensors for the X and Y axes are mounted on the vibration plate.

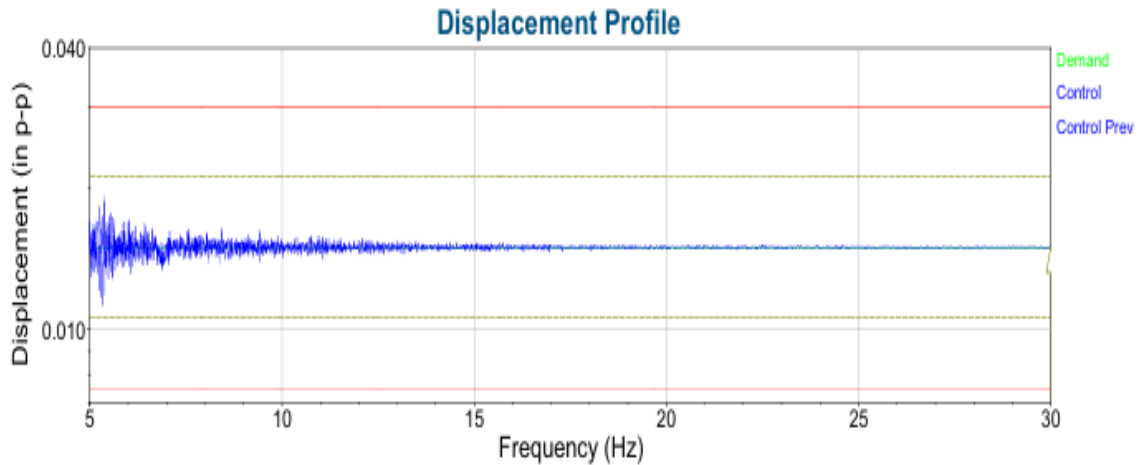
#### Resonant search Test (X Axis)

| 2 23, 2026 16:31:42 | Level 1) 100 % | Output: 0.04631 Volts peak | NEMA TS-2 2.2.8 |
| Demand: 0.015 in | Level Time: 0:12:30 | Frequency: 30 Hz | |
| Control: 0.01501 in | Total Time: 0:12:37 | End of Sweep Test | |

| Axis | Resonant Frequency (Hz) | Comment |
|---|---|---|
| X | - | No resonance detected. |

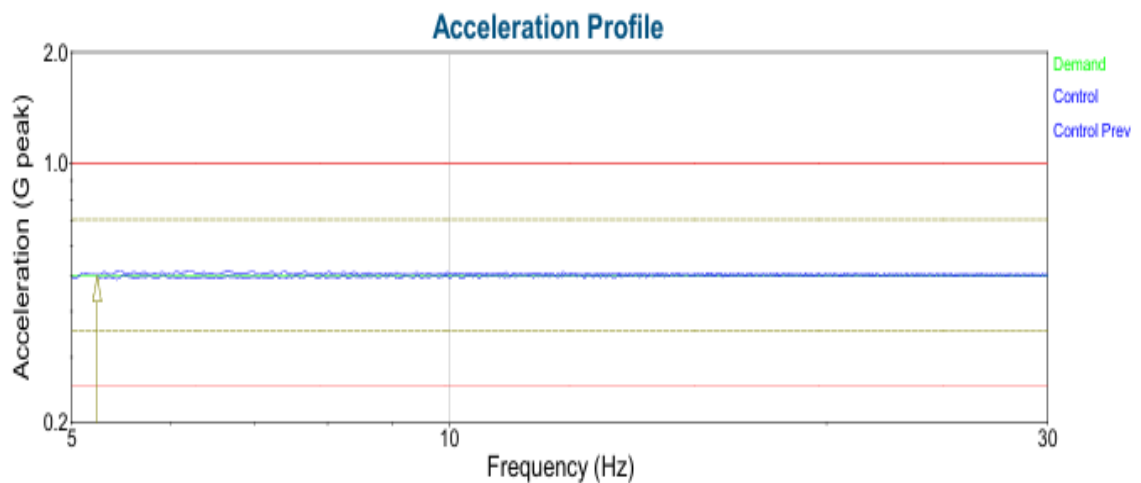
#### Endurance Test (X Axis)

| 2 23, 2026 17:32:56 | Level 1) 100 % | Output: 0.2247 Volts peak | NEMA TS-2 2.2.8 내구 |
| Demand: 0.5 G | Level Time: 01:00:00 | Frequency: 30Hz | |
| Control: 0.4956 G | Total Time: 01:00:00 | Stop Button Pressed | |

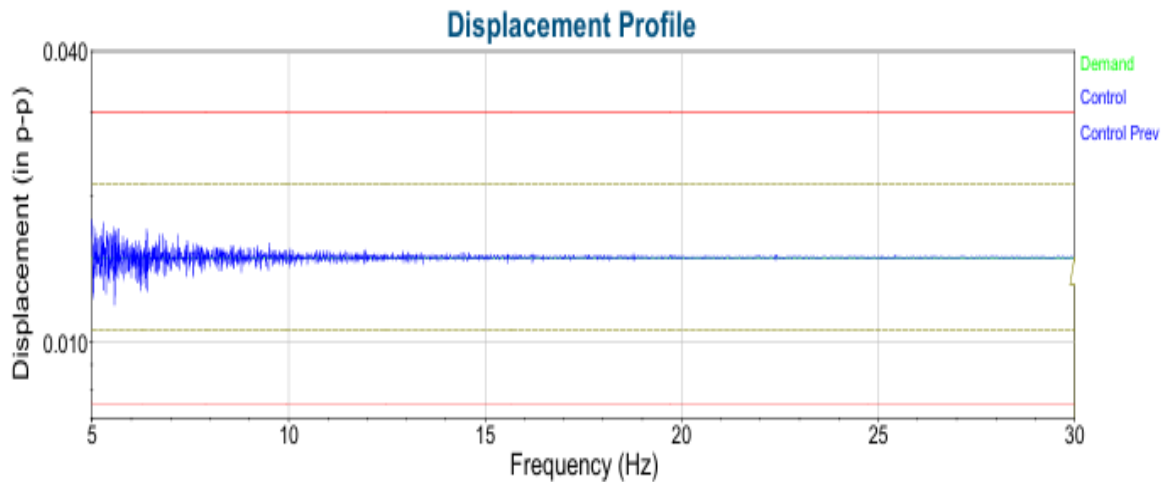
### Resonant search Test (Y Axis)

| 3 03, 2026 11:07:17 | Level 1) 100 % | Output: 0.04566 Volts peak | NEMA TS-2 2.2.8 |
| Demand: 0.015 in | Level Time: 0:12:30 | Frequency: 30 Hz | |
| Control: 0.015 in | Total Time: 0:12:39 | End of Sweep Test | |

| Axis | Resonant Frequency (Hz) | Comment |
|---|---|---|
| Y | - | No resonance detected. |

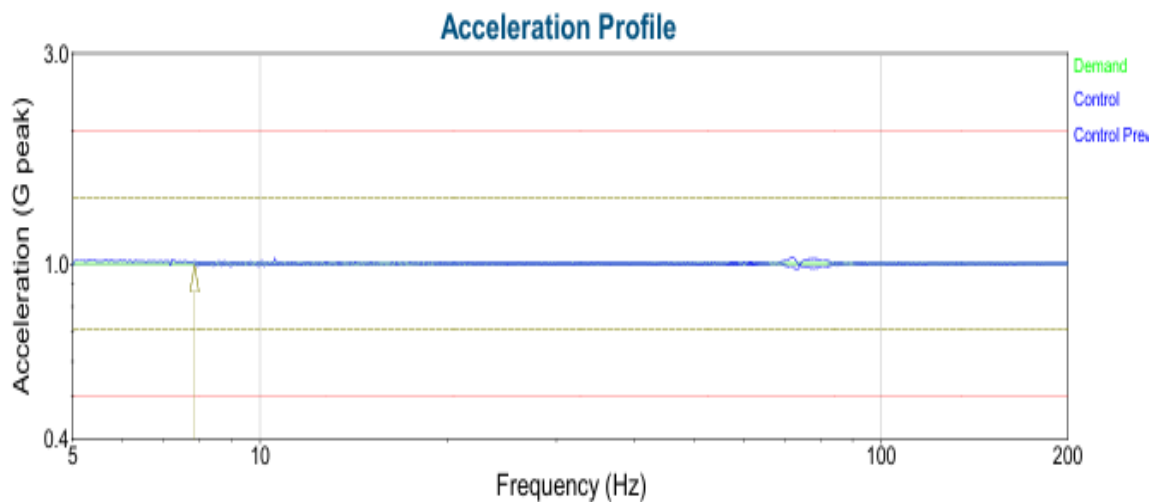
### Endurance Test (Y Axis)

| 3 03, 2026 10:50:11 | Level 1) 100 % | Output: 0.2691 Volts peak | 한화비전 60068-2 |
| Demand: 1 G | Level Time: 01:00:00 | Frequency: 30Hz | |
| Control: 0.9905 G | Total Time: 01:00:00 | End of Timed Test | |

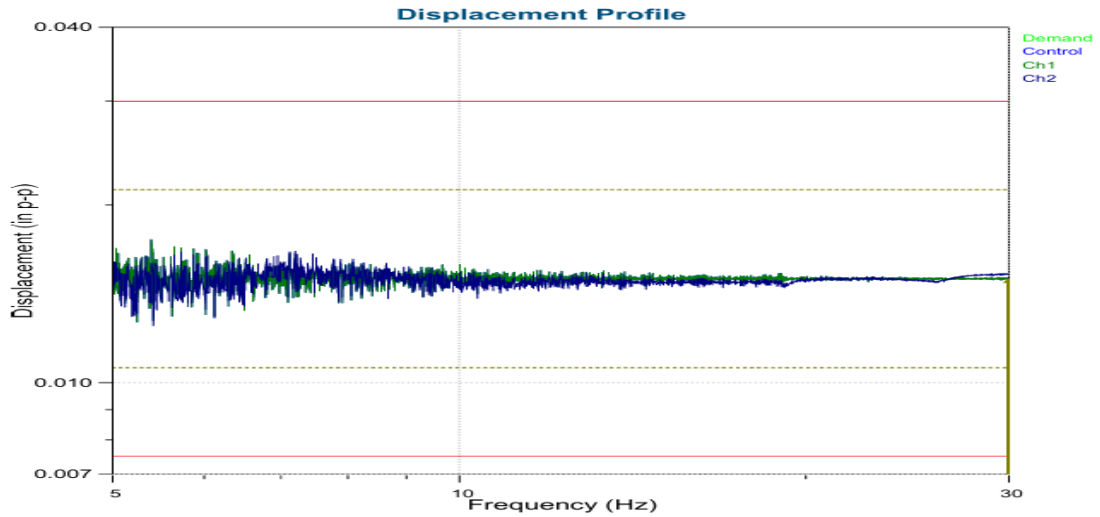
### Resonant search Test (Z Axis)

3 10, 2026 19:05:00 Level 1) 100 % Output: 0.09551 Volts peak 한화비전 NEMA-TS 공진테

Demand: 0.015 in Level Time: 0:12:30 Frequency: 29.97 Hz

Control: 0.01503 in Total Time: 0:12:38 End of Timed Test

| Axis | Resonant Frequency (Hz) | Comment |
|---|---|---|
| Z | - | No resonance detected. |

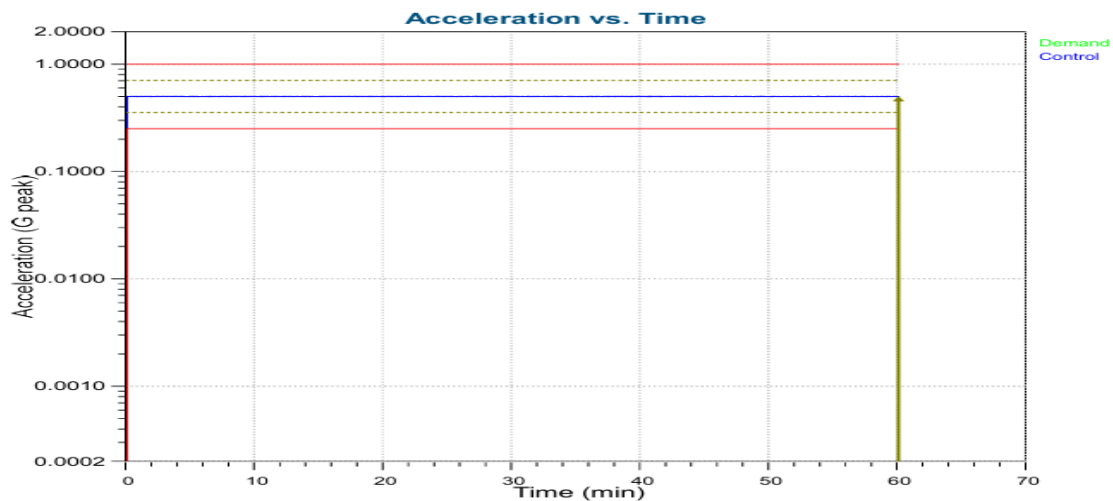
### Endurance Test (Z Axis)

3 10, 2026 20:07:34 Level 1) 100 % Output: 0.07015 Volts peak 20251021 한화비전 NEMA-TS 공진

Demand: 0.5 G Level Time: 1:00:00 Frequency: 30 Hz

Control: 0.50001 G Total Time: 1:00:00 End of Timed Test

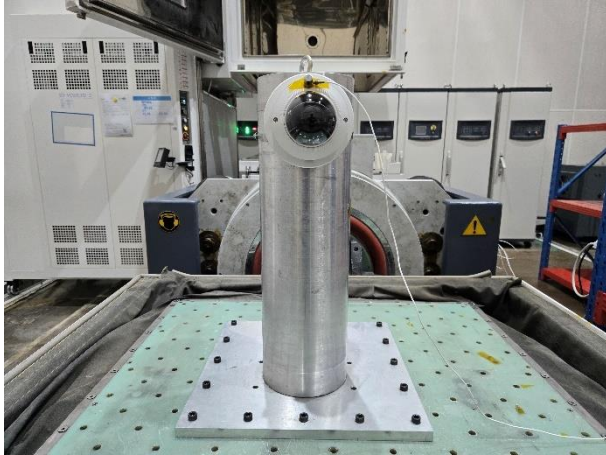
X axis

#### 5.3.1 Evidence of test setting (NEMA TS-2:2021 2.1.10)

※ The control sensors for the X and Y axes are mounted on the vibration plate.

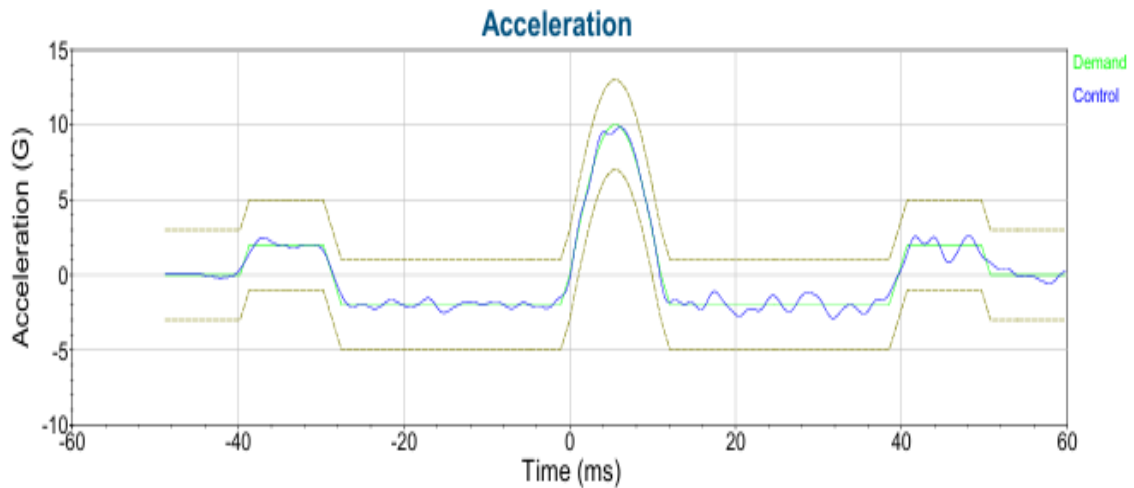
Mechanical Chock data +X Axis

2 23, 2026 16:09:53    Level 1) 100 %    Output: 0.4858 Volts peak    NEMA TS-2 2.2.9  
Demand: 10 G  
Control: 9.835 G    Pulse: 1 of 1    Running

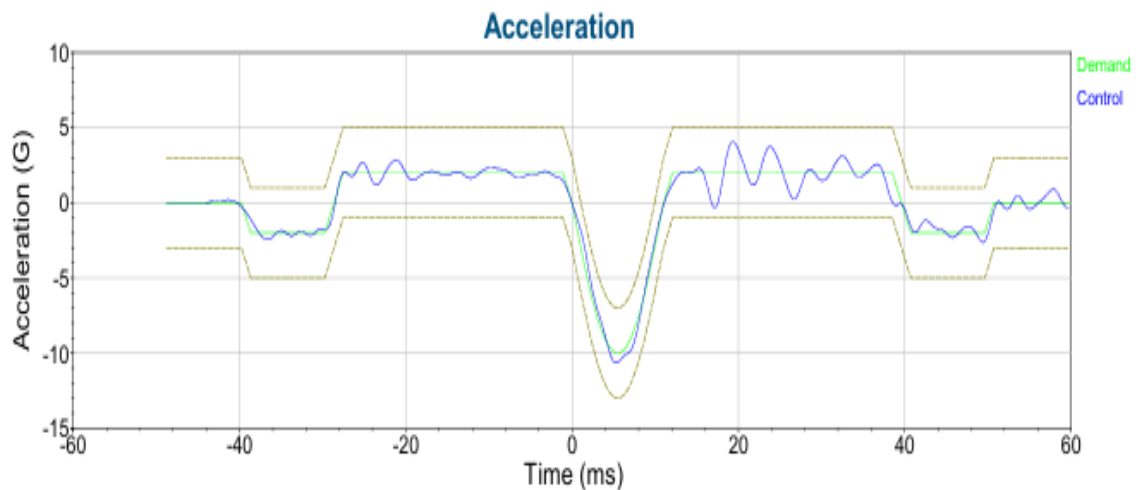
Mechanical Chock data -X Axis

2 23, 2026 16:09:58    Level 2) 100 %    Output: 0.481 Volts peak    NEMA TS-2 2.2.9  
Demand: 10 G  
Control: 10.66 G    Pulse: 1 of 1    End of Test

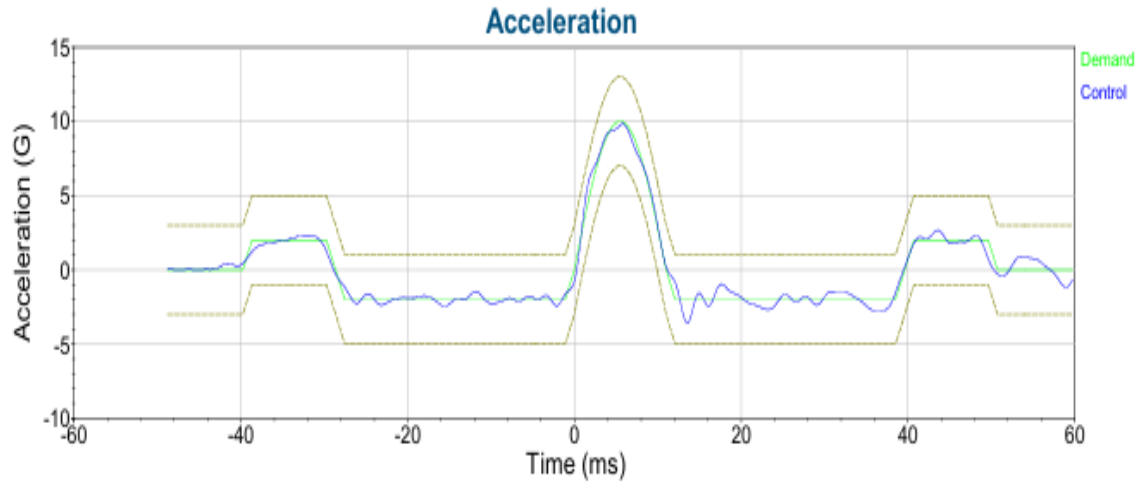
Mechanical Chock data +Y Axis

3 03, 2026 13:22:06    Level 1) 100 %    Output: 0.5356 Volts peak    NEMA TS-2 2.2.9  
Demand: 10 G  
Control: 9.815 G    Pulse: 1 of 1    Running

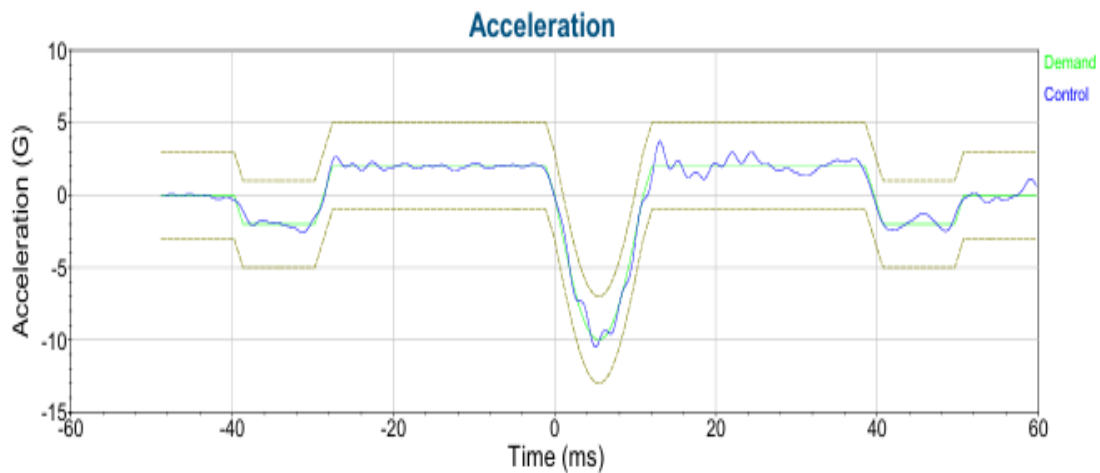
Mechanical Chock data -X Axis

3 03, 2026 13:22:11    Level 2) 100 %    Output: 0.5352 Volts peak    NEMA TS-2 2.2.9  
Demand: 10 G  
Control: 10.52 G    Pulse: 1 of 1    End of Test

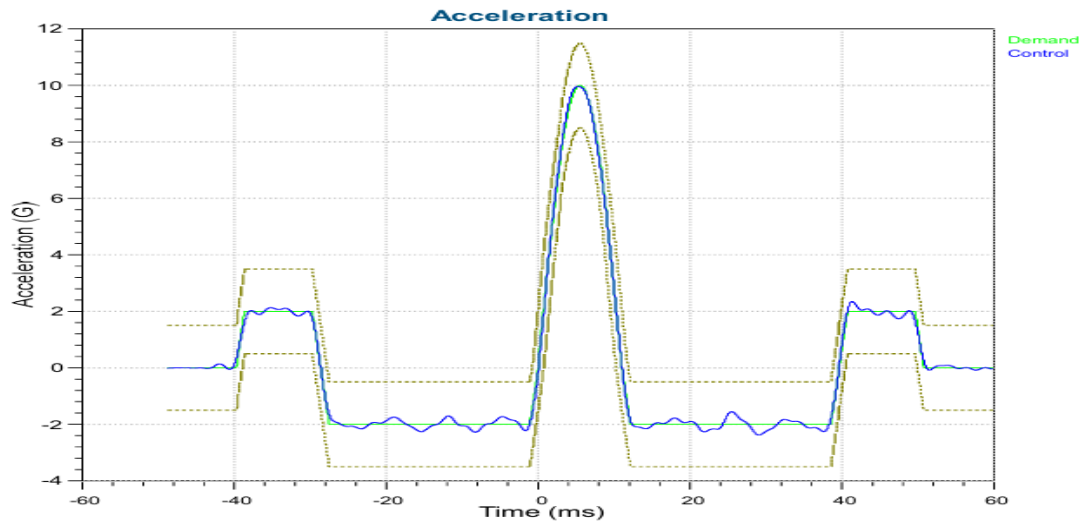
#### Mechanical Chock data +Z Axis

3 11, 2026 09:08:12 Level 1) 100 % Output: 0.9603 Volts peak 251021 NEMA TS-2 2.2.9

Demand: 10 G

Control: 9.958 G Pulse: 1 of 1 Running
