# TEST REPORT

REPORT No.:  
CTK-2026-00008  
Page (1) / (13) pages

NETWORK CAMERA / XNV-A9016R

IEC 60529:1989 +A1:1999+A2:2013

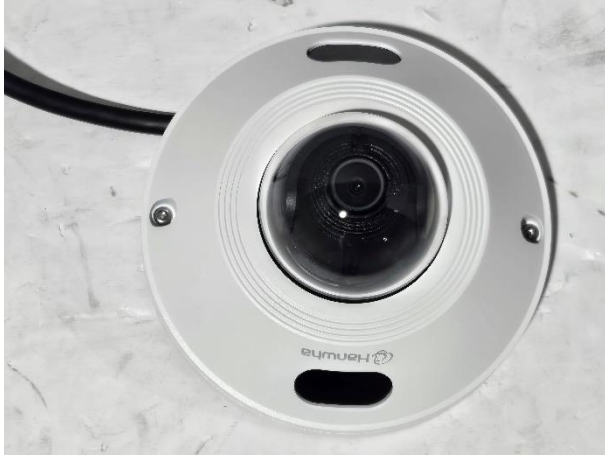
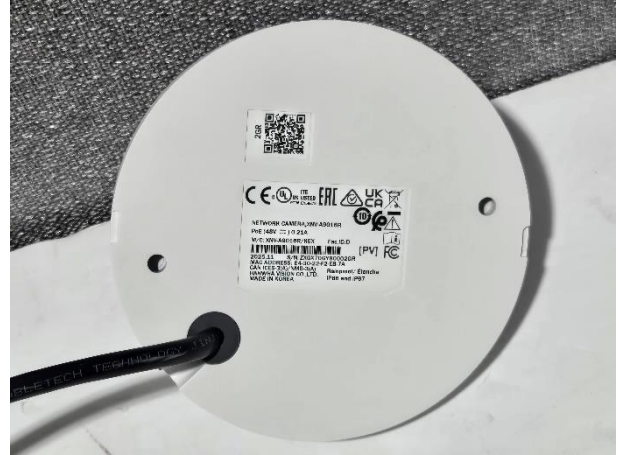
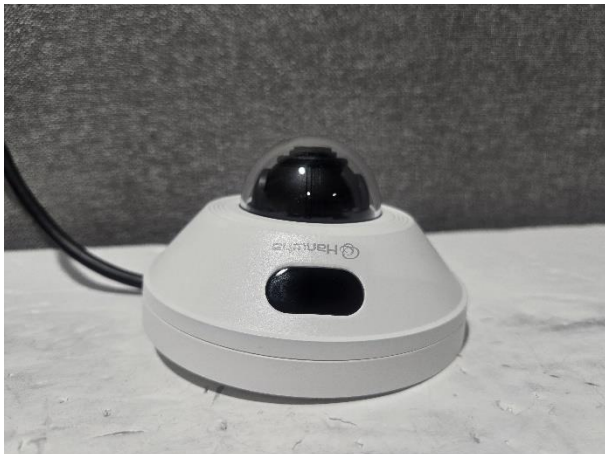
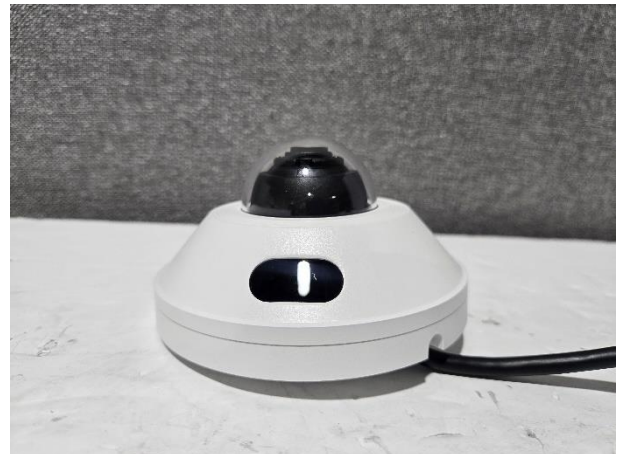
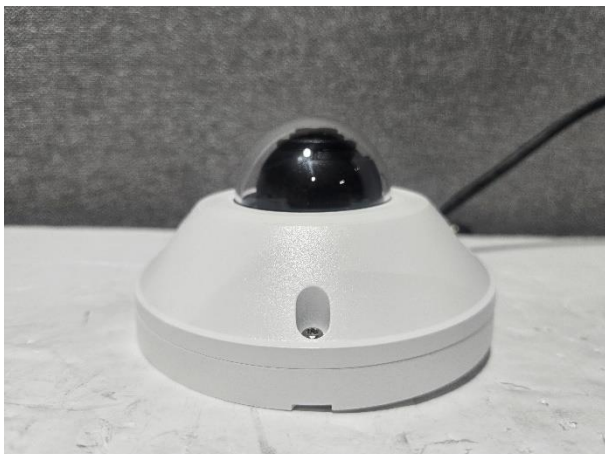
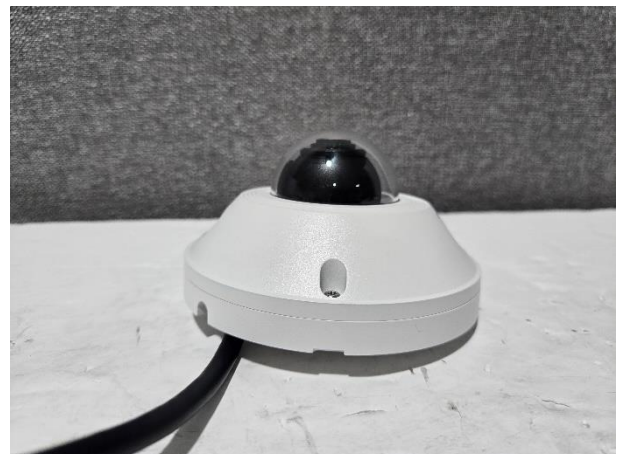
### 2.4.1 Test sample #1

Top

Bottom

Front

Rear

Left side

Right side

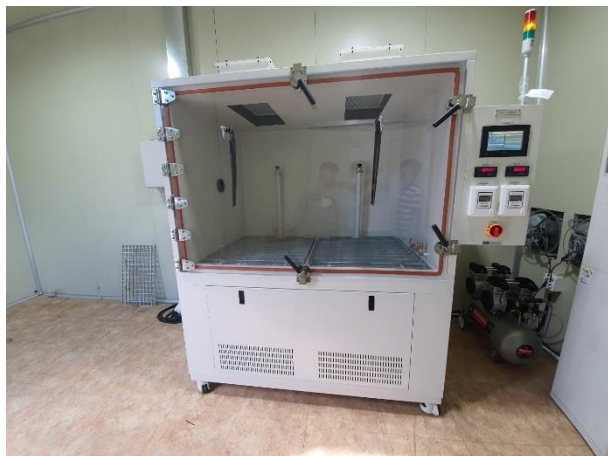
Dust Chamber

| First characteristic numeral | Degree of protection | Application |
|---|---|---|
| 6 | <p>In Dust Testing Equipment, the test sample must have no ingress of dust after testing atmospheric pressure present condition for 8 h.</p> <p>(The talcum powder must pass through a calibrated sieve with a 50 µm wire mesh, spaced at 75 µm intervals in a square pattern. Additionally, the bulk density of the talcum powder should be 2 kg/m<sup>3</sup>)</p> <p>Products in volume .....: <b>740.412 cm<sup>3</sup> → 0.740 L</b></p> <p>Target intake volume (Products in volume 80) : <b>59.232 L</b></p> <p>Suction volume (Max product in volume 60) ...: <b>44.424 LPH → 0.740 LPM</b></p> <p>Actual Suction volume .....: <b>0.738 L</b></p> <p>Suction pressure (Up to 2 kPa) .....: <b>2 kPa</b></p> <p>Test time (Up to 8 time) .....: <b>8 hr</b></p> | <input checked="" type="checkbox"/> |

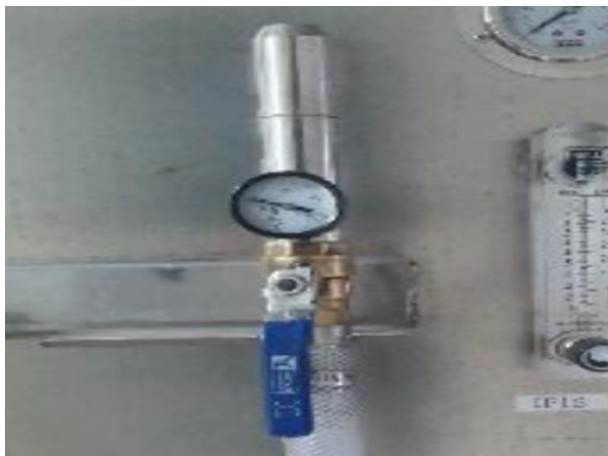
Hose Nozzle (12.5 mm)

| Second characteristic numeral | Degrees of protection | Application |
|---|---|---|
| 6 | <p>The product must not be harmed in any direction even strong jet water.</p> <p>Water jet hose nozzle Fig.6, Nozzle 12.5 mm diameter</p> <p>Water flow rate: 100 l/min ± 5 % : <b>100 LPM</b></p> <p>Distance: 2.5 m to 3 m: <b>3 m</b></p> <p>Duration of test: 1 min/m<sup>2</sup> at least 3 min: <b>3 min</b></p> | <input checked="" type="checkbox"/> |

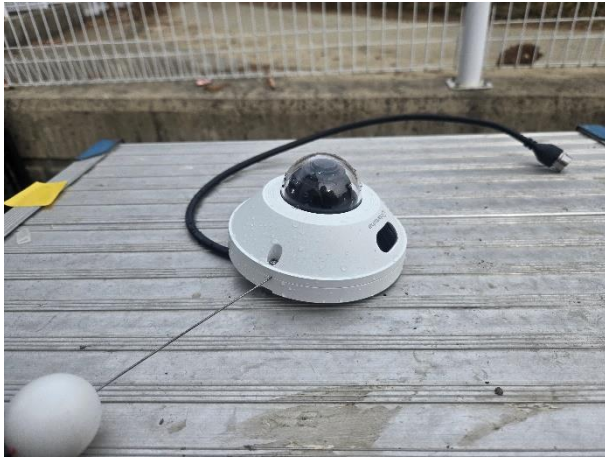
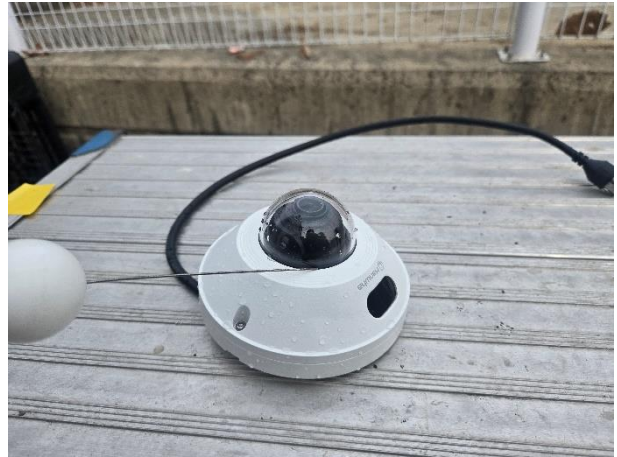
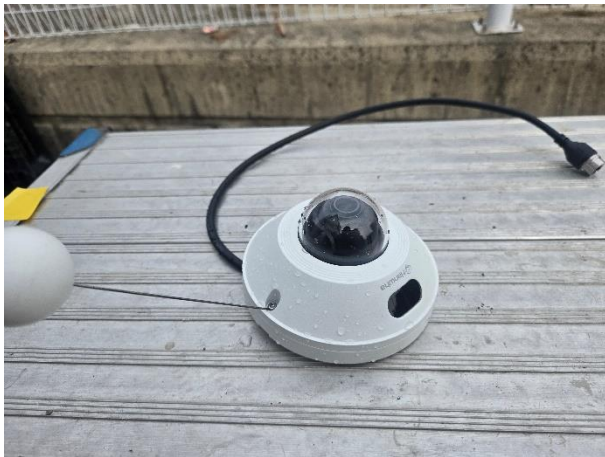
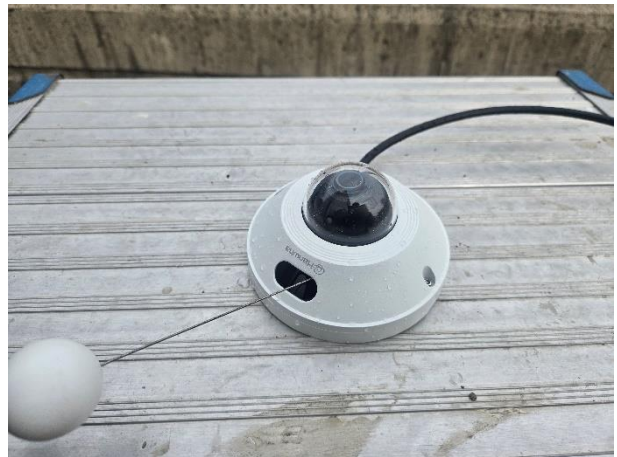
#### 3.3.1 Evidence of test setting (1)

Probe test

| First characteristic numeral | Degree of protection | Application |
|---|---|---|
| 6 | Protected against access to hazardous parts with a wire.<br>The access probe of 1.0 mmØ, shall not penetrate.<br>Test force: 1 N ± 10 % | <input checked="" type="checkbox"/> |

| IP code | Evaluation Criteria | Test Results | Remark |
|---|---|---|---|
| IP 6X | No ingress of Probe | Normal | - |

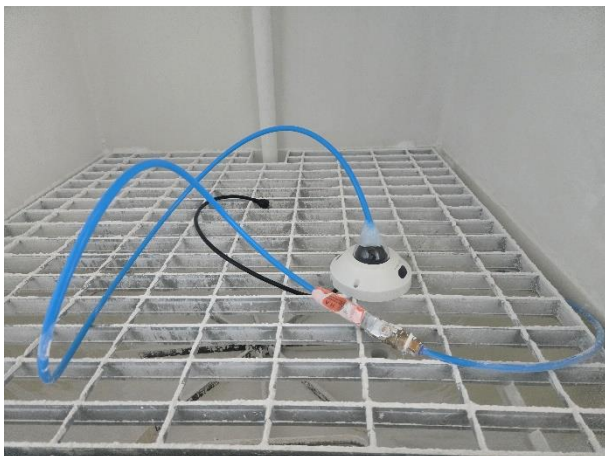
Dust test

| IP code | Evaluation Criteria | Test Results | Remark |
|---|---|---|---|
| | No ingress of dust | Normal | |

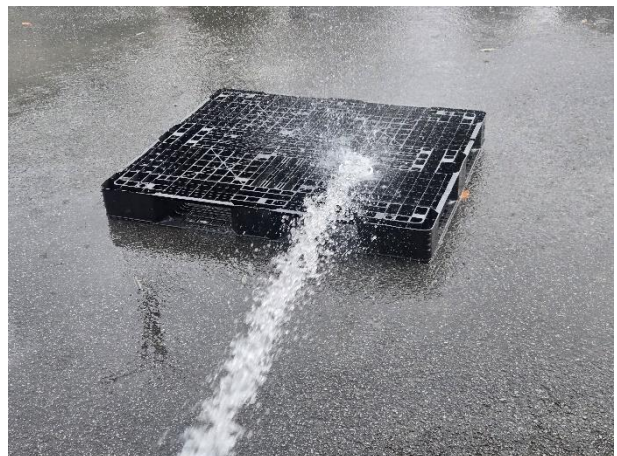
Water test

| IP code | Evaluation Criteria | Test Results | Remark |
|---|---|---|---|
| IP X6 | No ingress of water | Normal | |

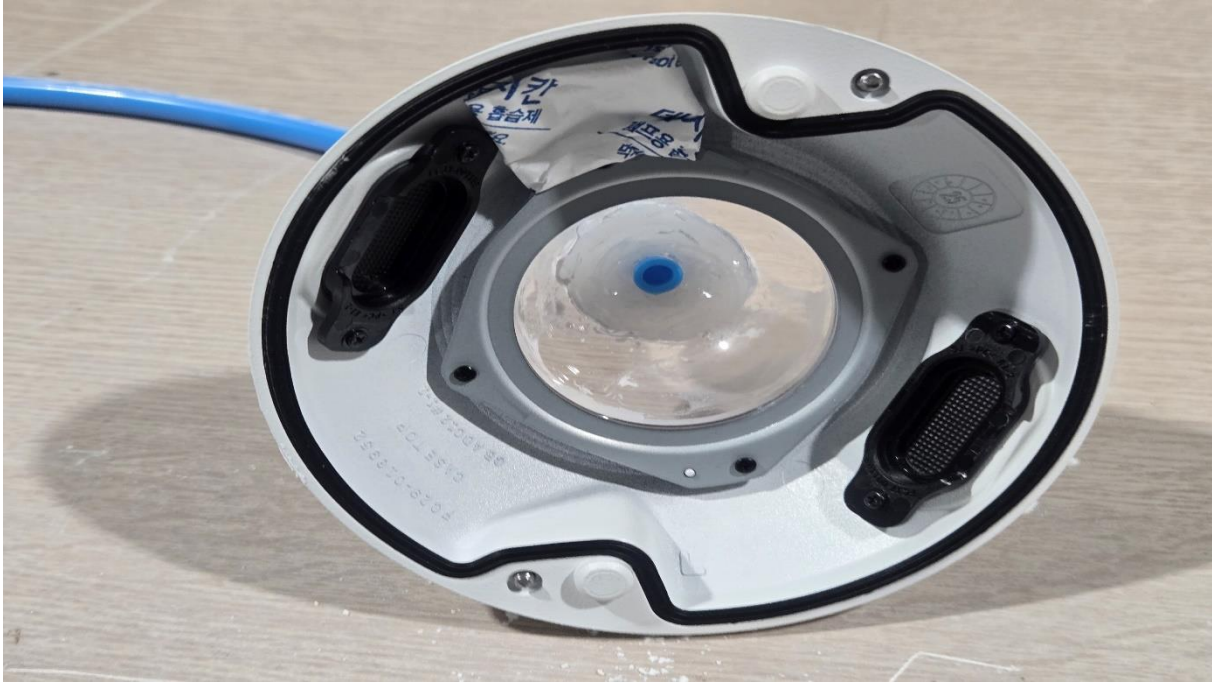
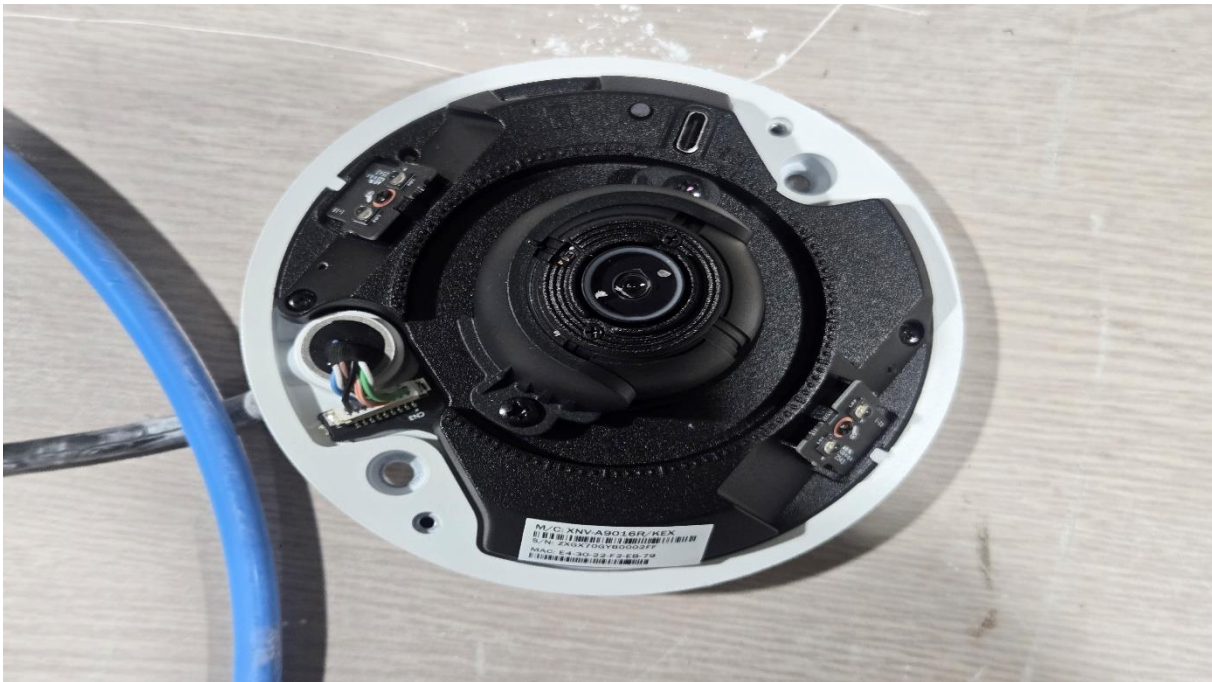
#### 3.5.1 Product internal images after test [The first characteristic numeral test]

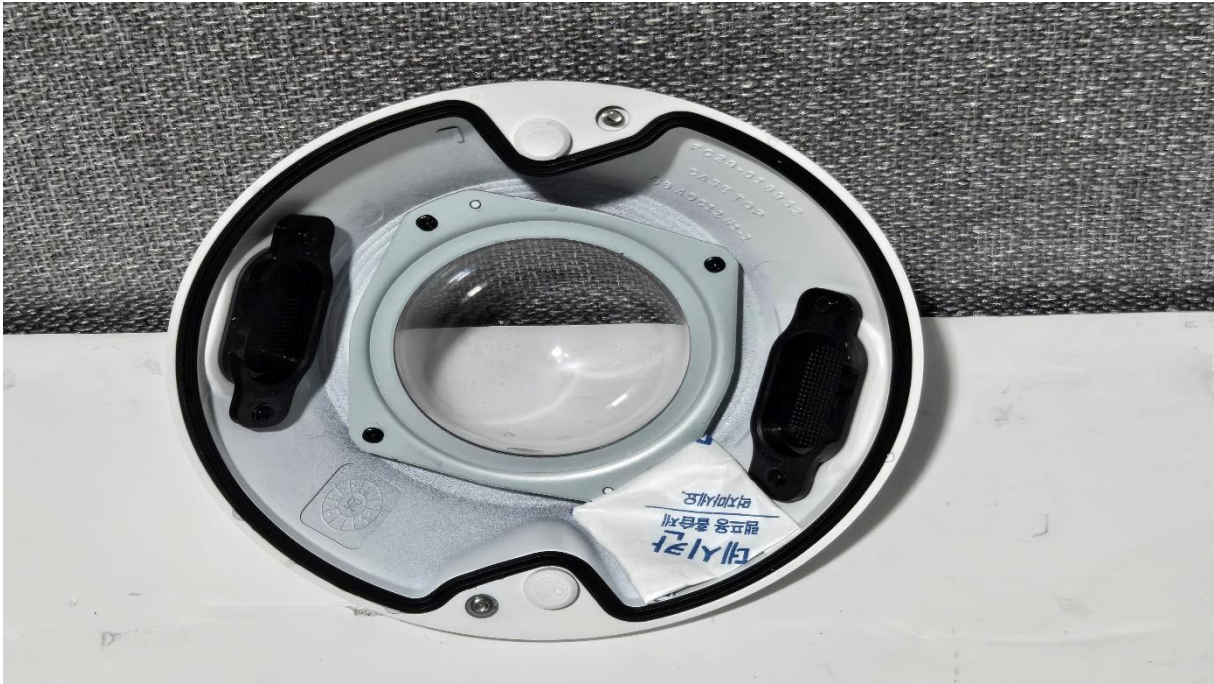
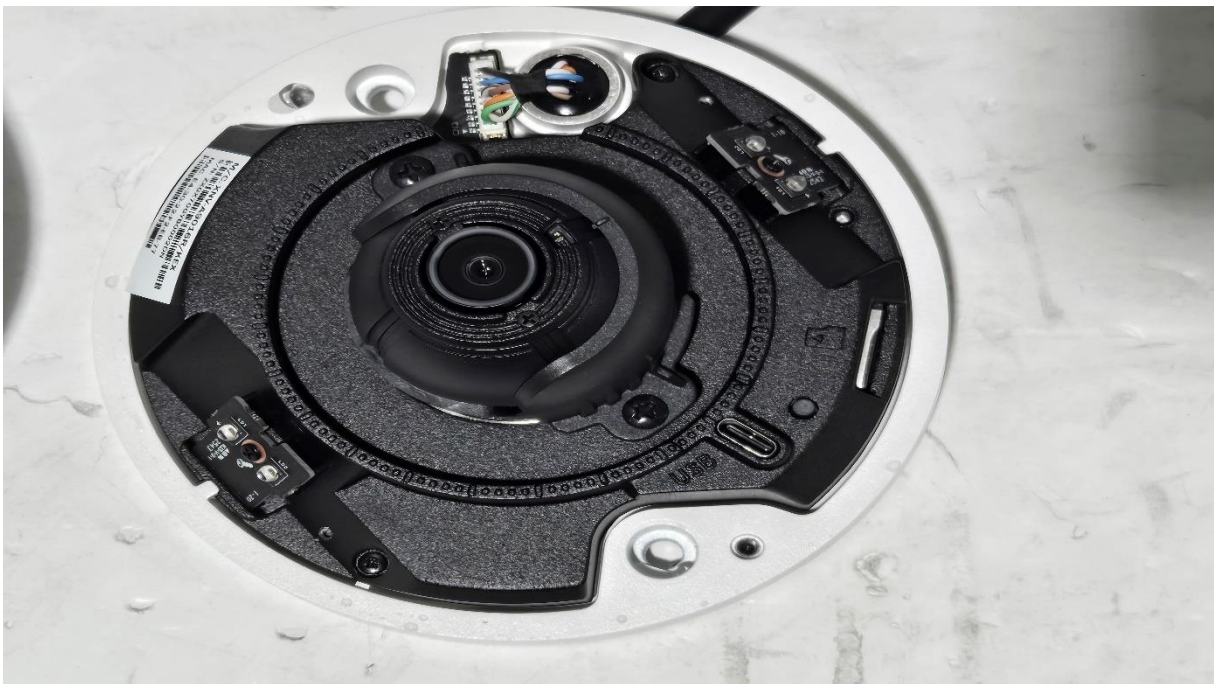
### 3.5.2 Product internal images after test [The second characteristic numeral test]
