# TEST REPORT

REPORT No.:  
CTK-2025-02942  
Page (1) / (12) pages

NETWORK CAMERA / XNV-A9085R

IEC 62262:2002+AMD1:2021

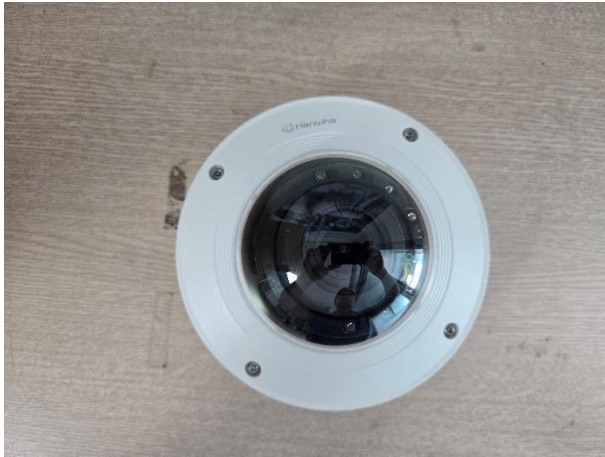
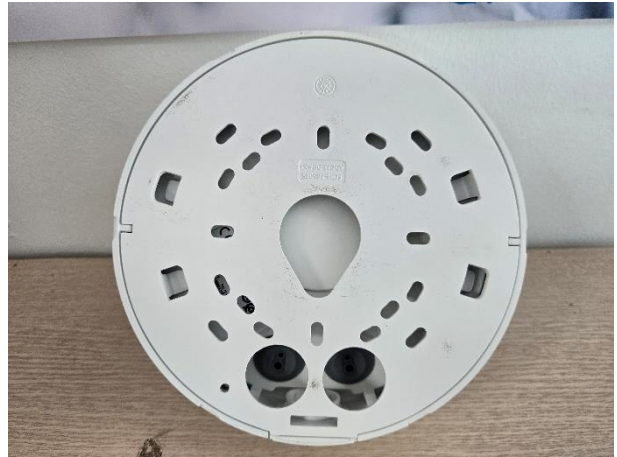
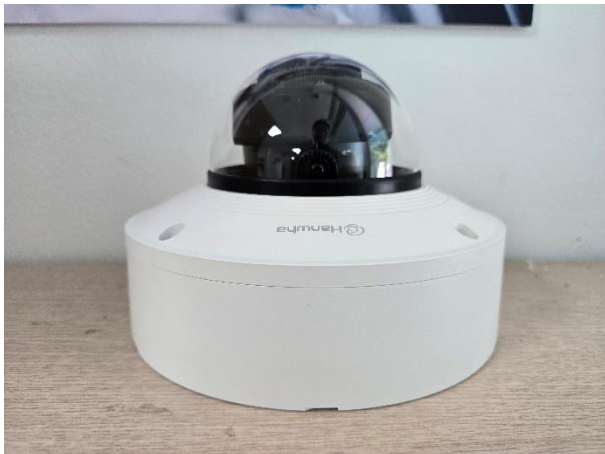
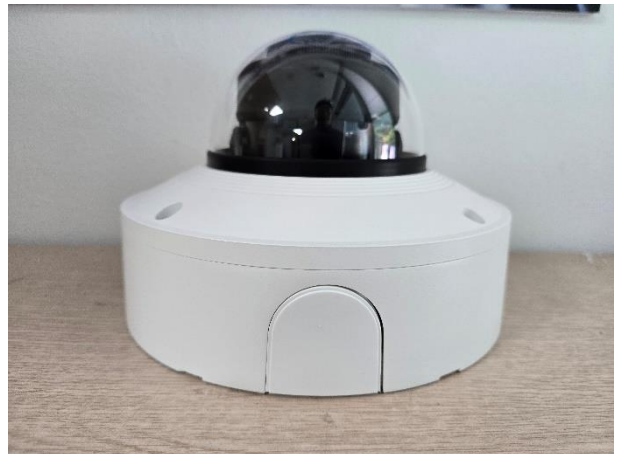
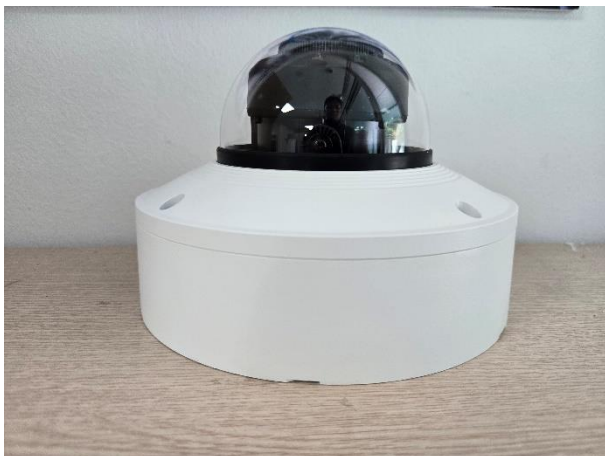
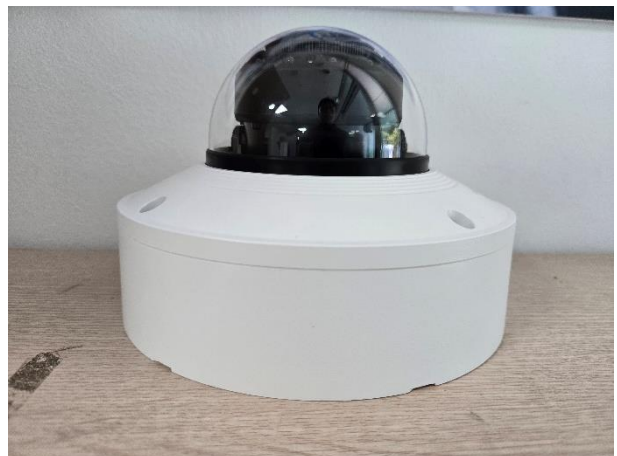
### 2.4.1 Test sample #1

Top

Bottom

Front

Rear

Left side

Right side

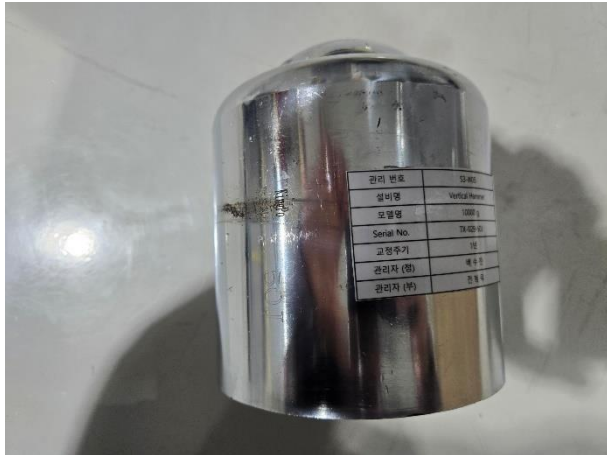
Vertical Hammer

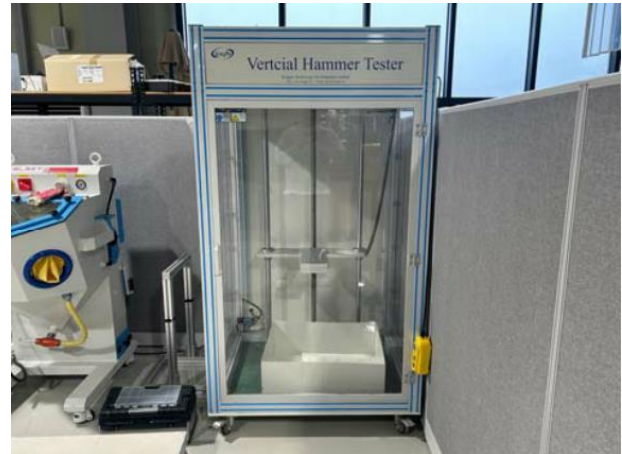
Vertical Hammer Tester

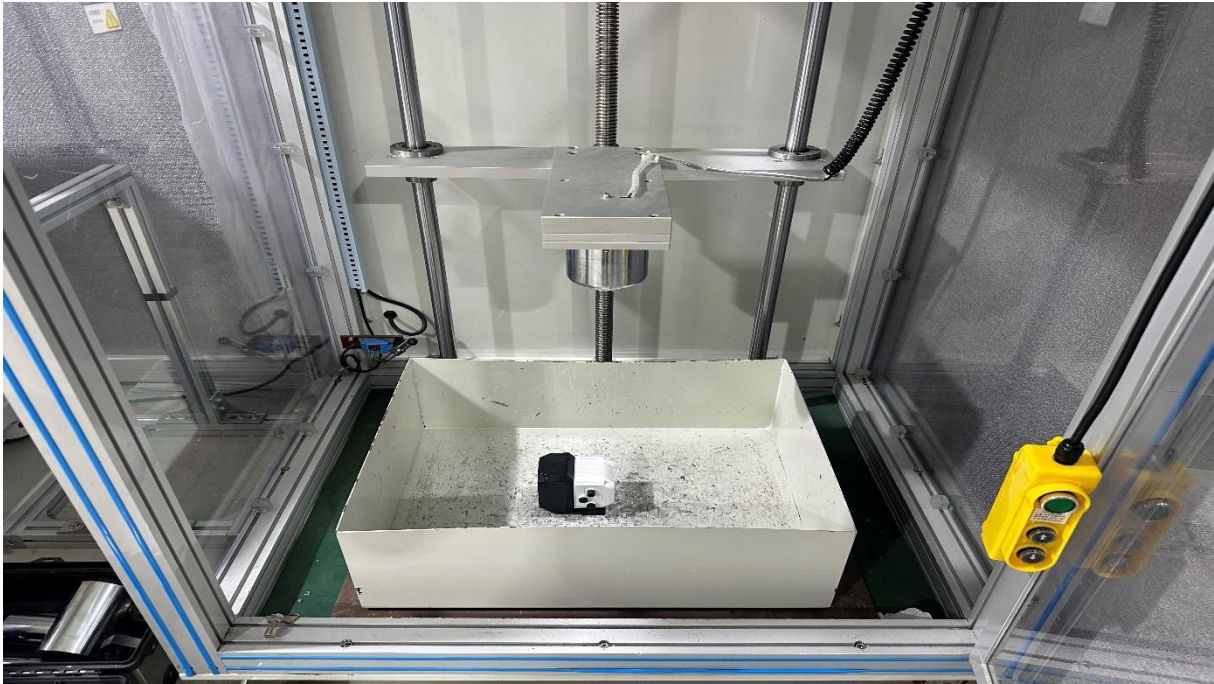
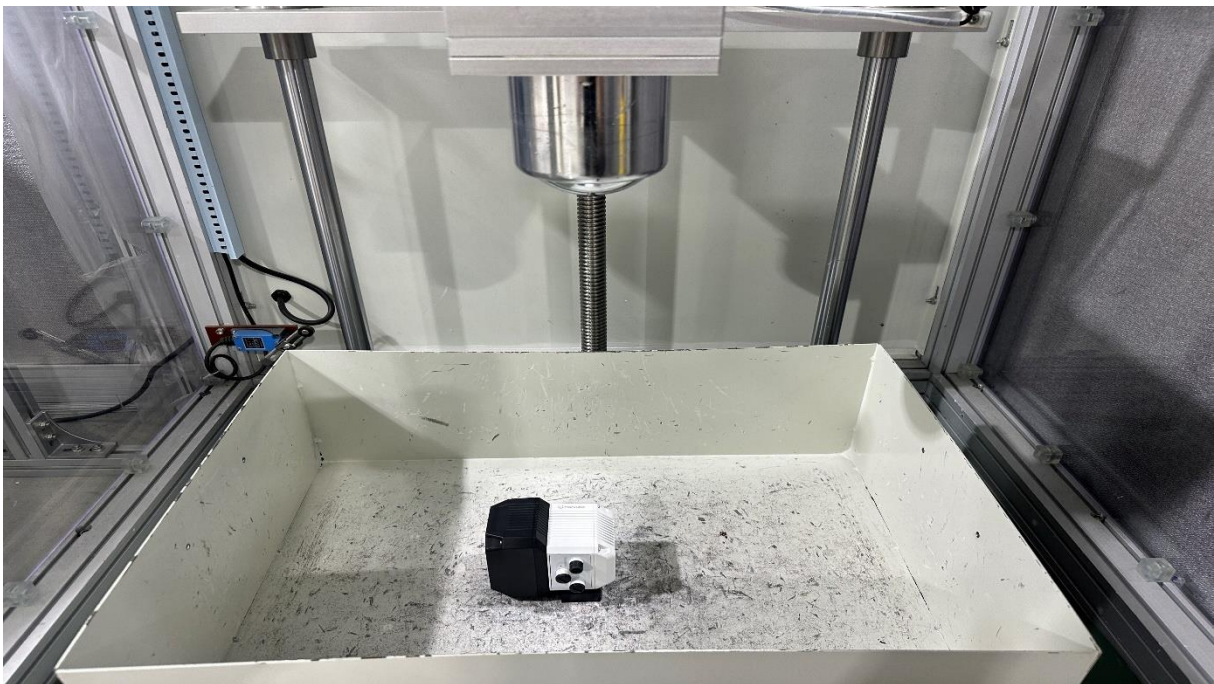
#### 3.3.1 Evidence of test setting (1)

| IK code | Impact Energy (J) | Equivalent mass (kg) | Drop height (mm ± 1%) | Application |
|---|---|---|---|---|
| 11 | 50.00 | 10.00 | 500 | <input checked="" type="checkbox"/> |

Impact times: five times for each of the exposed surface. (Do not impact more than 3 times in the same spot)

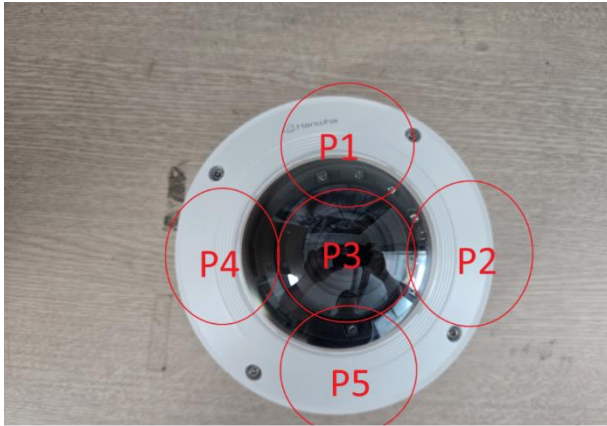
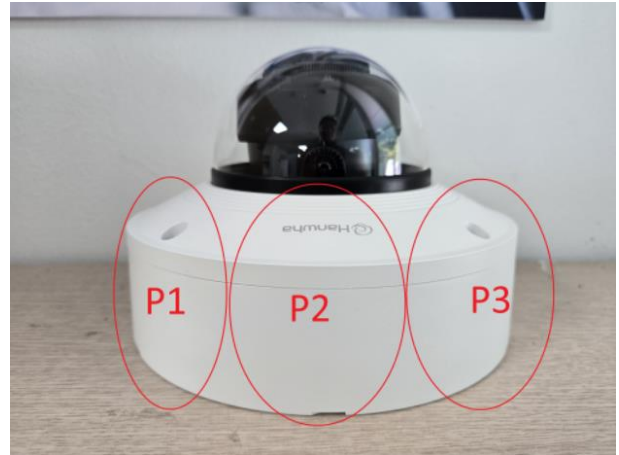
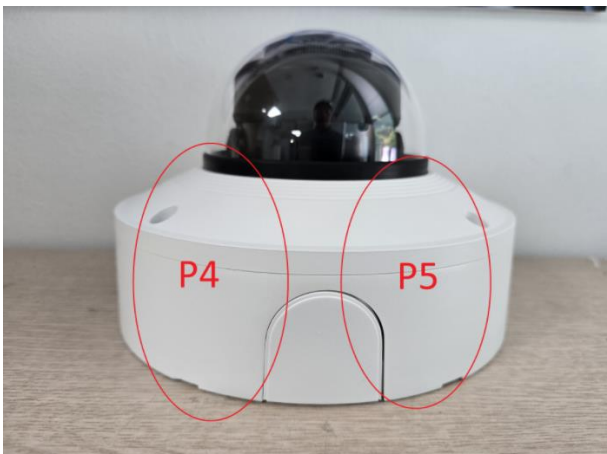
#### 3.5.1 Check the hit area during the test

Check the hit area the test\_1

Check the hit area the test\_2

Check the hit area the test\_3

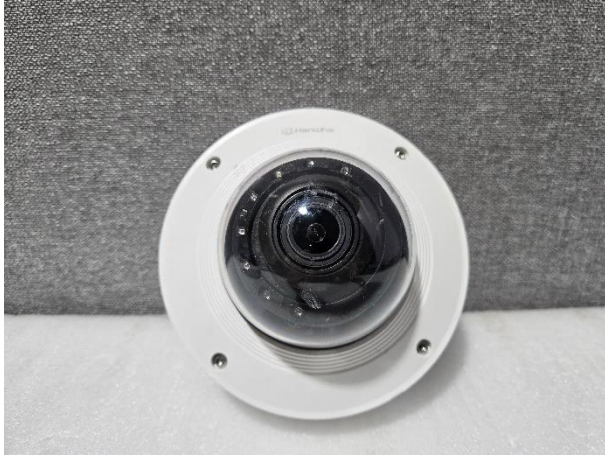
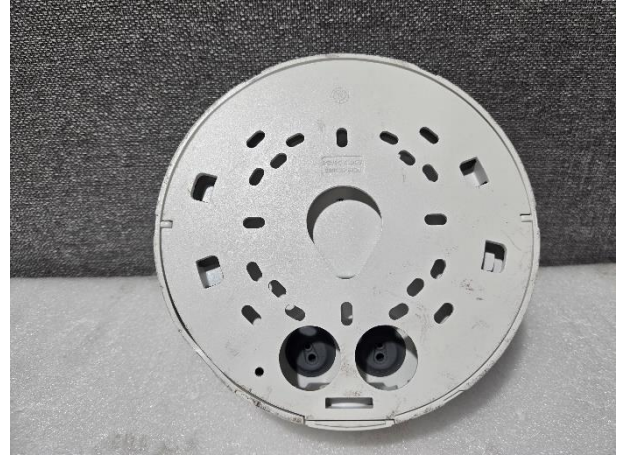
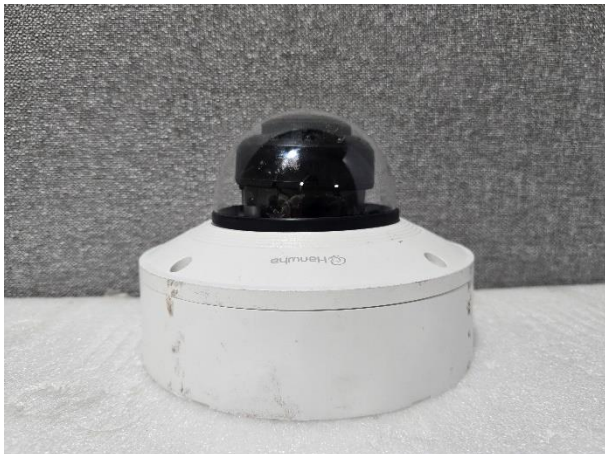
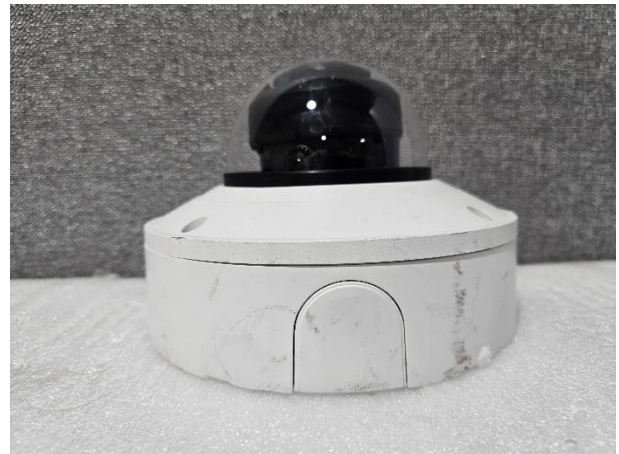
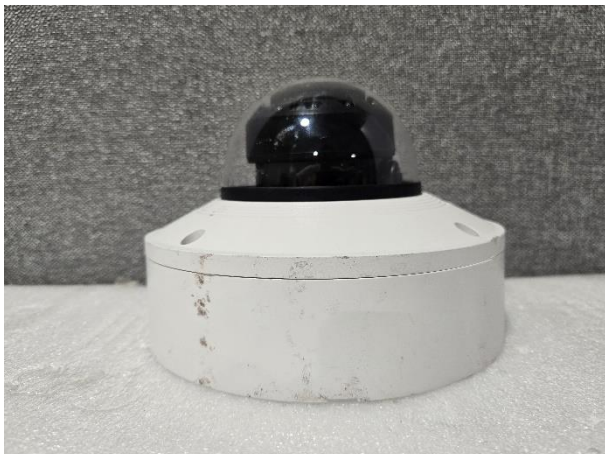
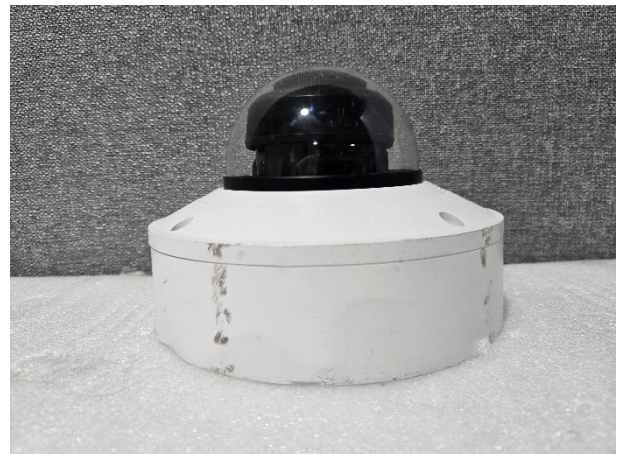
### 3.5.2 Post-test product images

| Evaluation Criteria | Test Results | Remark |
|---|---|---|
| Visual Inspection | Some scratches were generated on the outside of the product. | - |

※ Refer to the product photos after the completion of testing in section 3.5.2
