# TEST REPORT

REPORT No.:  
CTK-2025-02940  
Page (1) / (13) pages

NETWORK CAMERA / XNV-A9085R

IEC 60529:1989 +A1:1999+A2:2013

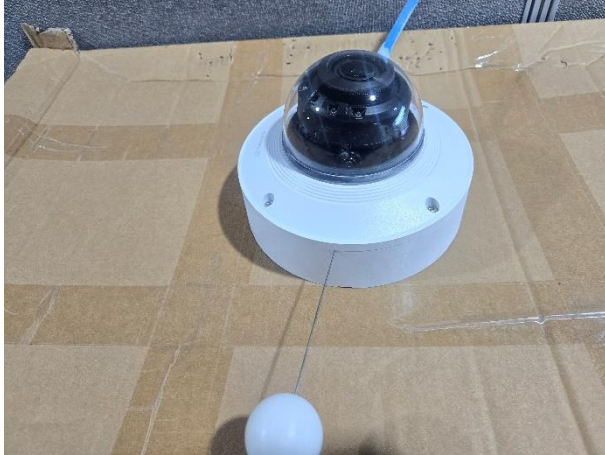
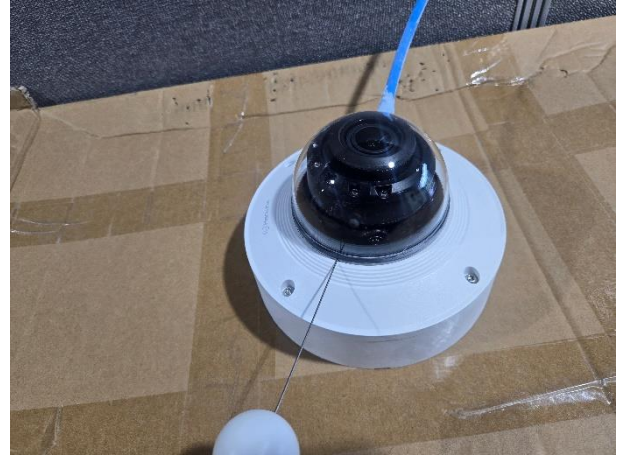
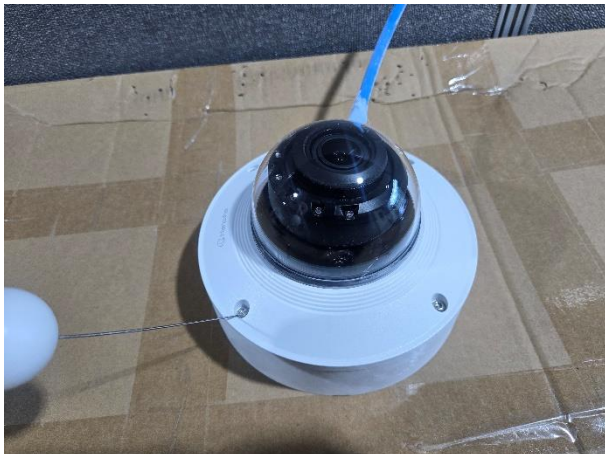
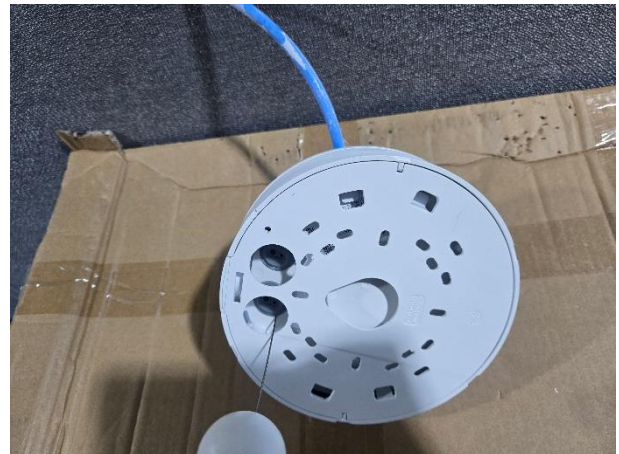
| First characteristic numeral | Degree of protection | Application |
|---|---|---|
| 6 | Protected against access to hazardous parts with a wire.<br>The access probe of 1.0 mmØ, shall not penetrate.<br>Test force: 1 N ± 10 % | <input checked="" type="checkbox"/> |

Probe test

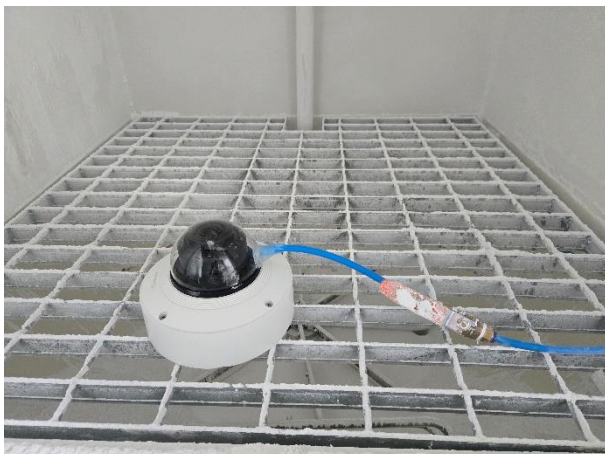
| First characteristic numeral | Degree of protection | Application |
|---|---|---|
| 6 | <p>In Dust Testing Equipment, the test sample must have no ingress of dust after testing atmospheric pressure present condition for 8 h.</p> <p>(The talcum powder must pass through a calibrated sieve with a 50 µm wire mesh, spaced at 75 µm intervals in a square pattern. Additionally, the bulk density of the talcum powder should be 2 kg/m<sup>3</sup>)</p> <p>Products in volume .....: <b>3 179.25 cm<sup>3</sup> → 3.179 L</b></p> <p>Target intake volume (Products in volume 80) : <b>254.34 L</b></p> <p>Suction volume (Max product in volume 60) ...: <b>190.755 LPH → 3.179 LPM</b></p> <p>Actual Suction volume .....: <b>3.175 L</b></p> <p>Suction pressure (Up to 2 kPa) .....: <b>2 kPa</b></p> <p>Test time (Up to 8 time) .....: <b>8 hr</b></p> | <input checked="" type="checkbox"/> |

Dust test

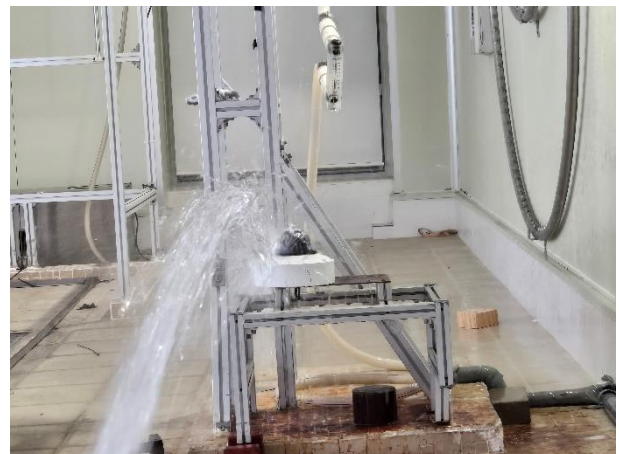
| Second characteristic numeral | Degrees of protection | Application |
|---|---|---|
| 6 | <p>The product must not be harmed in any direction even strong jet water.</p> <p>Water jet hose nozzle Fig.6, Nozzle 12.5 mm diameter</p> <p>Water flow rate: 100 l/min ± 5 % : <b>100 LPM</b></p> <p>Distance: 2.5 m to 3 m: <b>3 m</b></p> <p>Duration of test: 1 min/m<sup>2</sup> at least 3 min: <b>3 min</b></p> | <input checked="" type="checkbox"/> |

Water test

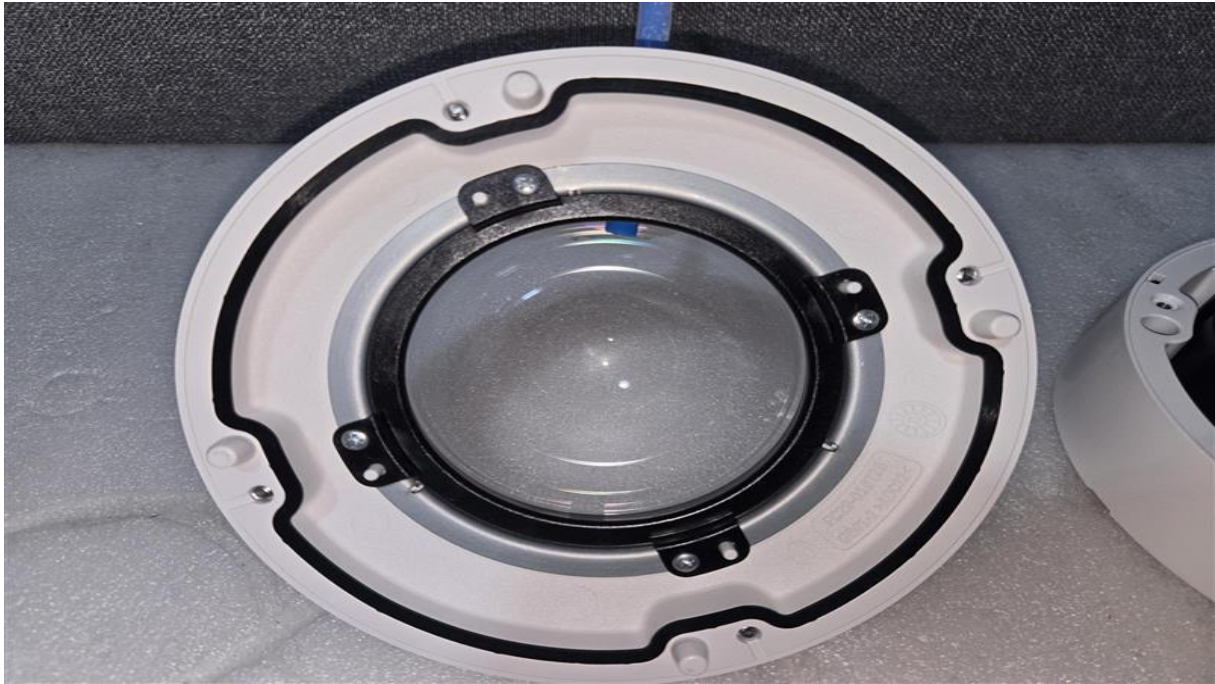
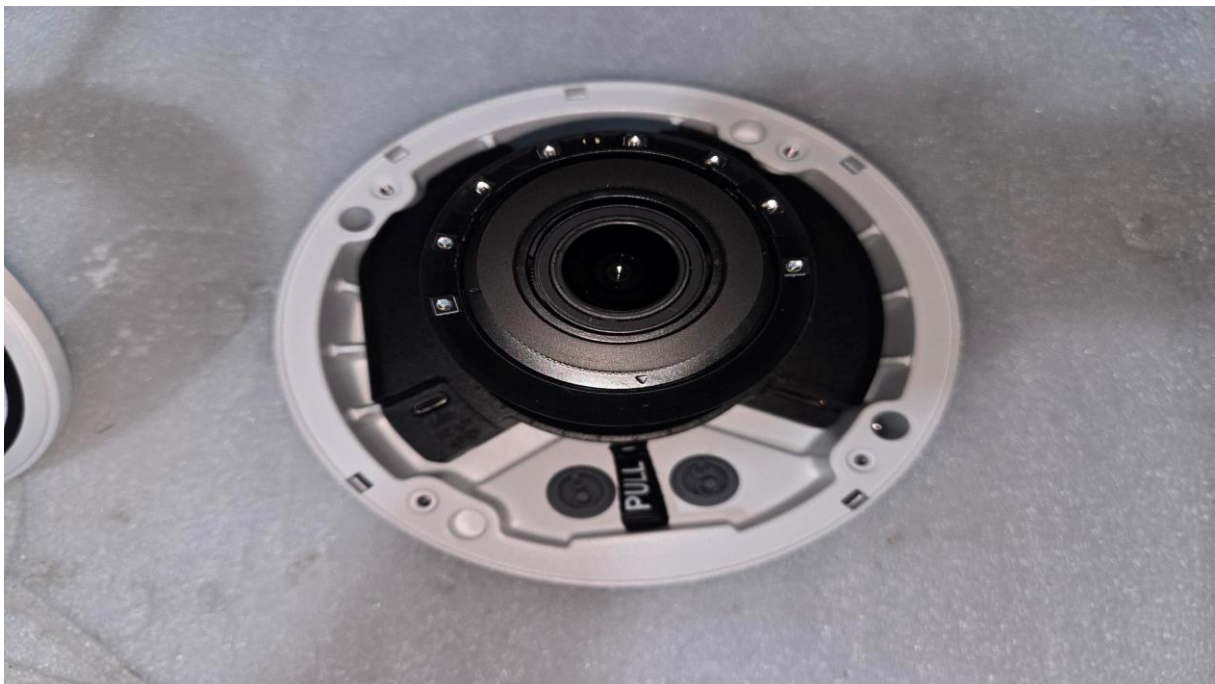
#### 3.5.1 Product internal images after test [The first characteristic numeral test]

| IP code | Evaluation Criteria | Test Results | Remark |
|---|---|---|---|
| IP 6X | No ingress of Probe | Normal | - |
| | No ingress of dust | Normal | |
