# TEST REPORT

REPORT No.:  
CTK-2025-02944  
Page (1) / (13) pages

NETWORK CAMERA / XNV-A9085R

IEC 60529:1989 +A1:1999+A2:2013

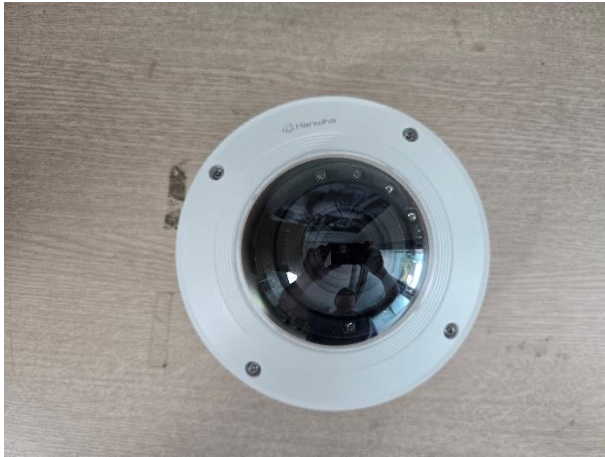
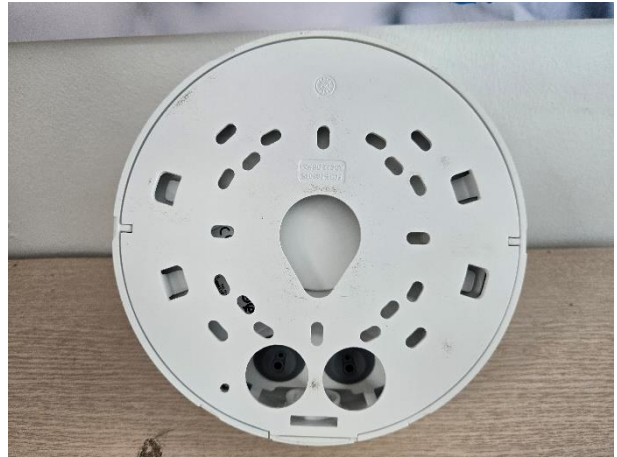
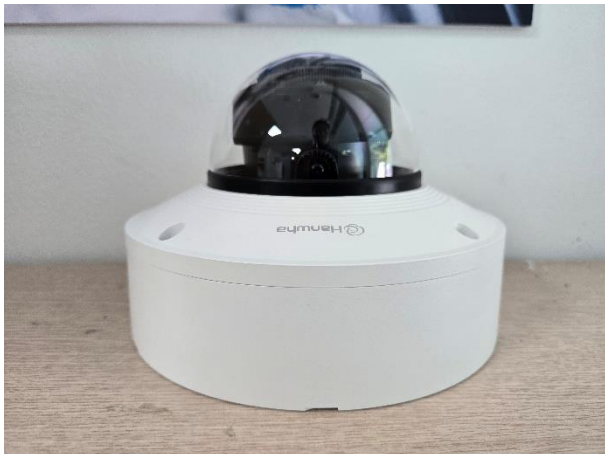
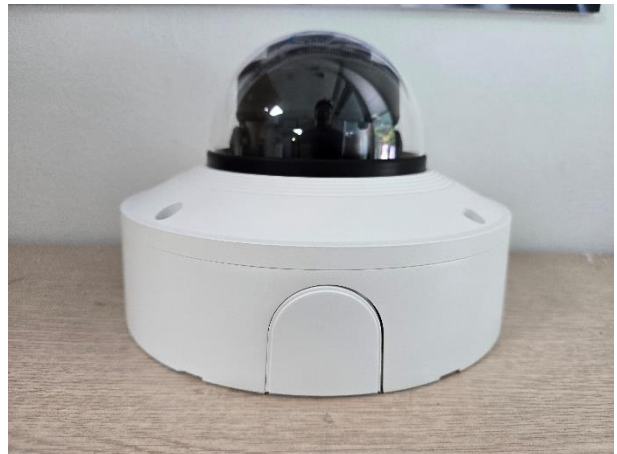
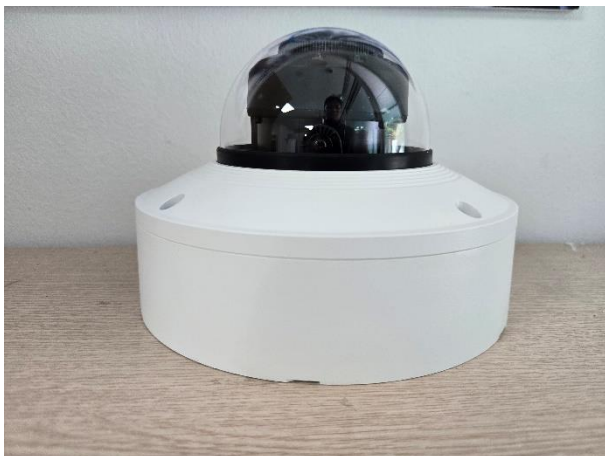
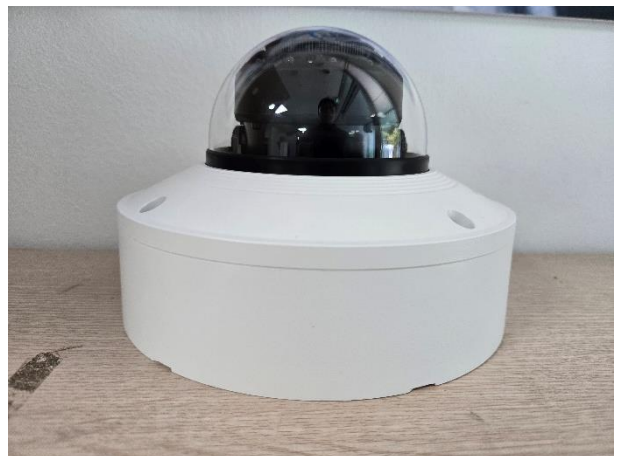
### 2.4.1 Test sample #1

## 2.4 Pre-test product images

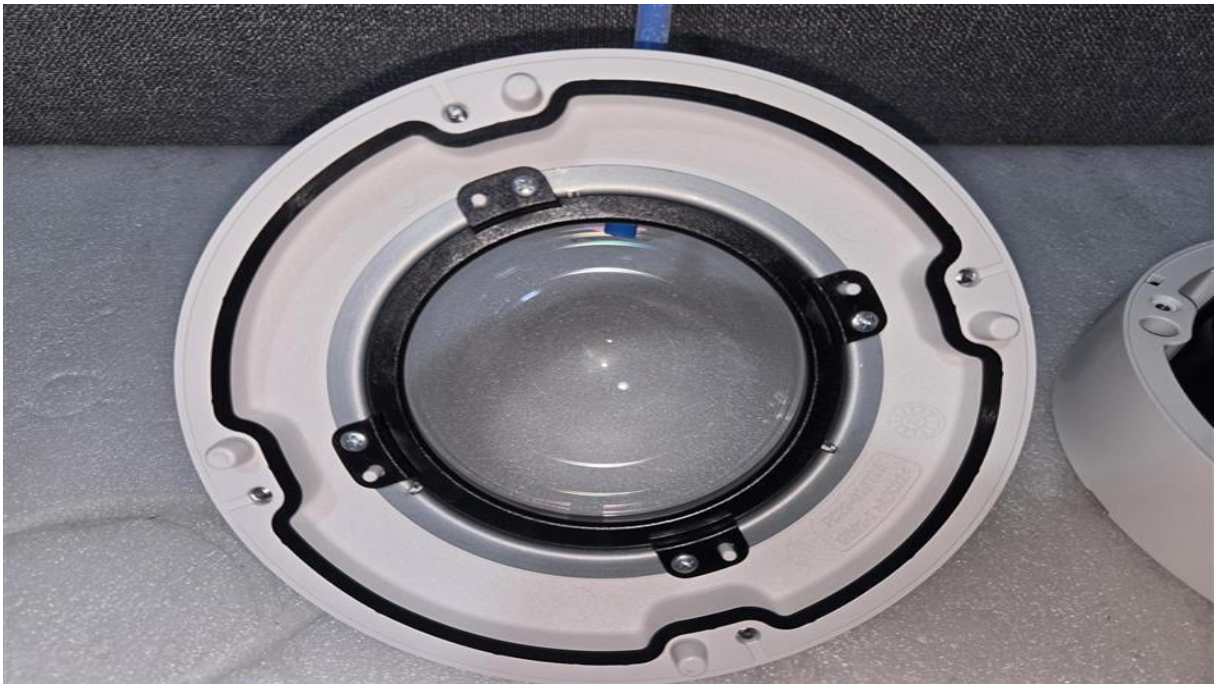
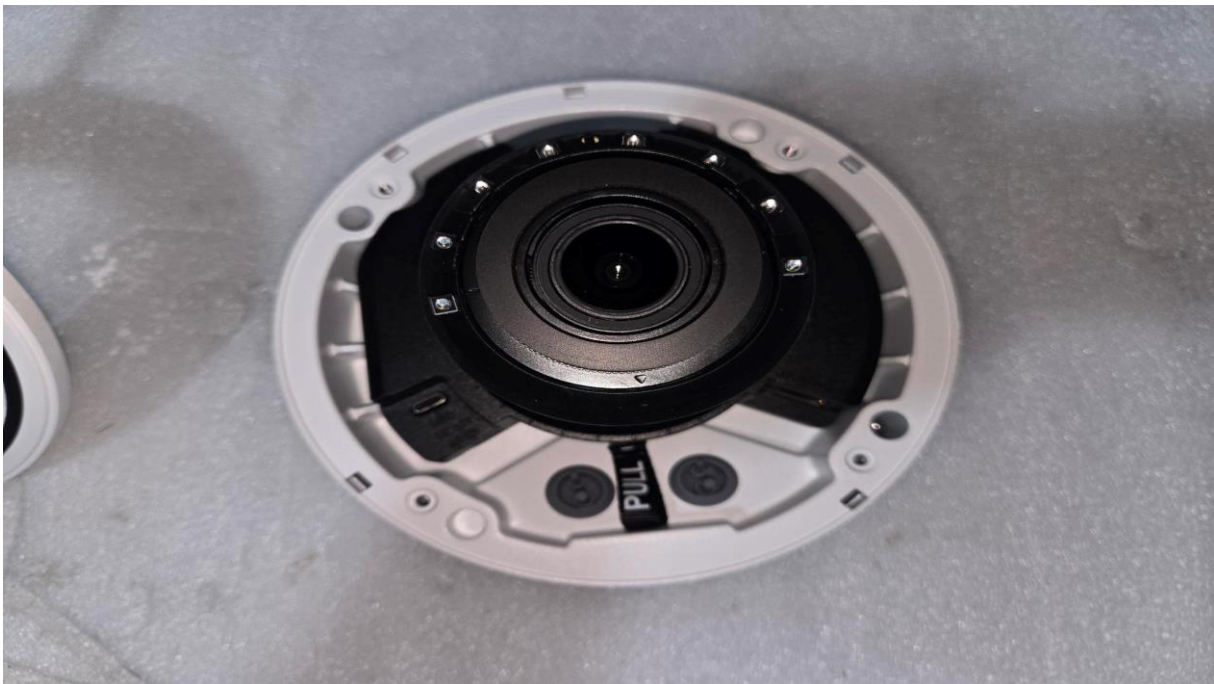
#### 3.5.1 Product internal images after test [The first characteristic numeral test]

| IP code | Evaluation Criteria | Test Results | Remark |
|---|---|---|---|
| IP 6X | No ingress of Probe | Normal | - |
| | No ingress of dust | Normal | |

※ Refer to the product photos after the completion of testing in section 3.5.

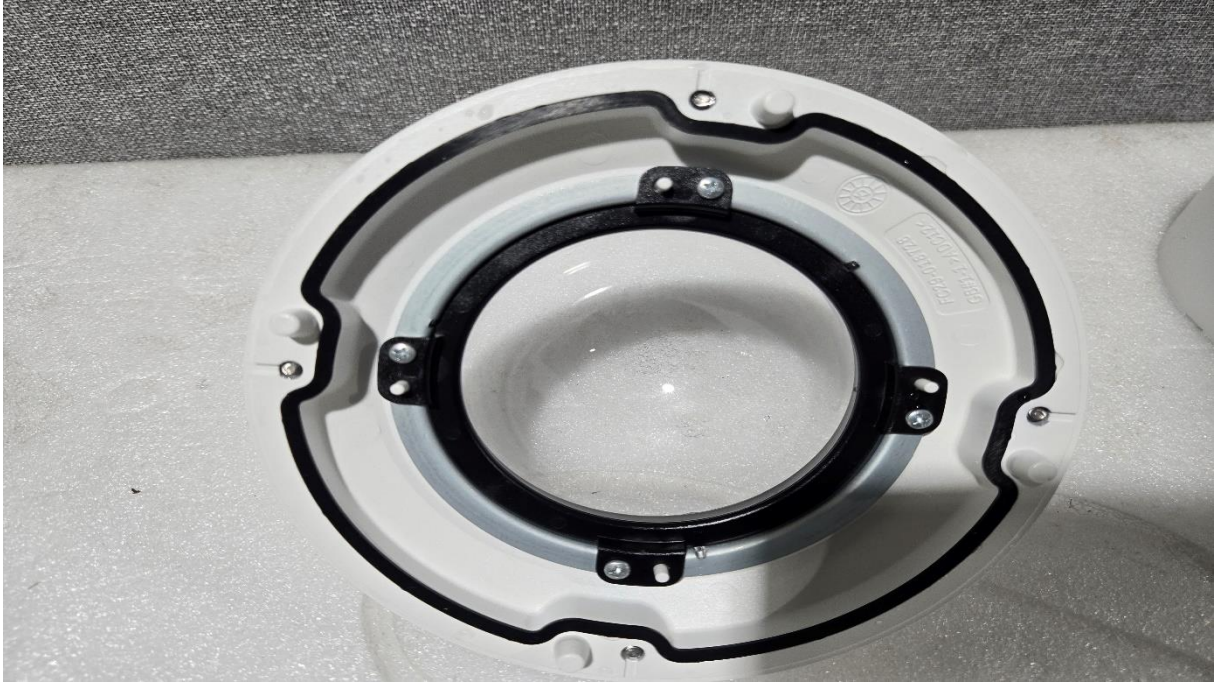
### 3.5.2 Product internal images after test [The second characteristic numeral test]

| IP code | Evaluation Criteria | Test Results | Remark |
|---|---|---|---|
| IP X7 | No ingress of water | Normal | |
